Field Assessment Report (Hot Spots)

Site No.: 1 Location: 700 Blk McKie St (Willow Springs Creek)

San Marcos Comprehensive Watershed Master Plan
Field Assessment Form - Local Flood Complaints

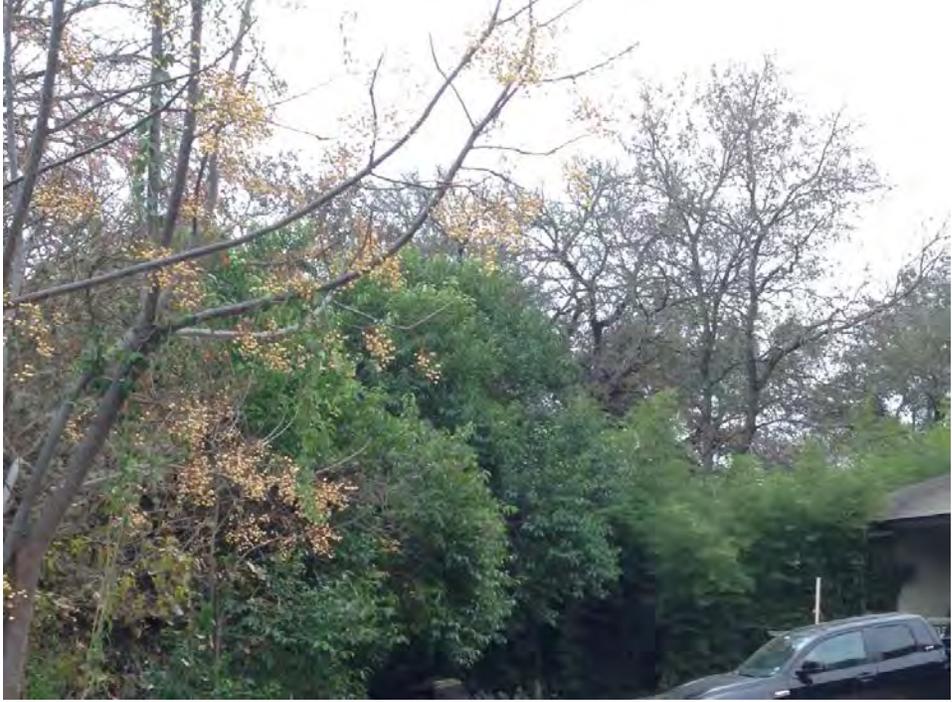
Site No.: 2 Location: 600 Blk Moore St		BACK TO MAP
SITE PHOTOGRAPHS	Photo #	Caption
	P3	<i>Vegetation & bamboo behind houses along channel; looking south from Oscar Smith St</i>

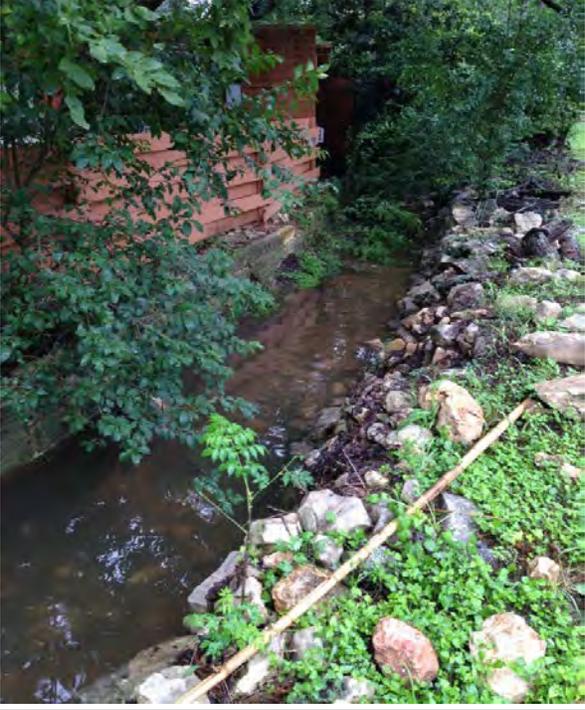
SITE PHOTOGRAPHS	Photo #	Caption
	P4	<i>Stone channel wall in need of repair and vegetation U/S of inlet; looking SW from inlet</i>

OPT C *Repair/reinforce damaged channel walls upstream of the grate on 613 Moore.* 1

Notes: Vegetation mgmt. recommended to reduce bamboo and other debris accumulation
Repair of stone channel walls near 613 Moore is recommended
Extension of existing 54" SD to Blanco St may intercept stormwater U/S of channel

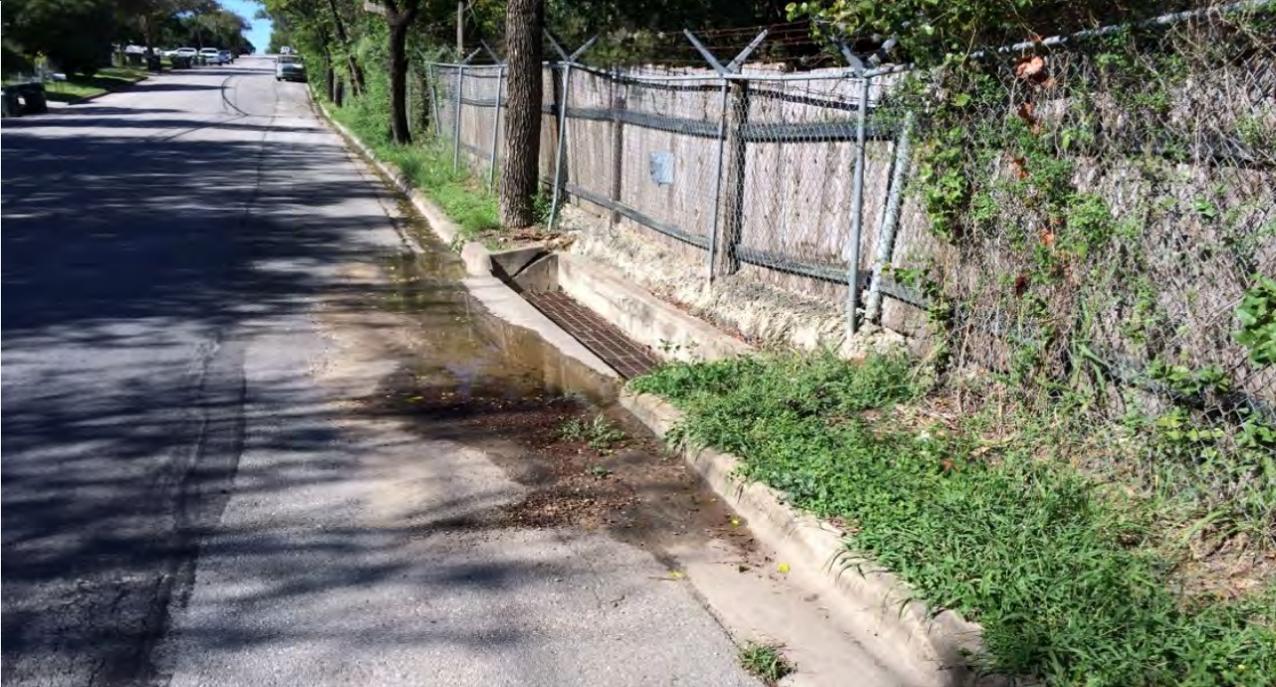
Cause of Flooding: *Grate inlet clogs during every storm event. Inlet is located in local sag on Allen Street and runoff floods area when grate clogs during nearly every rainfall event.*

Photo #	Caption
P1	<i>Looking NW along Allen St; debris, standing water, and cracking at grate inlet (10/31/13)</i>

Notes: *Replace grate inlet with multiple curb inlets to reduce cloggin/flooding frequency. If flooding persists and D/S private storm drain system has capacity, extend storm drain NW along Allen St and add curb inlets to capture flow upslope of sag area.*

Replace existing 2' x 15' grate inlet with three (3) 10-foot curb inlets to reduce

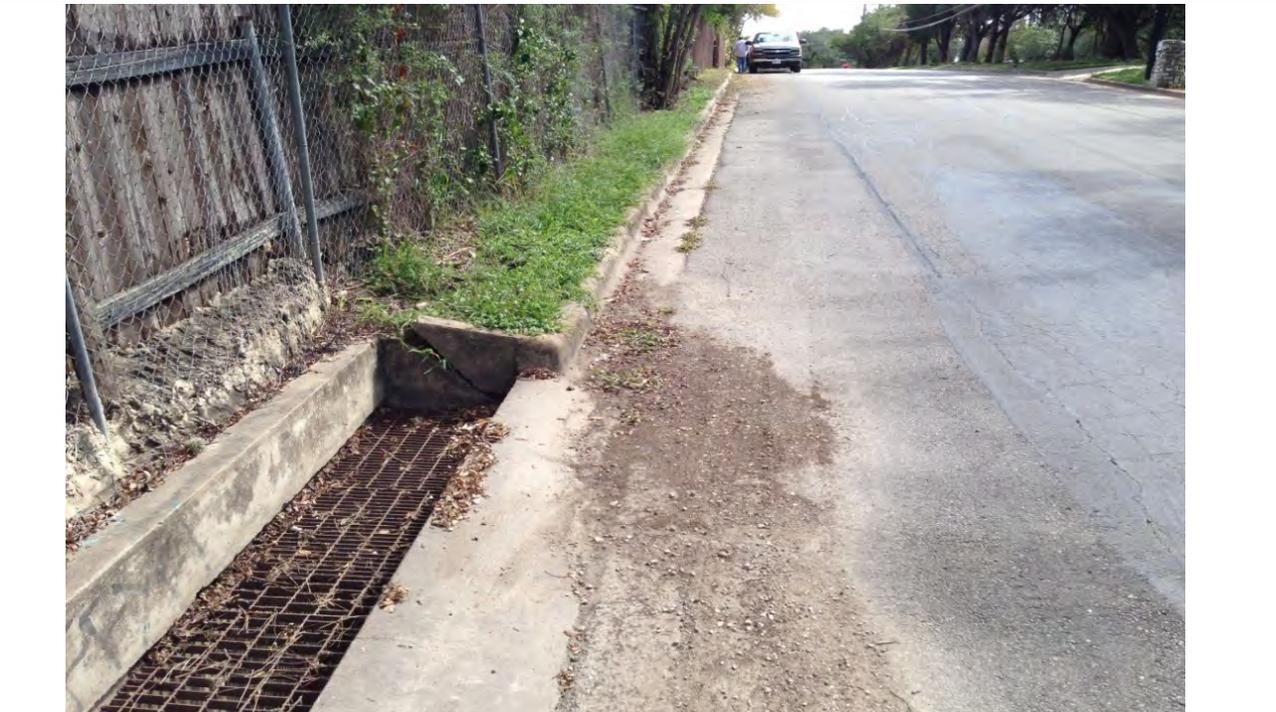
Photo #	Caption
P2	<i>Looking SE along Allen St; debris and concrete cracking at grate inlet (10/25/13)</i>

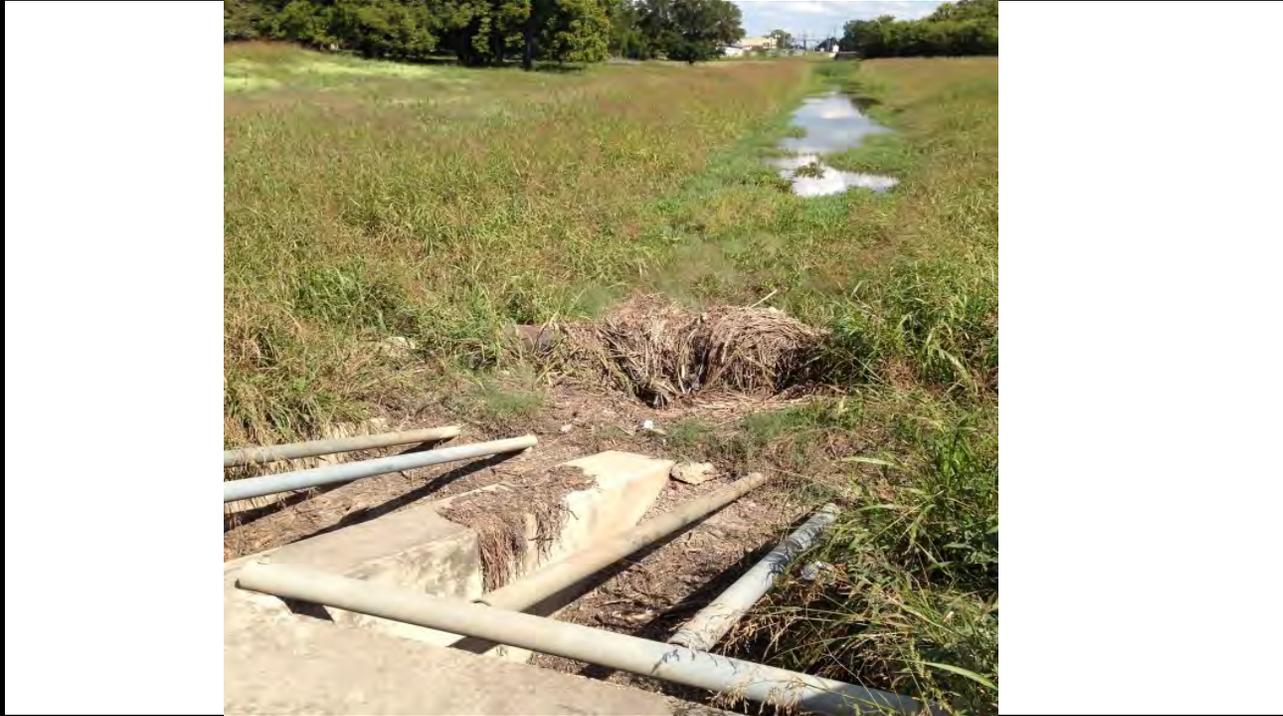
Site No.:	6	Location:	400 Bld Jackman (Purgatory Creek)	BACK TO MAP
Cause of Flooding:	<u>Low water x-ing along Purgatory Creek with frequent culvert grate clogging.</u> <u>Roadway Elev ~574'; 2yr WSE = 575.9'; 10yr WSE = 577.9'; 25yr WSE = 579'</u>			
Conceptual Solution(s):	Add Inlet / Storm Drain Pipe / Detention / Channel Improvements Vegetation Mgmt / Curb & Gutter / Driveway Adjustments Bridge/Culvert Upgrade / Structural Repair / Grading			
Notes:	<u>Remove culvert grates to improve conveyance/reduce overtopping & maintenance; avoid debris accumulation potential on WW crossing by converting to inverted siphon or encasing/protecting; Regrade channel to reduce D/S ponding in Dunbar Park</u>			
Survey Required:	Inlet / Pipe / Outfall / Channel / Street / Building / Bridge / Utility			
Notes:				
Add'l Assessment Required:	<u>Inspect WW line for leaks (algae growth noted in D/S ponding)</u>

P1	<i>Looking E from crossing; debris on D/S grate and WW crossing, ponding D/S (10/25/13)</i>
----	---

OPT A *Existing WW line on D/S side of crossing must be protected with rock riprap/encasement or converted to inverted siphon (preferred) to prevent debris accumulation/damage.*

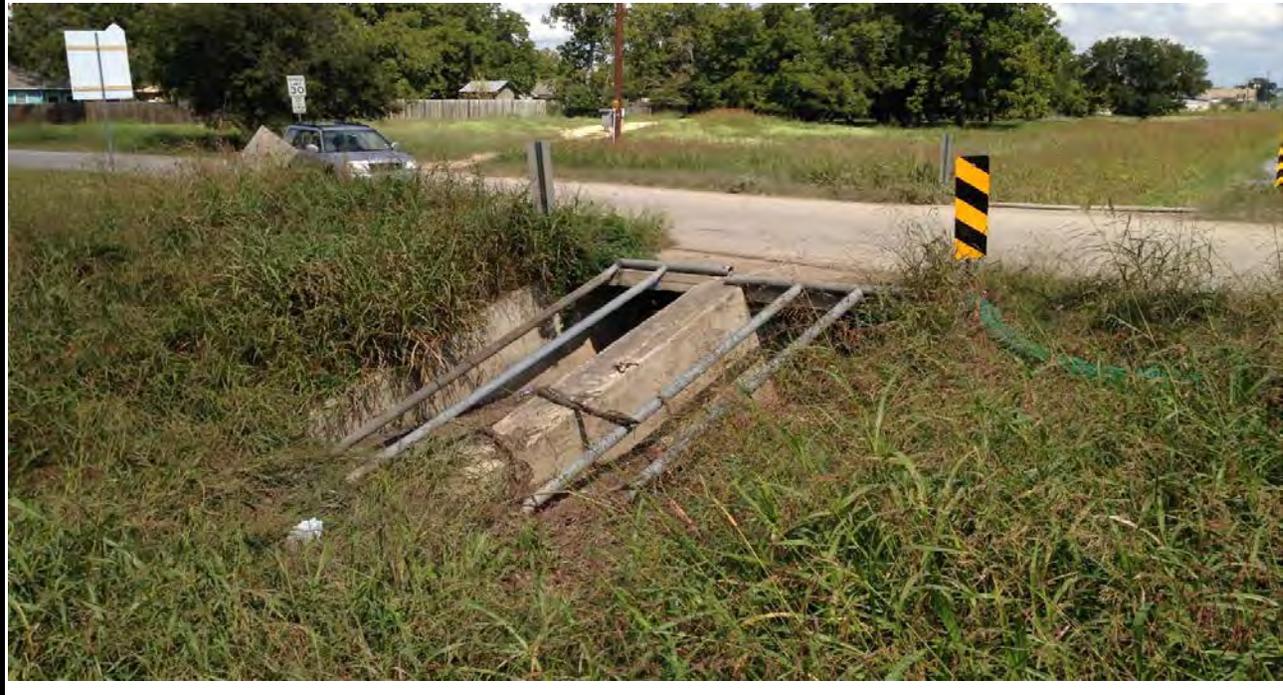
P2	<i>Looking E from Gravel St; debris on U/S grate (10/25/13)</i>
----	---

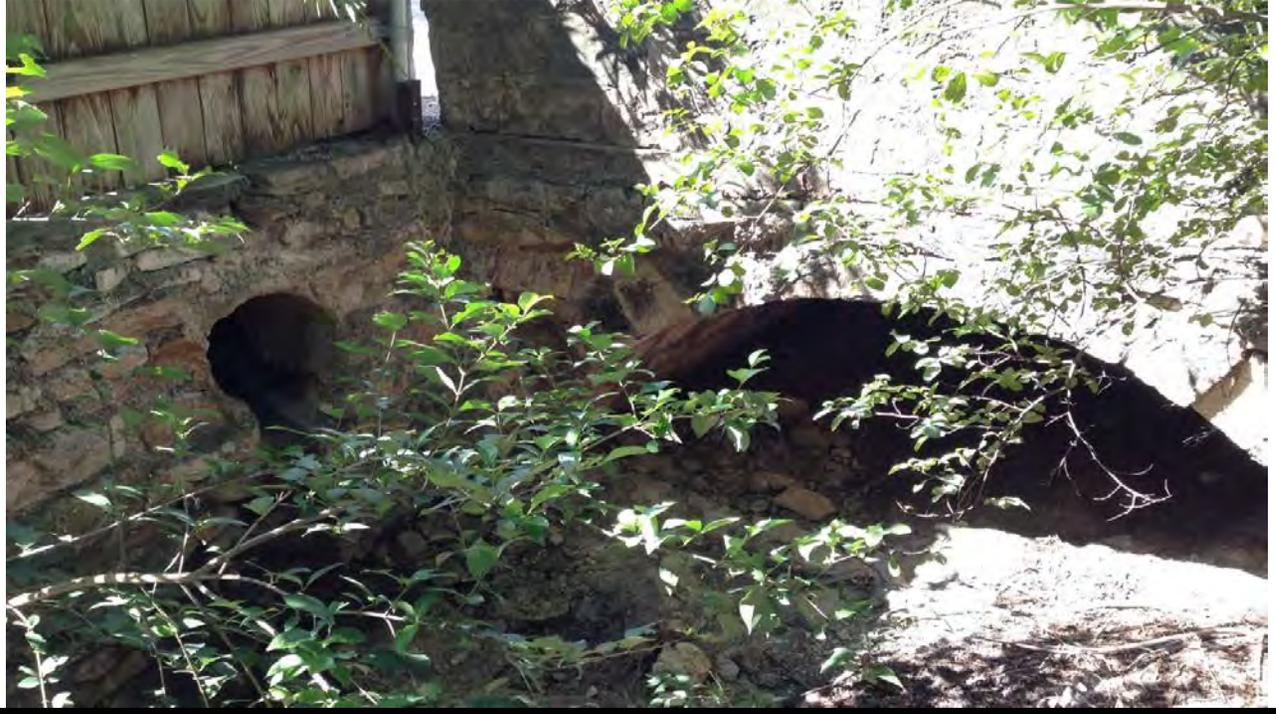
P4	<i>Looking W at outfall of stone arch culvert and 18" lateral from south grate inlet</i>
----	--

Replace two grate inlets with curb inlet(s) to reduce clogging/flooding frequency.

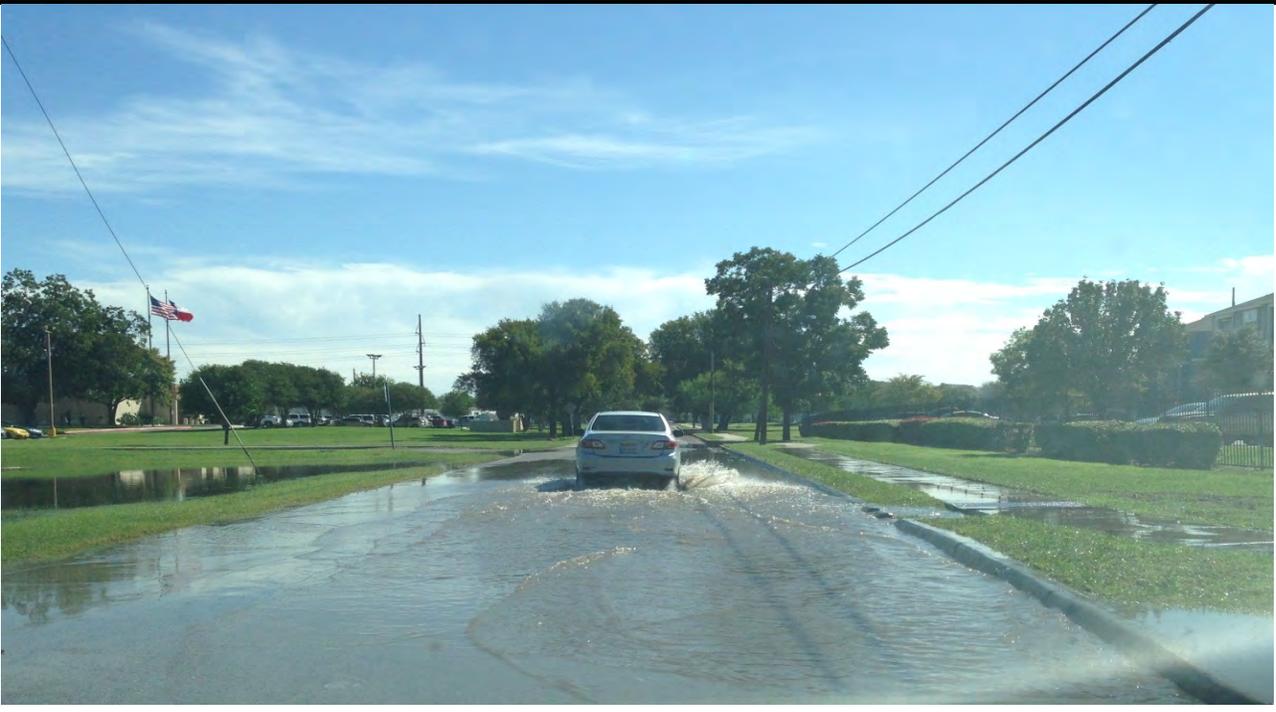
P1	<i>Looking E along Uhland Rd; significant roadway and property flooding (10/31/13)</i>
----	--

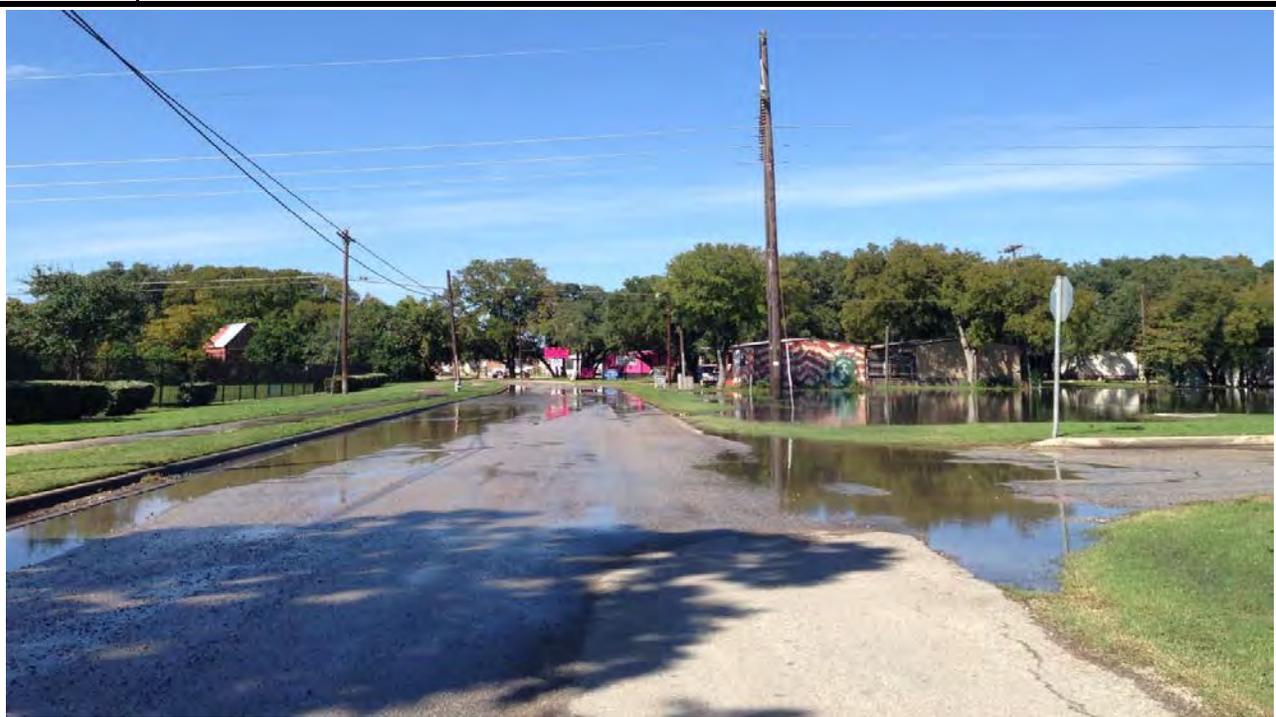
P2	<i>Looking W along Uhland Rd; significant roadway and property flooding (10/31/13)</i>
----	--

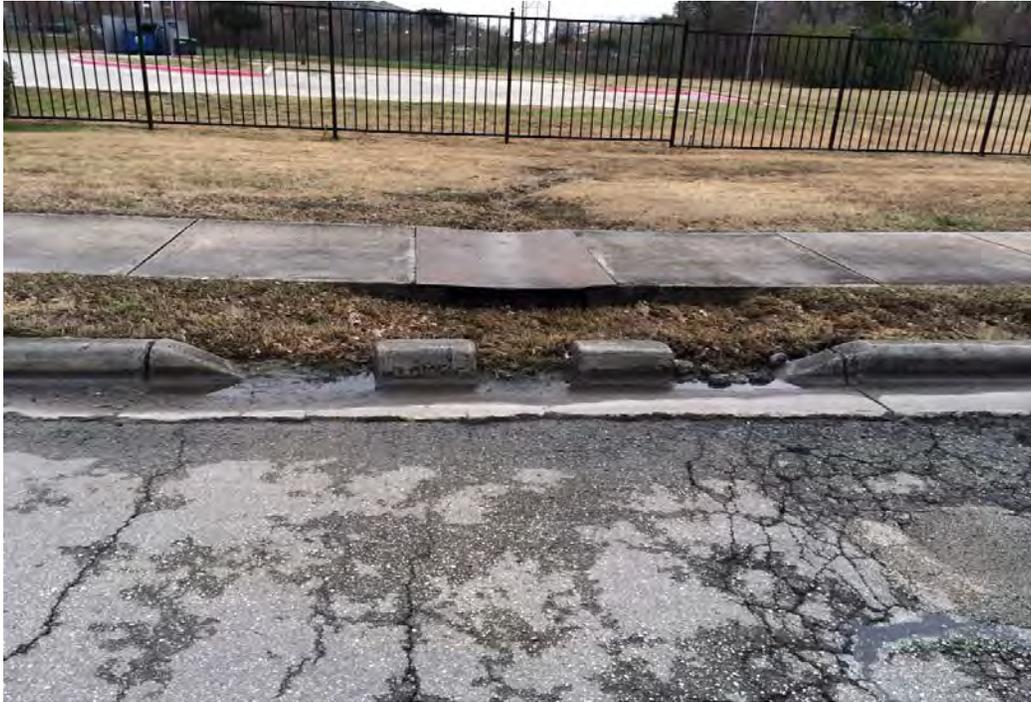
P3	<i>Lkg S at curb cut & poorly defined channel; standing water, pavement damage (1/9/14)</i>
----	---

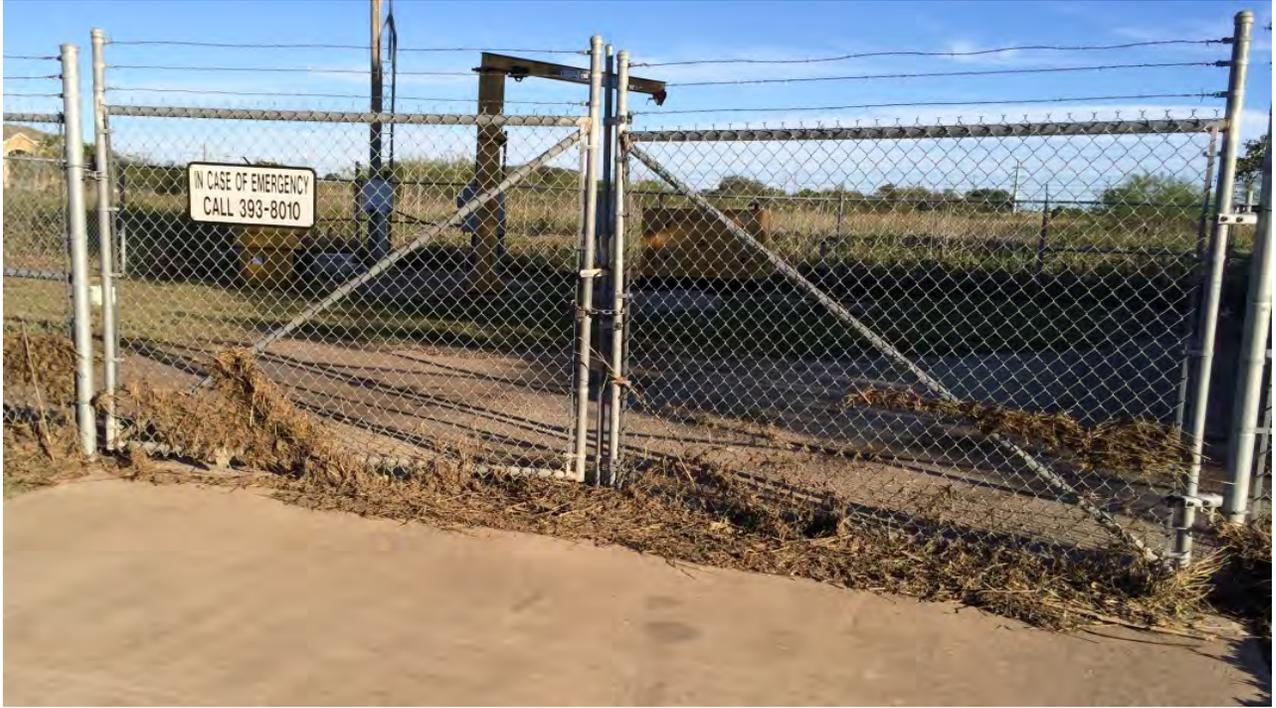
P1	Looking E at lift station chain link fence/gate; debris line 2-3ft high (10/31/13)
----	--

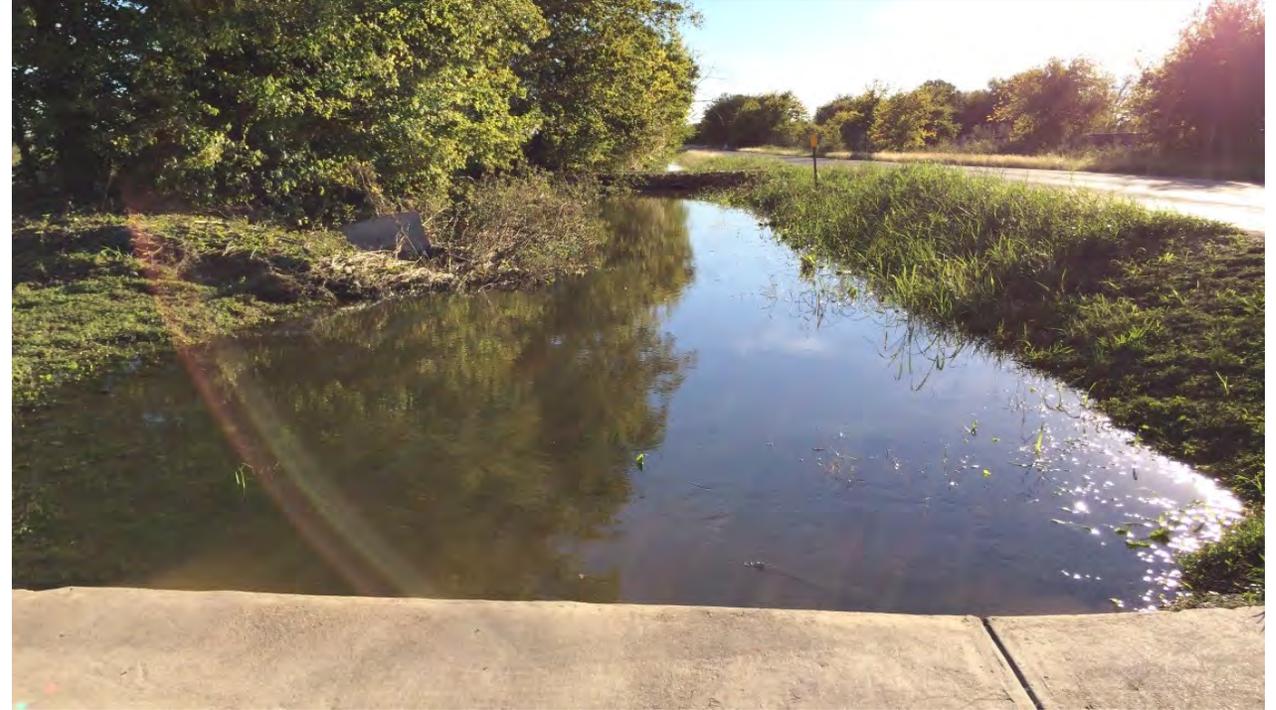
P2	Looking SW from lift station driveway along roadside ditch; standing water (10/31/13)
----	---

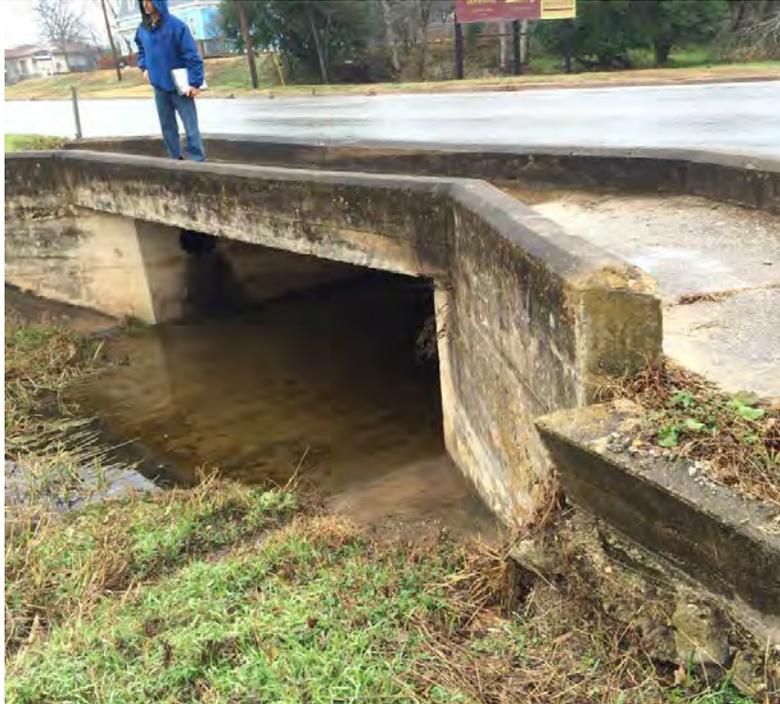
<i>P3</i>	<i>Looking NE at retaining wall failure on U/S face of crossing</i>
-----------	---

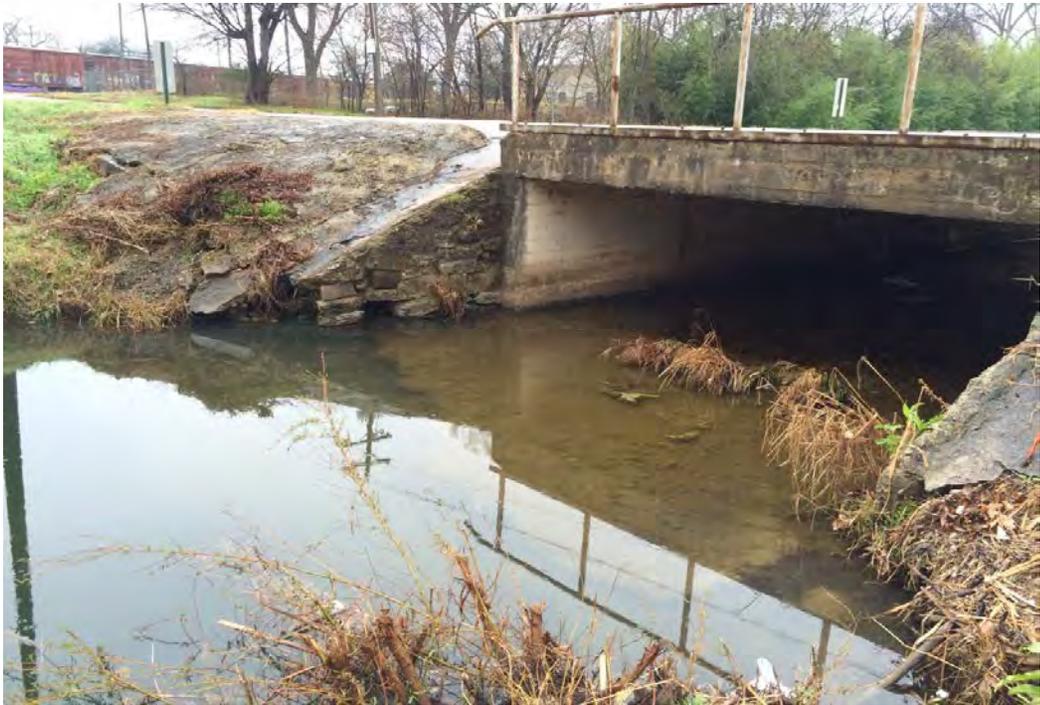
<i>P4</i>	<i>Looking SW at cracking on D/S embankment slope paving</i>
-----------	--

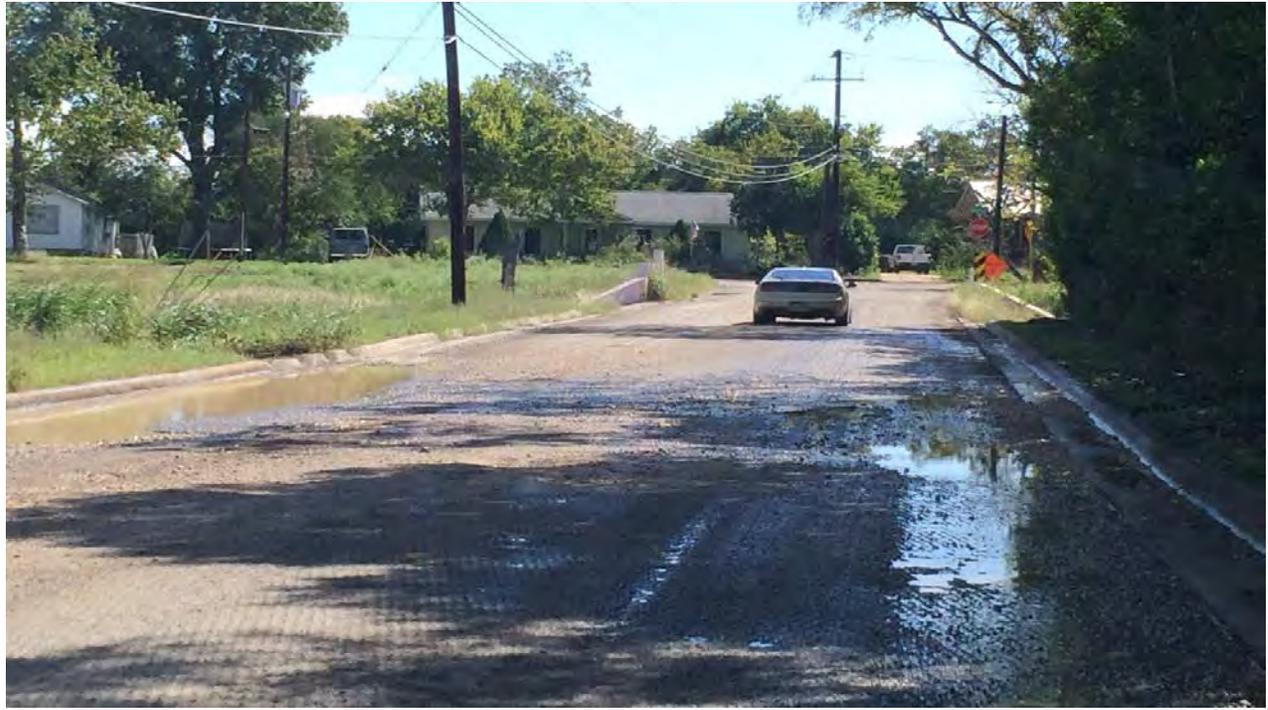
P1	<i>Looking SE along Mitchell toward crossing; standing water/mud in road (10/31/13)</i>
----	---

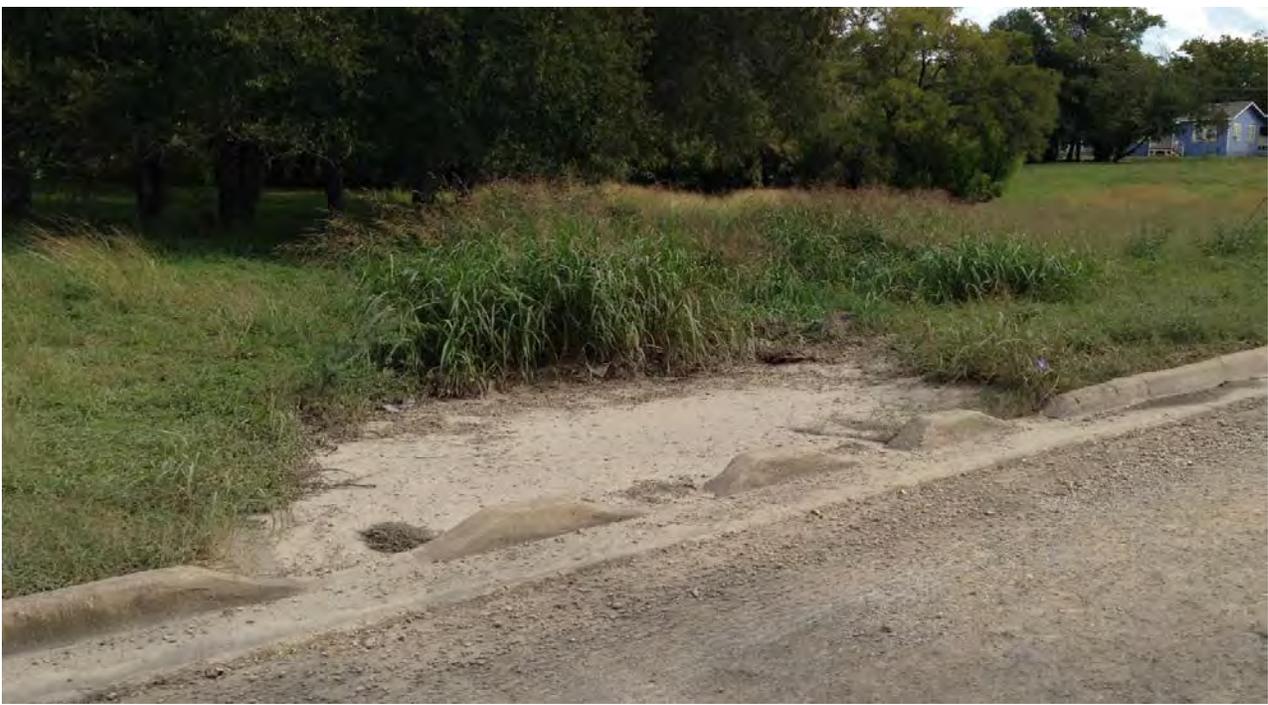
P2	<i>Looking E at curb cut along NE side of Mitchell; erosion and debris accumulation</i>
----	---

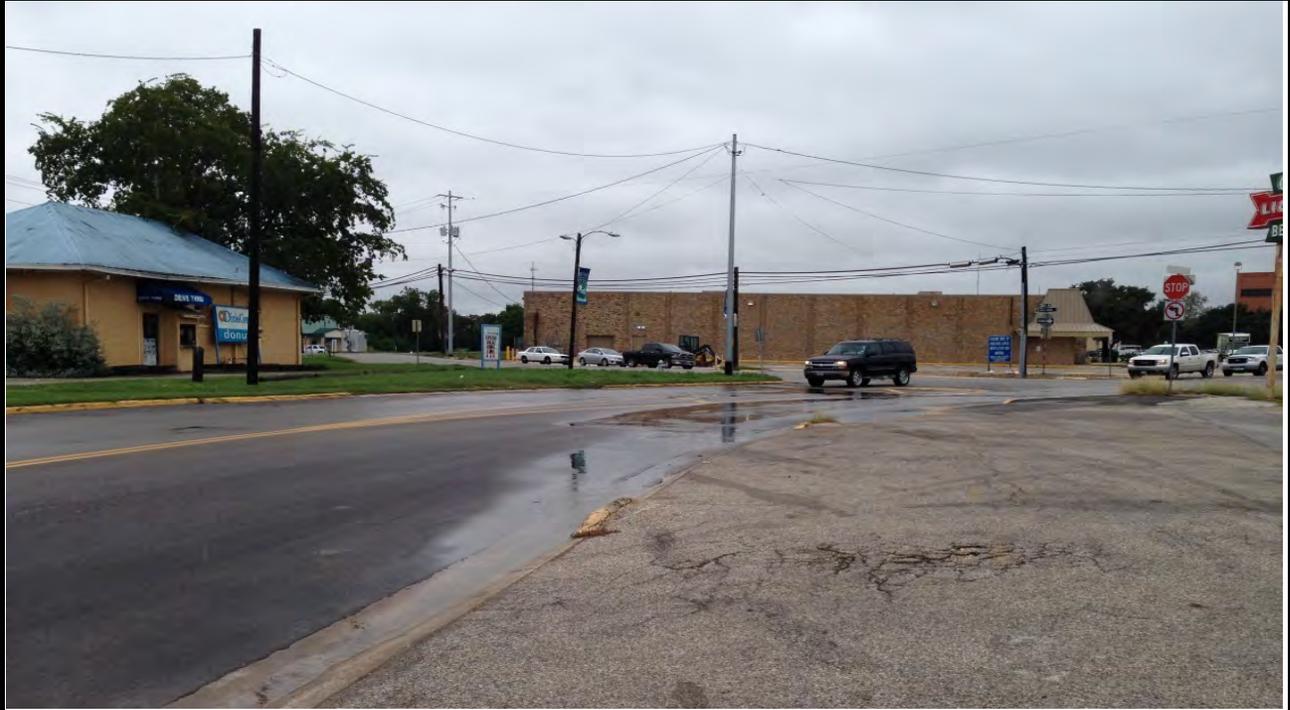
P1	<i>Looking SW towards LBJ from NW side of Ed Gary; standing water in roadway</i>
----	--

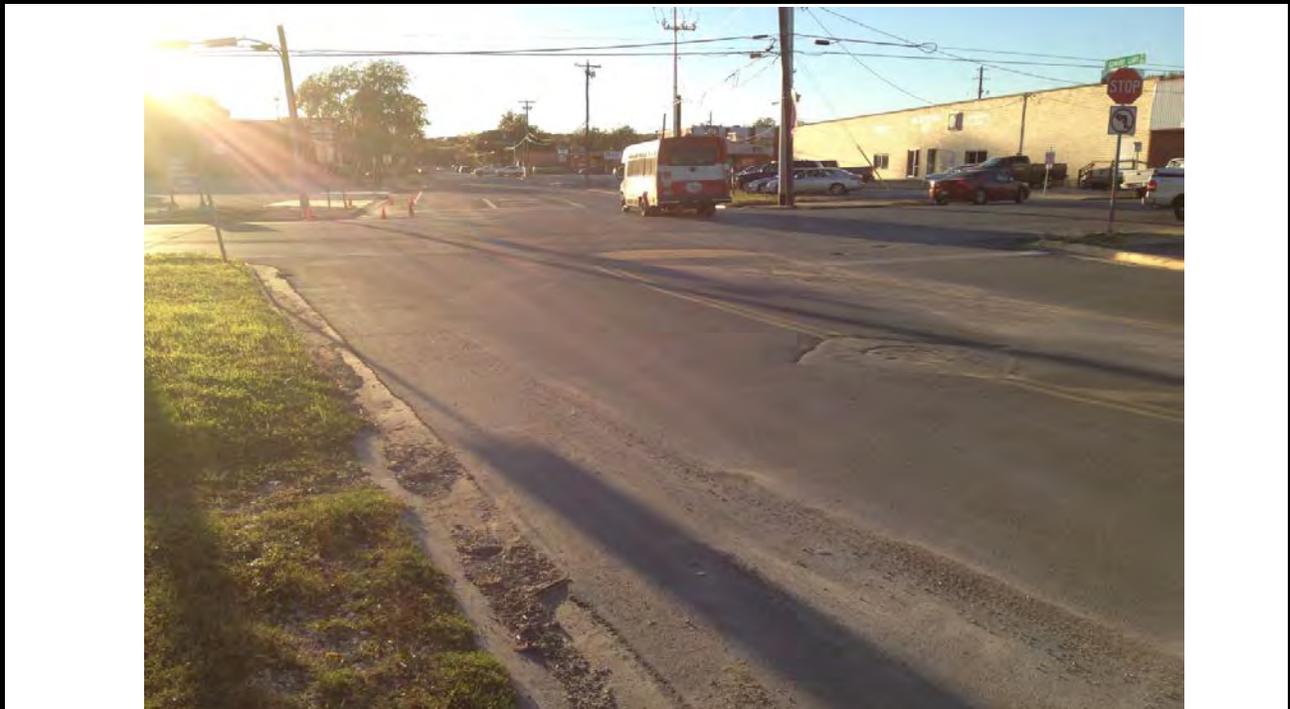
P2	<i>Looking W towards intersection of Ed Gary / LBJ; sediment in road from previous flooding</i>
----	---

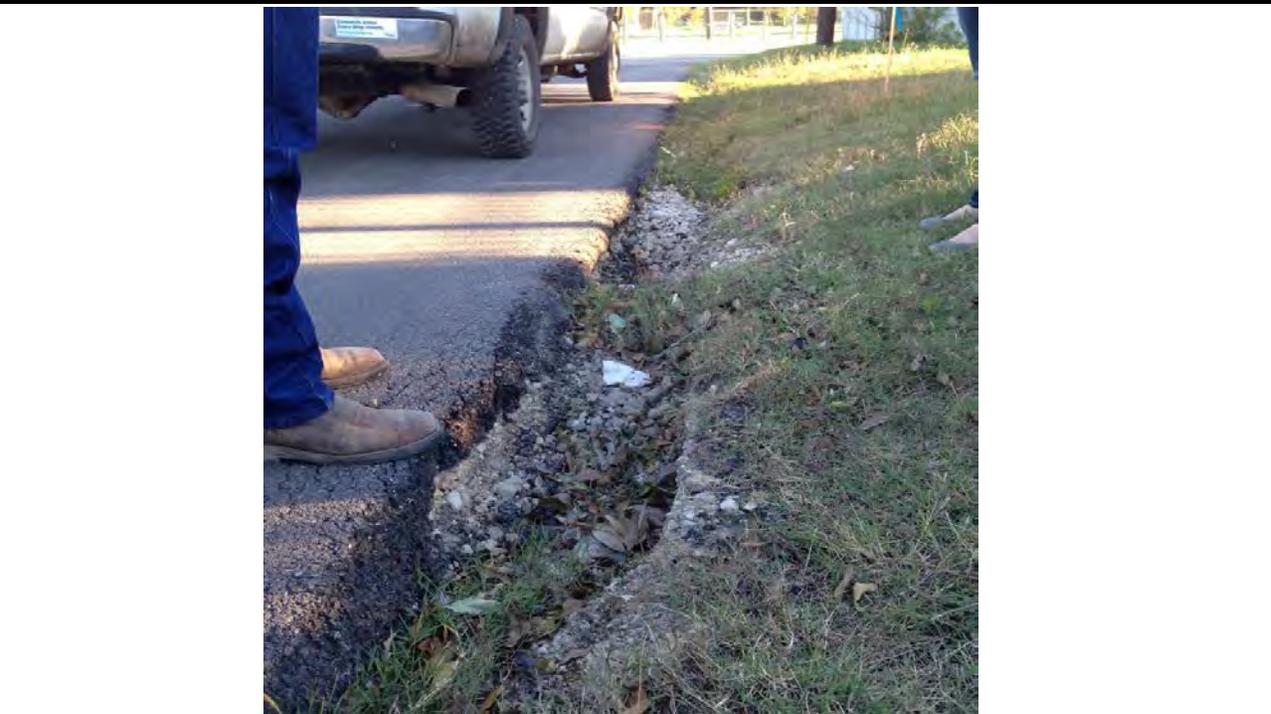
<i>P4</i>	<i>Looking S on Ed Gary on W edge of pavement; erosion</i>
-----------	--

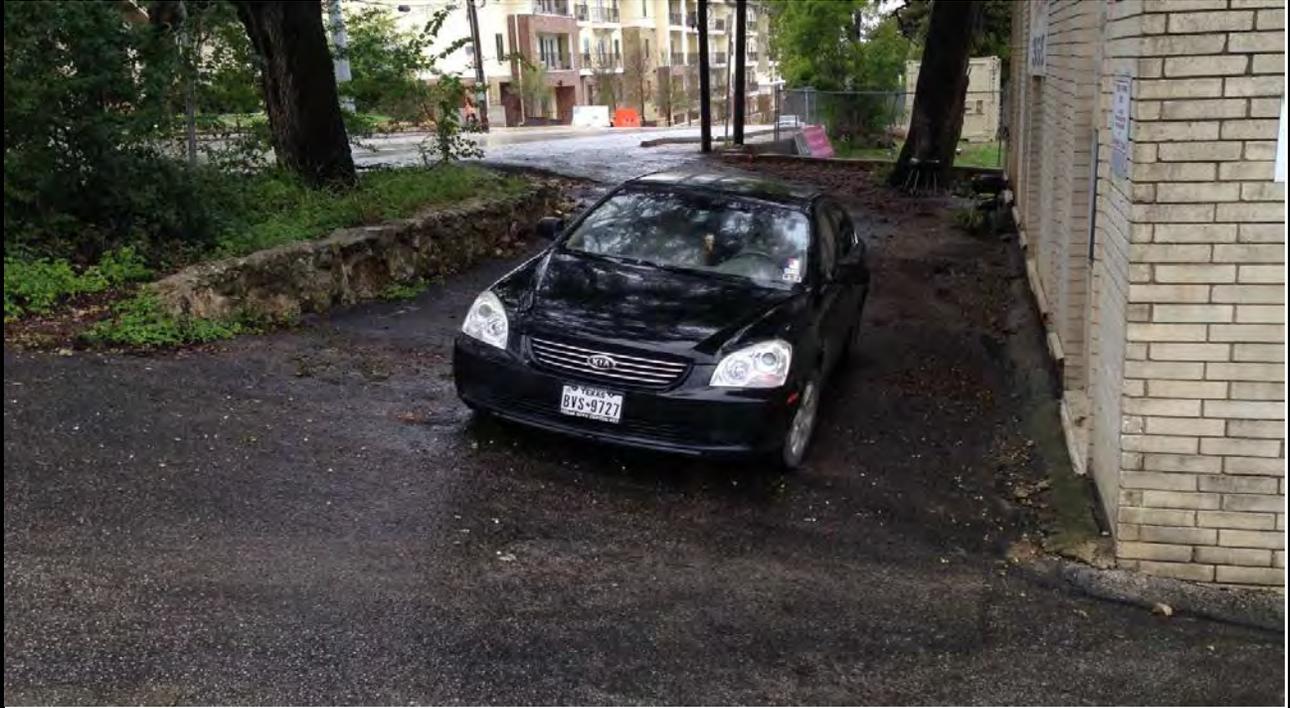
P1	<i>Looking S at local sag area along E side of apartment complex</i>
----	--

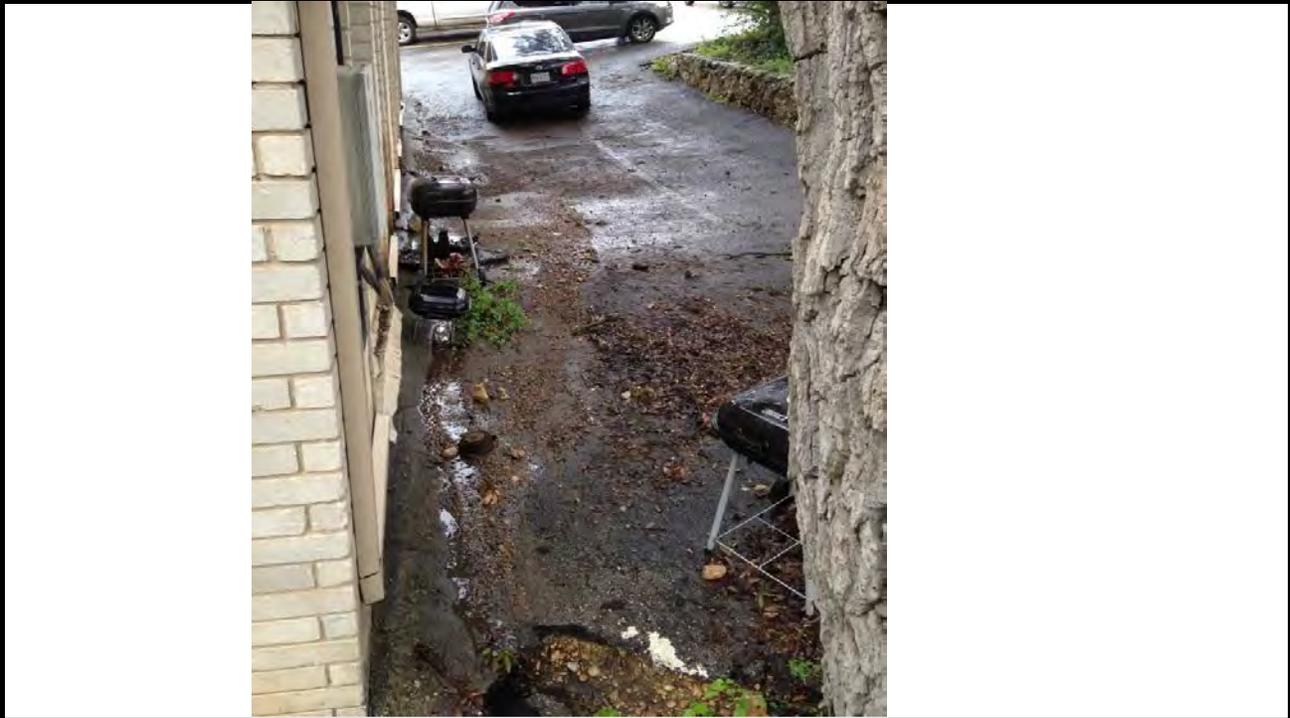
P2	<i>Looking N along E edge of bldg; concrete/pavement damage and erosion; debris accumulation</i>
----	--

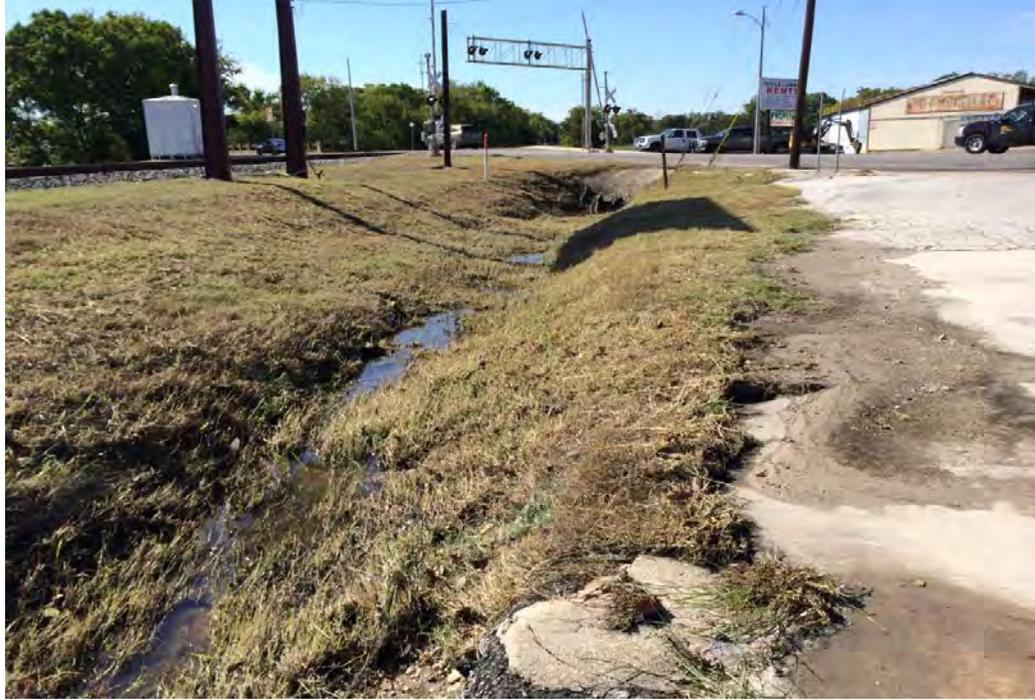
P1	<i>Looking W toward S Guadalupe Street; light flow in channel; sediment in parking lot</i>
----	--

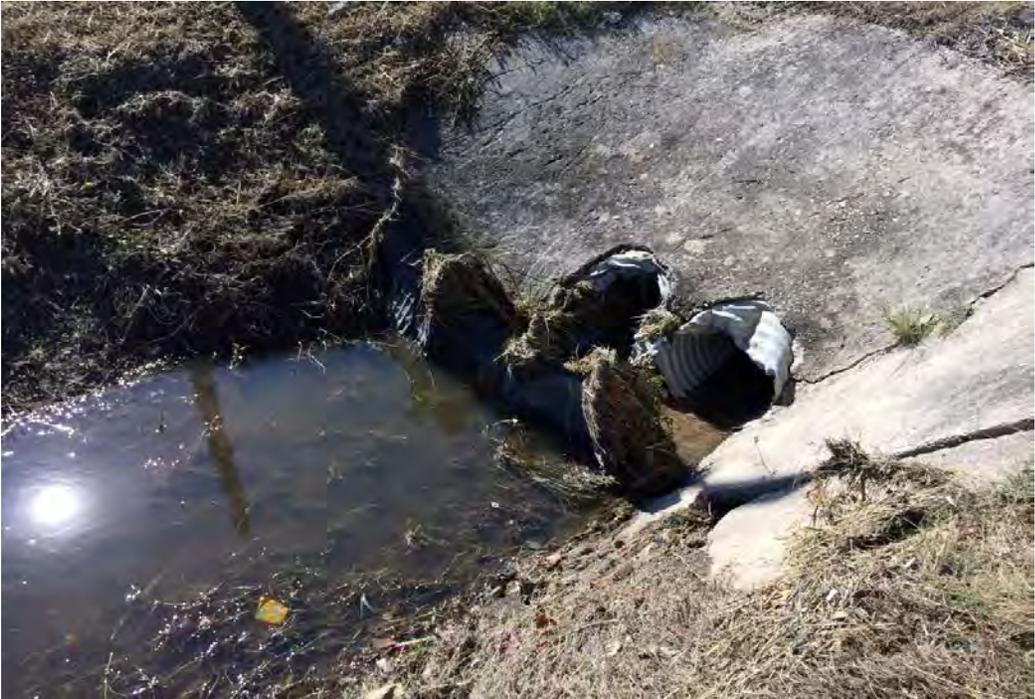
P2	<i>Looking W at damaged CMP culvert inlet at S Guadalupe Street</i>
----	---

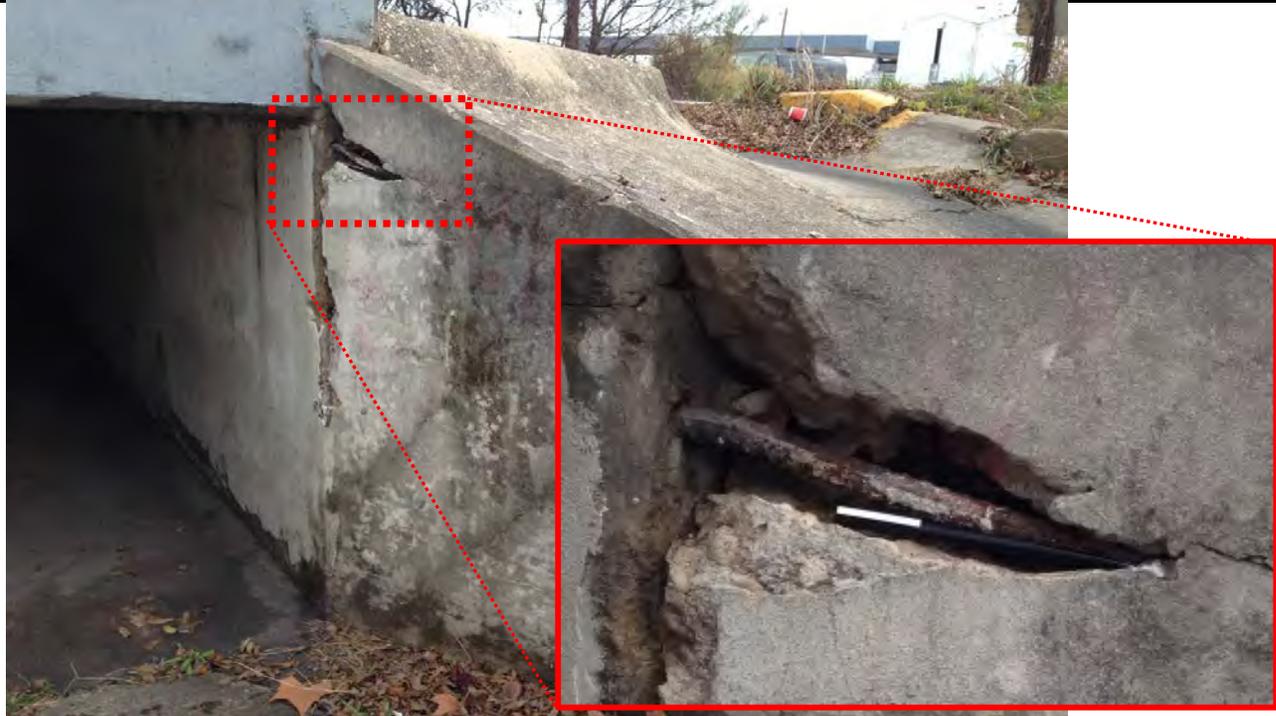
P1	<i>Looking SE at concrete spauling and exposed rebar on U/S wingwall/culvert (w/ detail)</i>
----	--

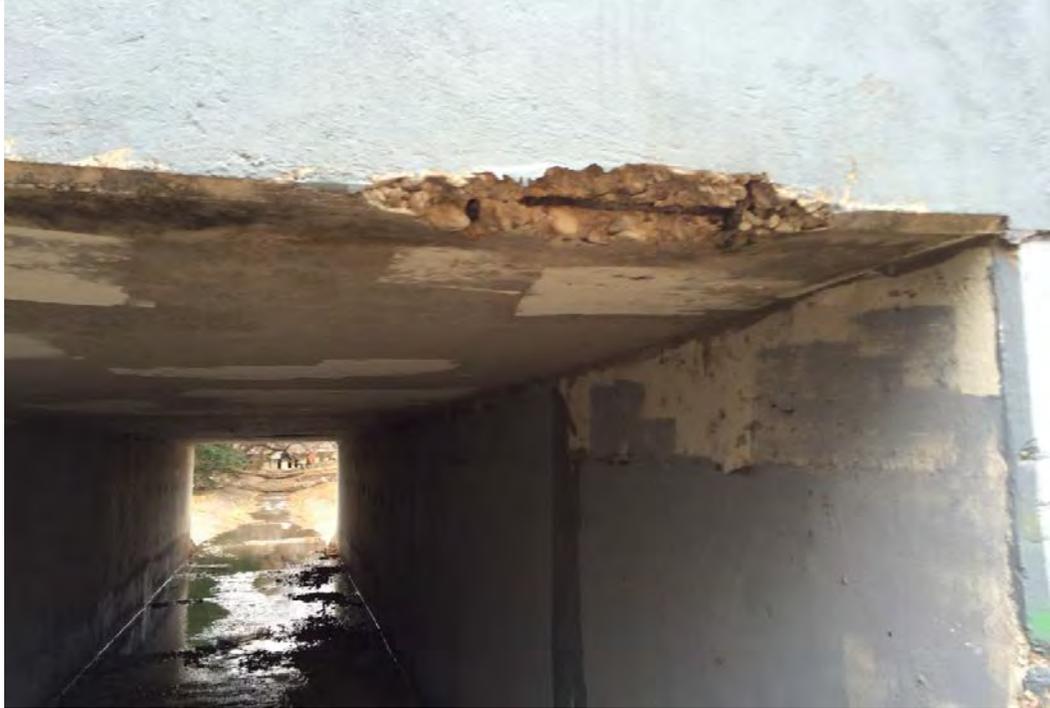
P3	<i>Looking W at concrete spalling and exposed rebar at top of center culvert at D/S face</i>
----	--

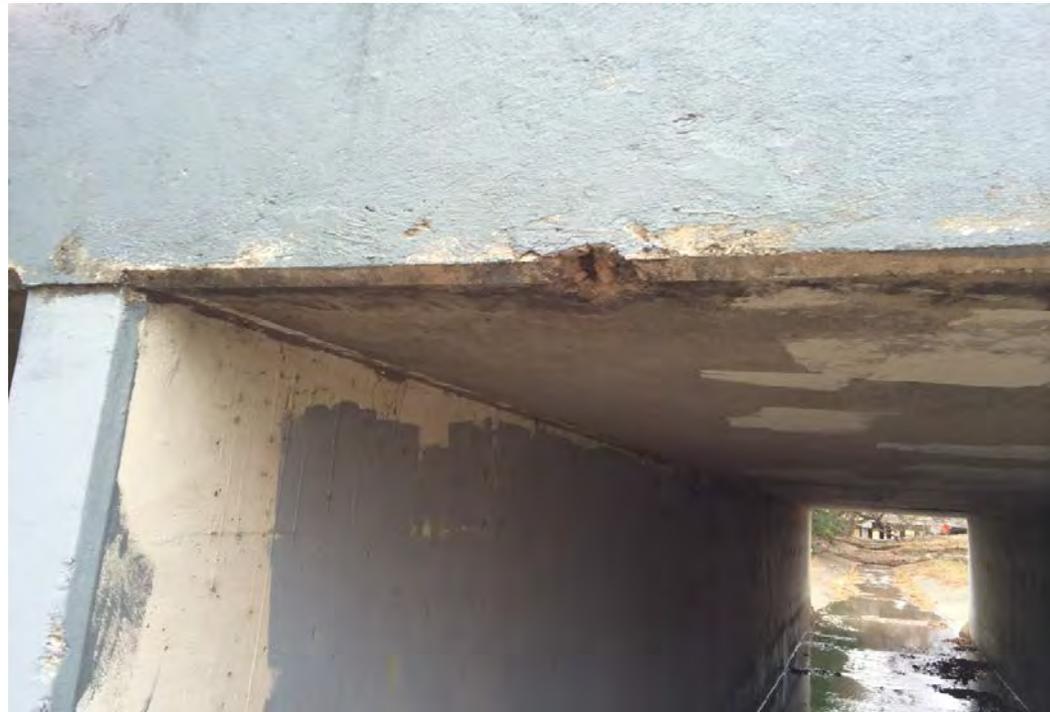
P4	<i>Looking W at concrete spalling and exposed rebar at top of center culvert at D/S face</i>
----	--
