Field Assessment Report (Hot Spots)

Site No.: 1 Location: 700 Blk McKie St (Willow Springs Creek)

San Marcos Comprehensive Watershed Master Plan
Field Assessment Form - Local Flood Complaints

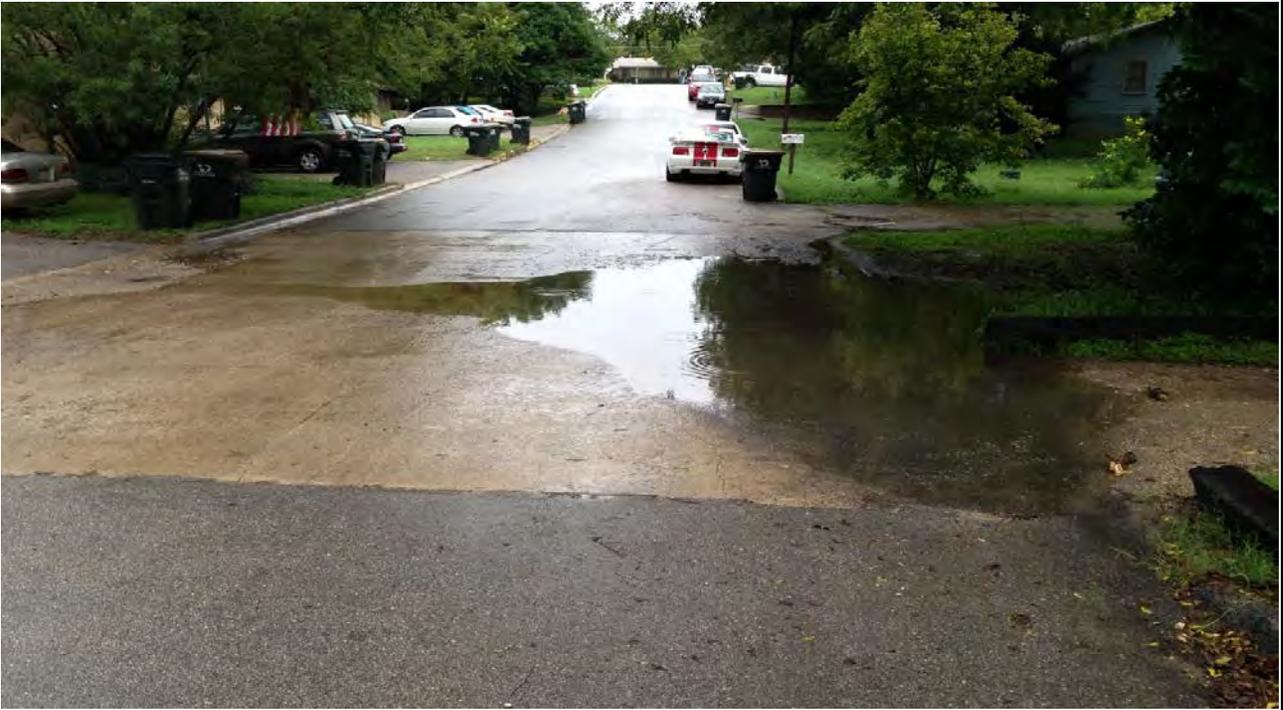
P1	<i>Looking NE at ponding in front of 425 Sarah Street (10/16/13)</i>
----	--

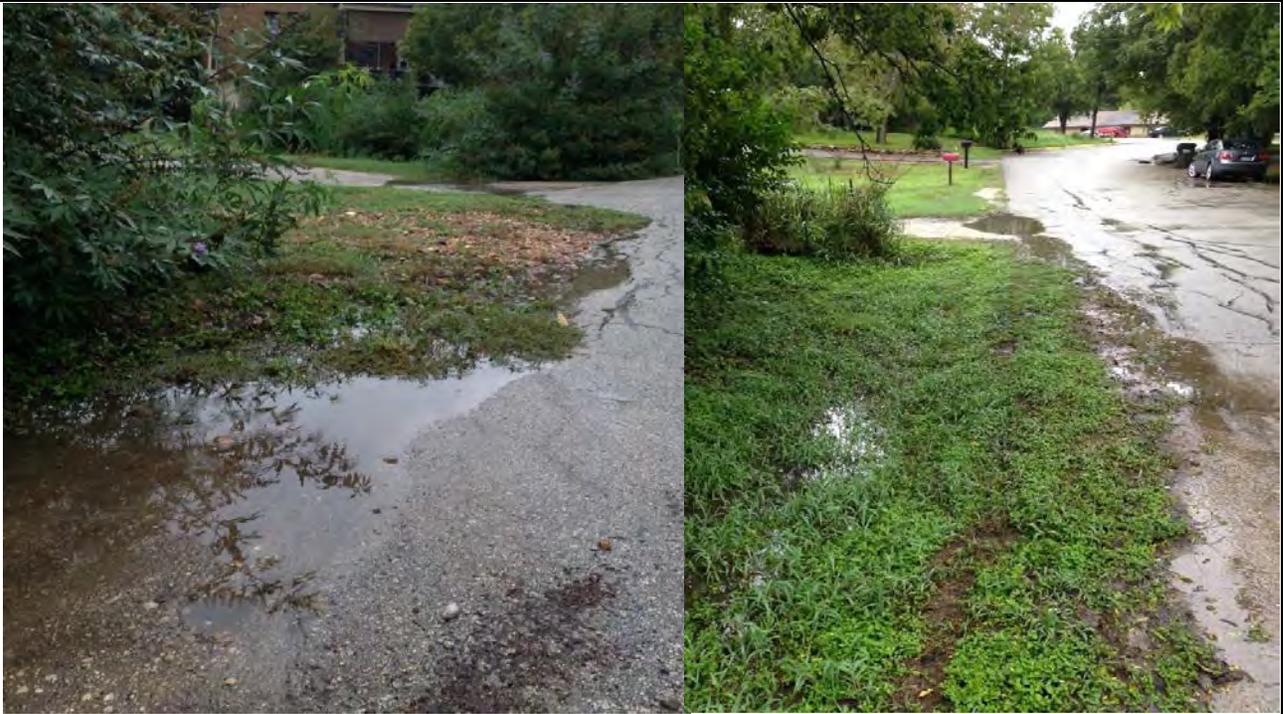
P2	<i>Looking NE (left) and SW (right) on Coers Circle; ponding in roadway (10/16/13)</i>
----	--

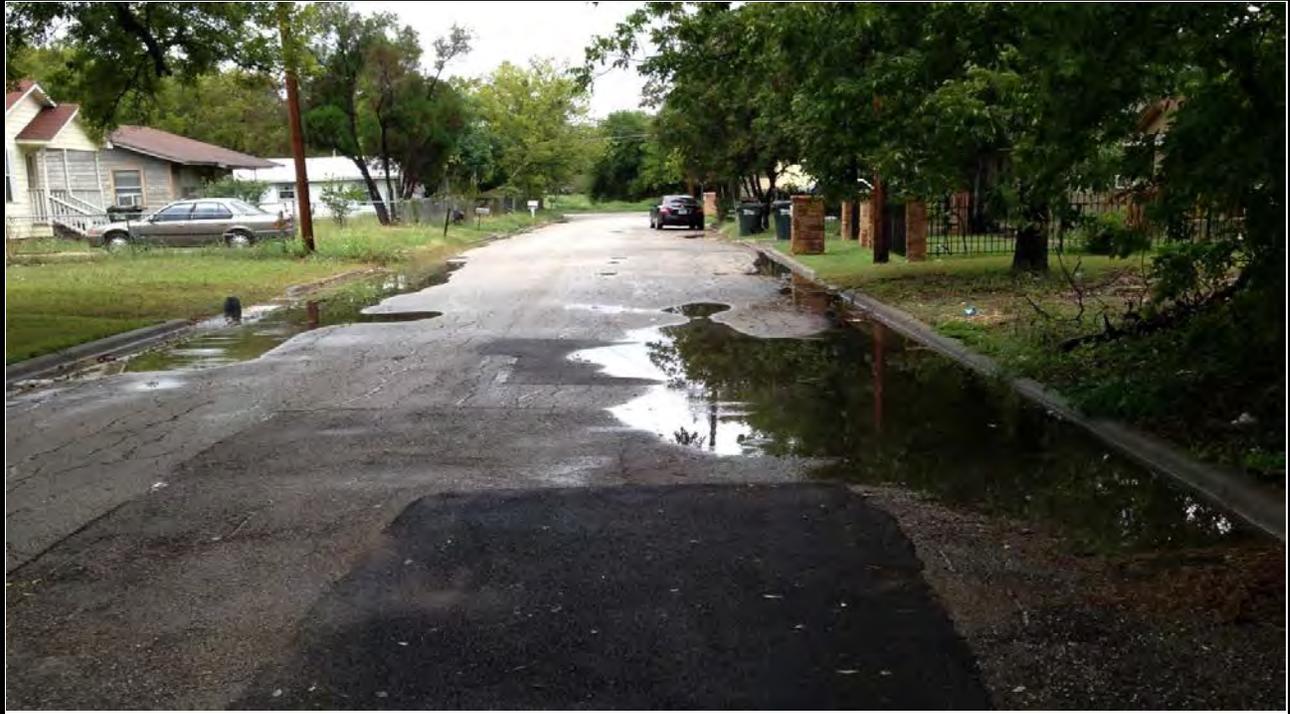
P1	<i>Looking NW along Marshall from Hines; ponding and pavement wear (10/16/13)</i>
----	---

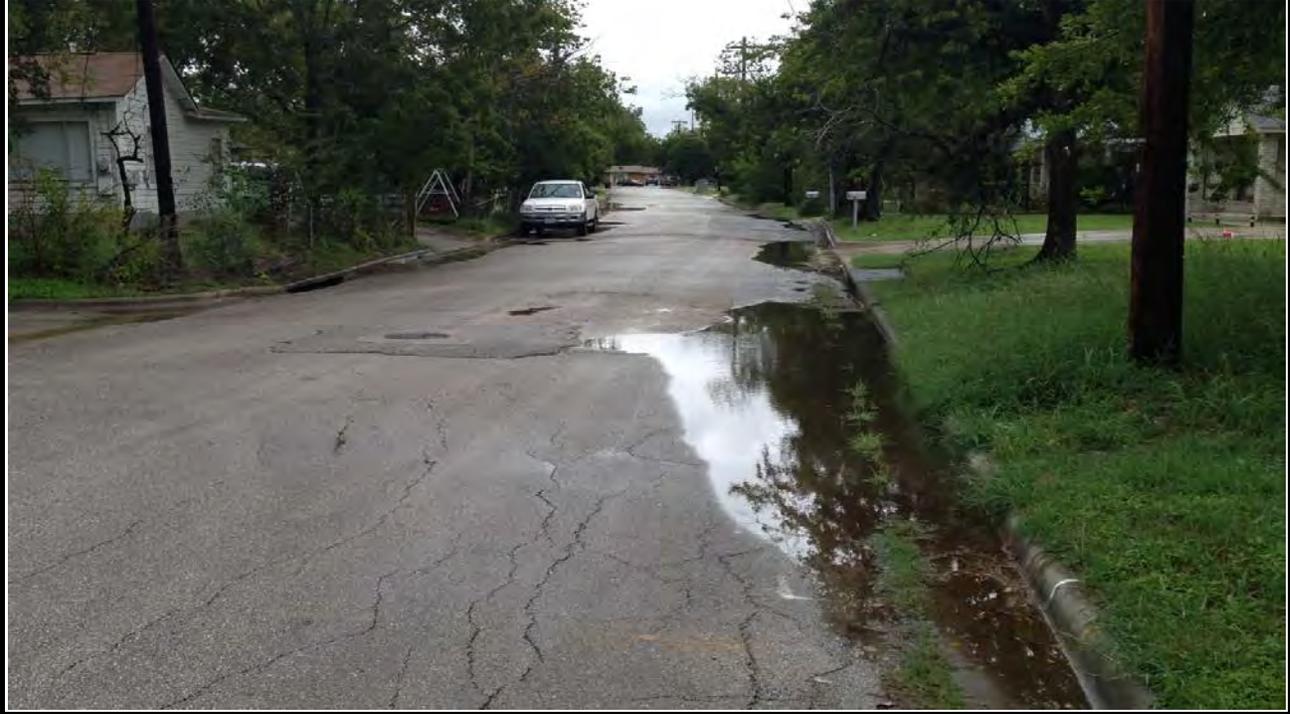
P2	<i>Looking SW along Knox at Marshall; ponding and pavement wear (10/16/13)</i>
----	--

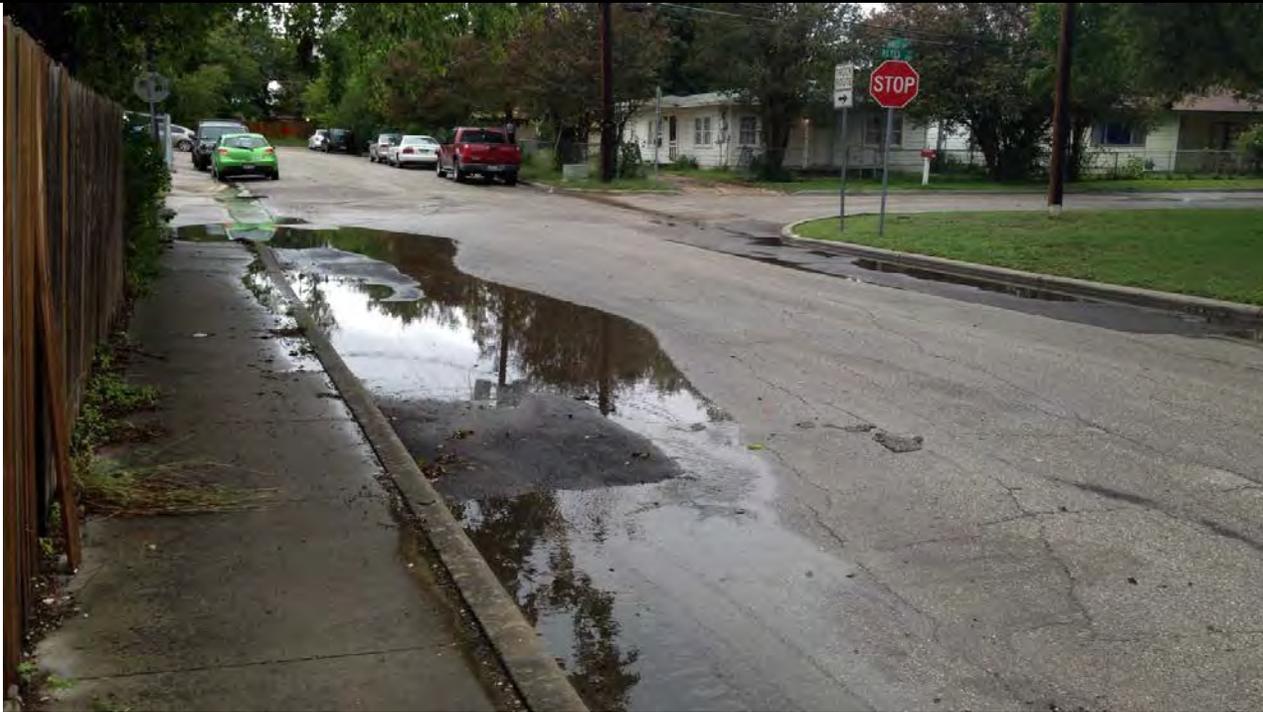
P3	<i>Looking SW along Hines at Reyes; ponding and pavement wear (10/16/13)</i>
----	--

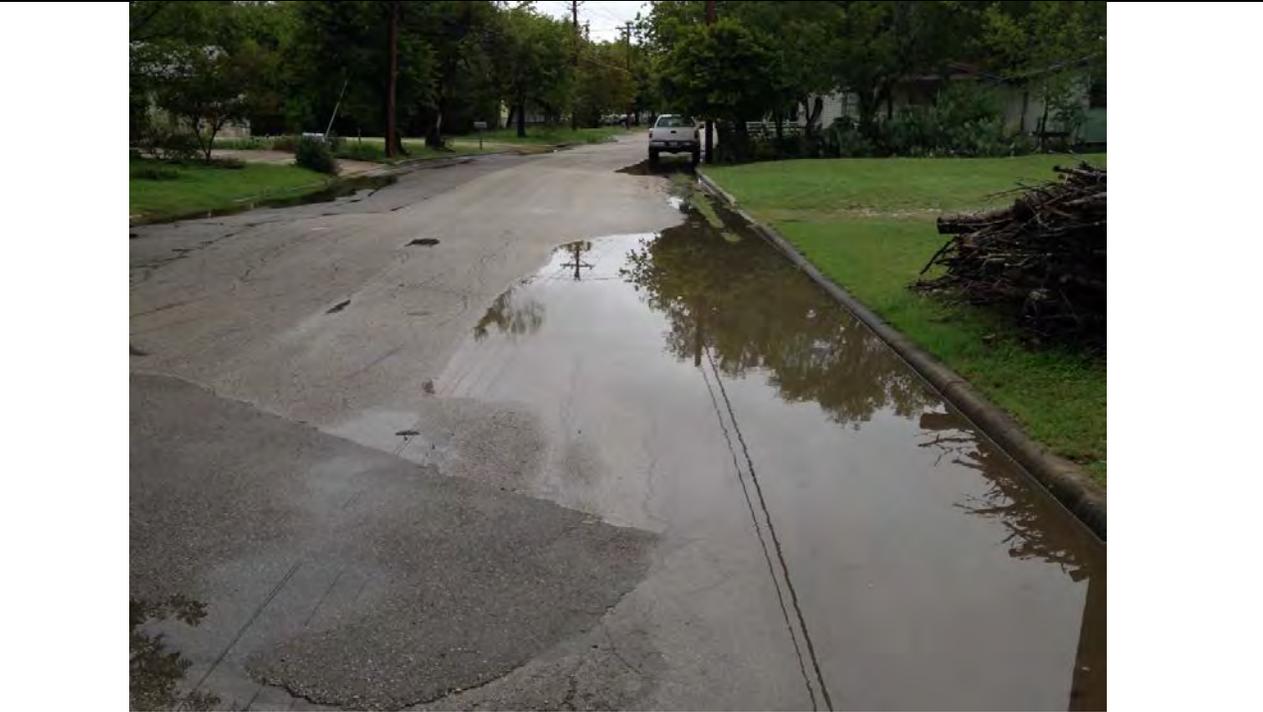
P4	<i>Looking NE along Knox between Reyes/Marshall; ponding and pavement wear (10/16/13)</i>
----	---

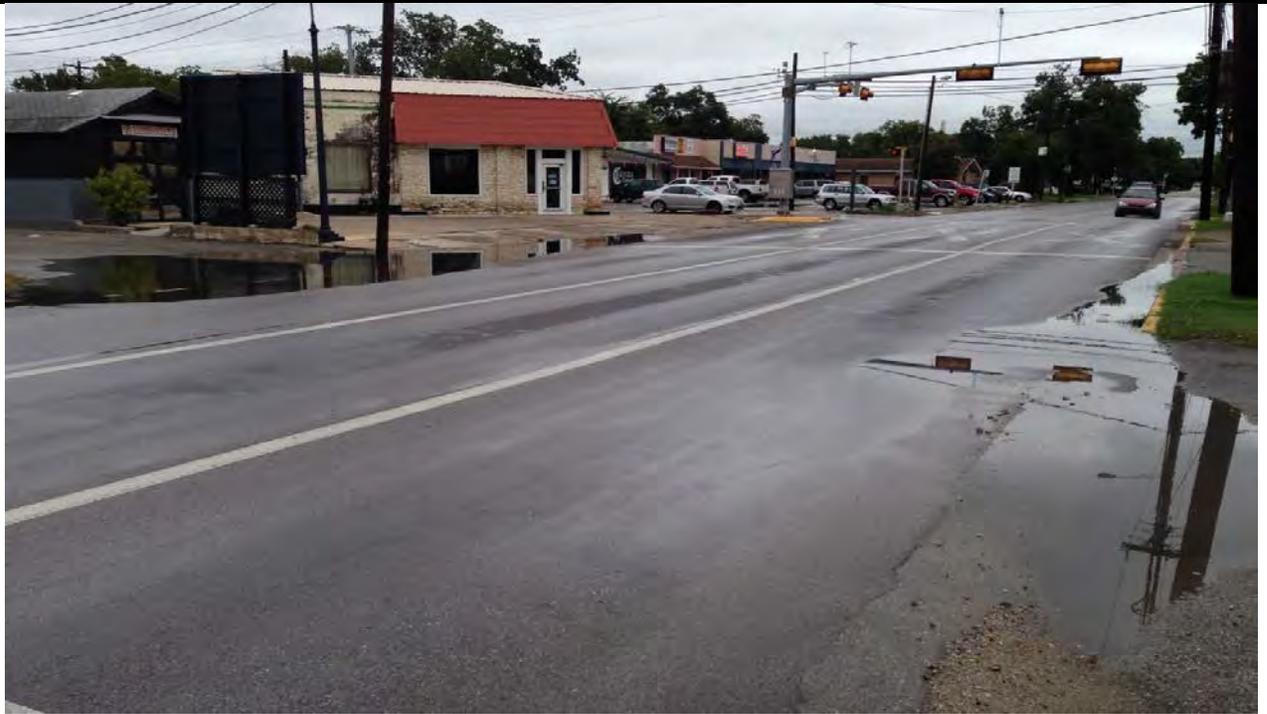
Photo #	Caption
P2	<i>Looking SE along W side of LBJ; flooding in roadway & private property (10/16/13)</i>

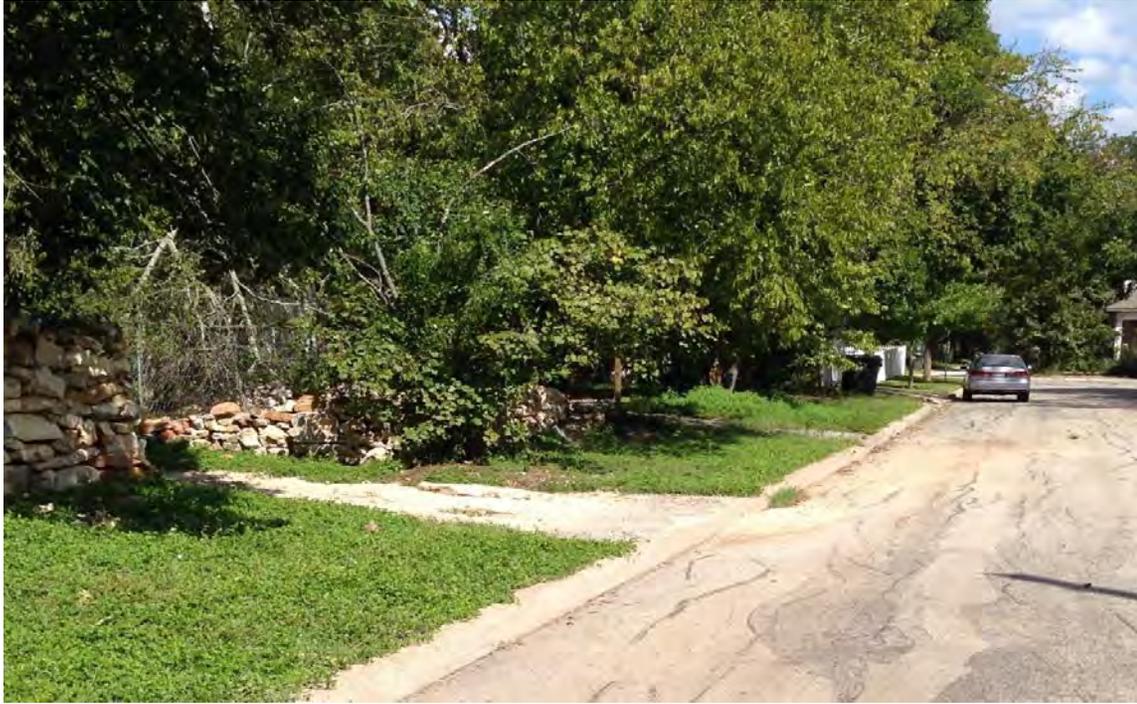
P3	<i>Lkg NE along McAllister at rear of 1117 Hopkins; pavement wear & sediment from runoff</i>
----	--

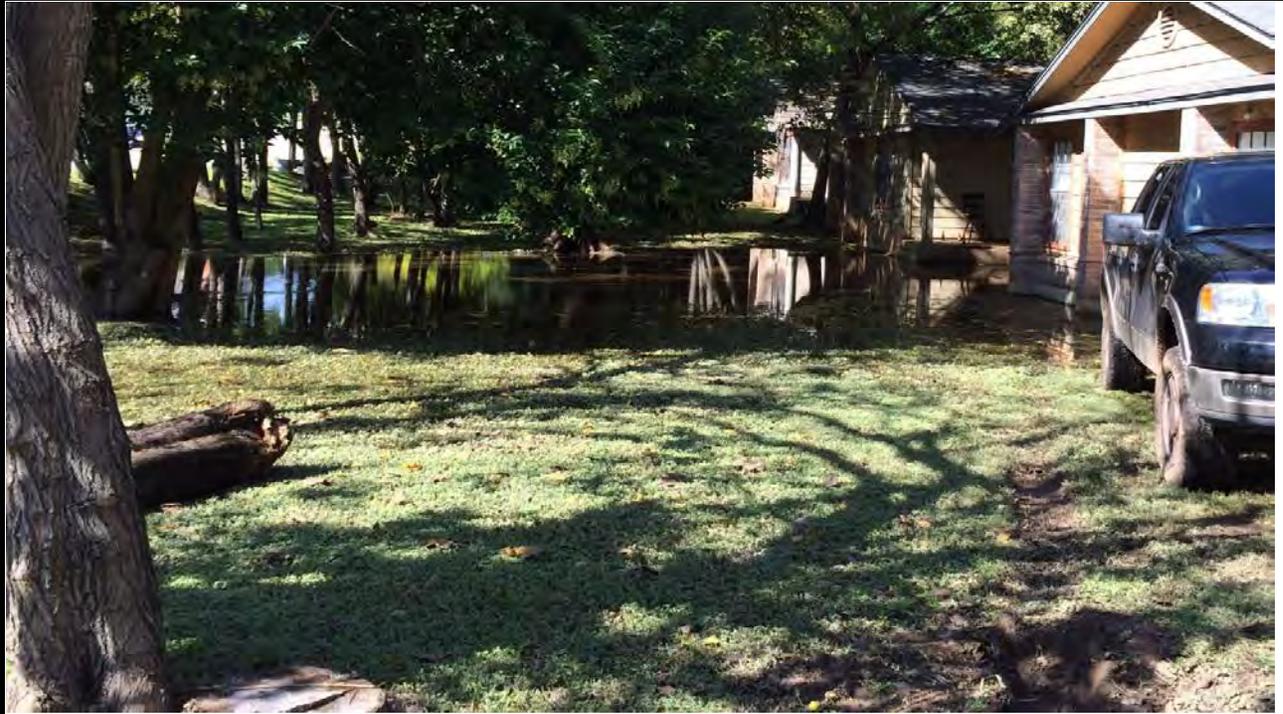
P1	<i>Lkg NW from Orchard at property flooding at 1102, 1104, and 1106 Academy St (10/31/13)</i>
----	---

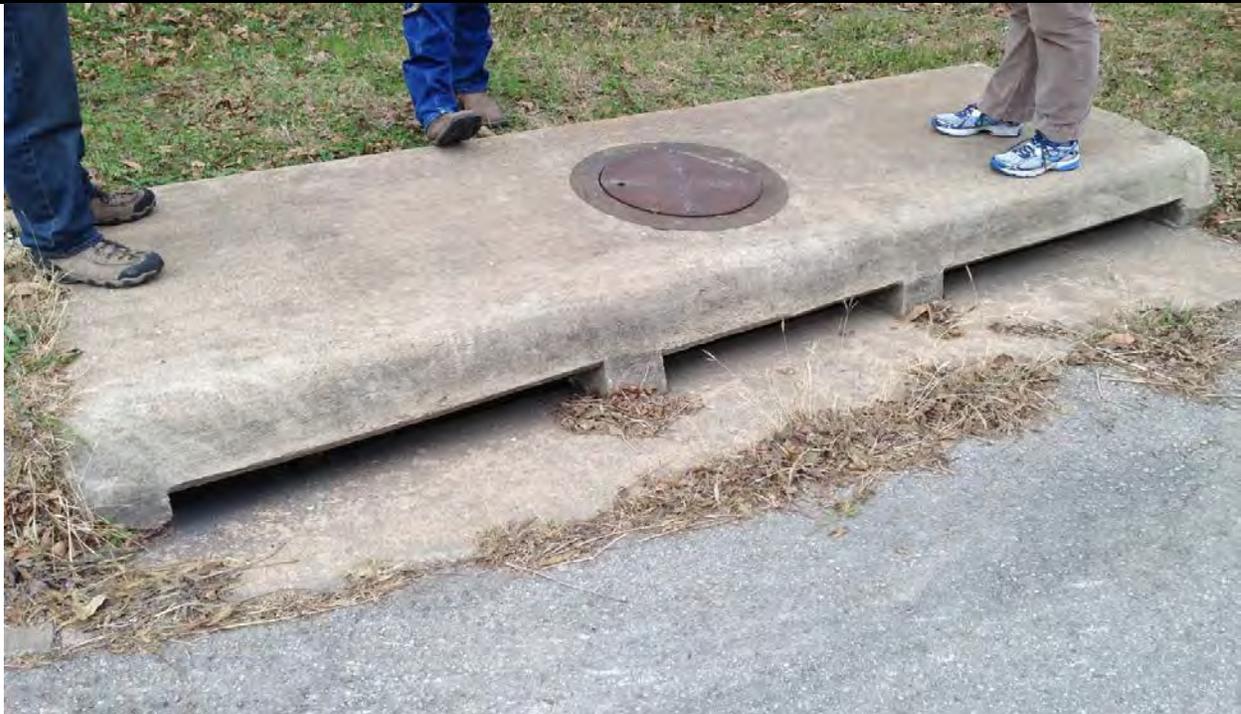
P4	<i>Lkg N at curb inlet on N corner of Academy/Orchard; curb inlet is undersized/inefficient</i>
----	---

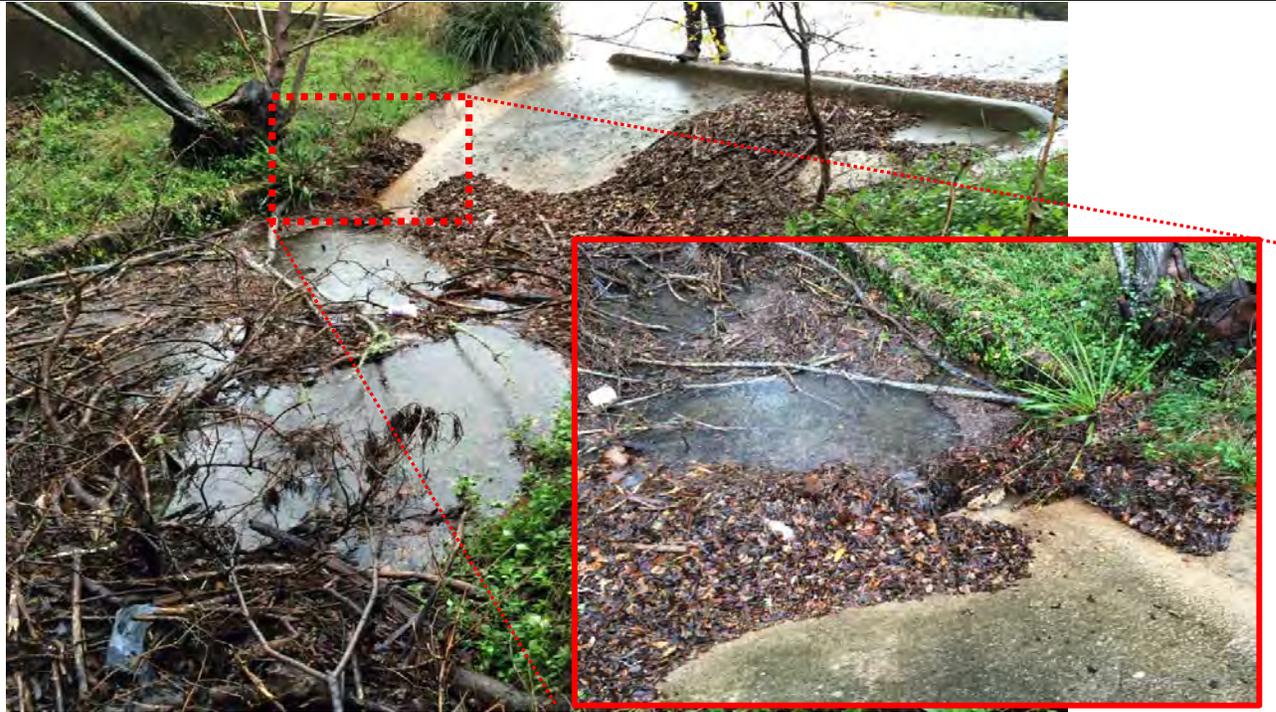
Photo #	Caption
P1	Looking at U/S side of culvert on SW loop of Oakridge St clogged with debris

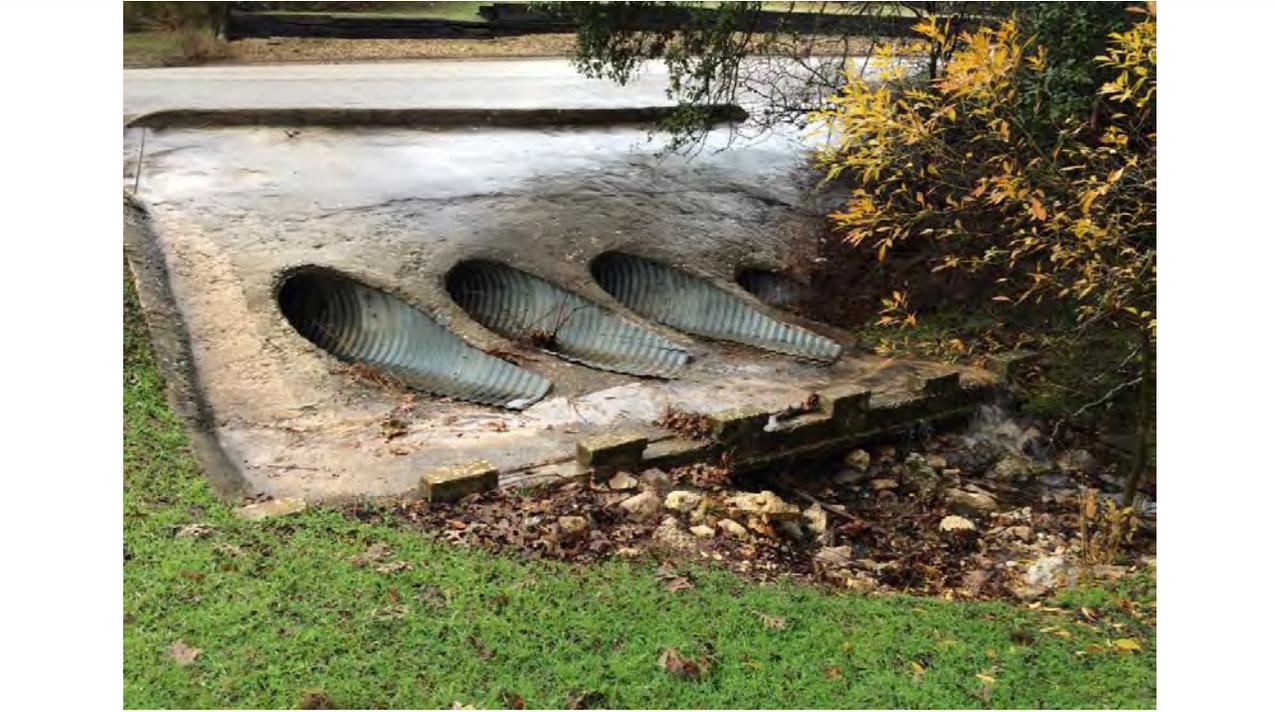
Photo #	Caption
P2	Looking at undermining of D/S side of culvert on NW loop of Oakridge St

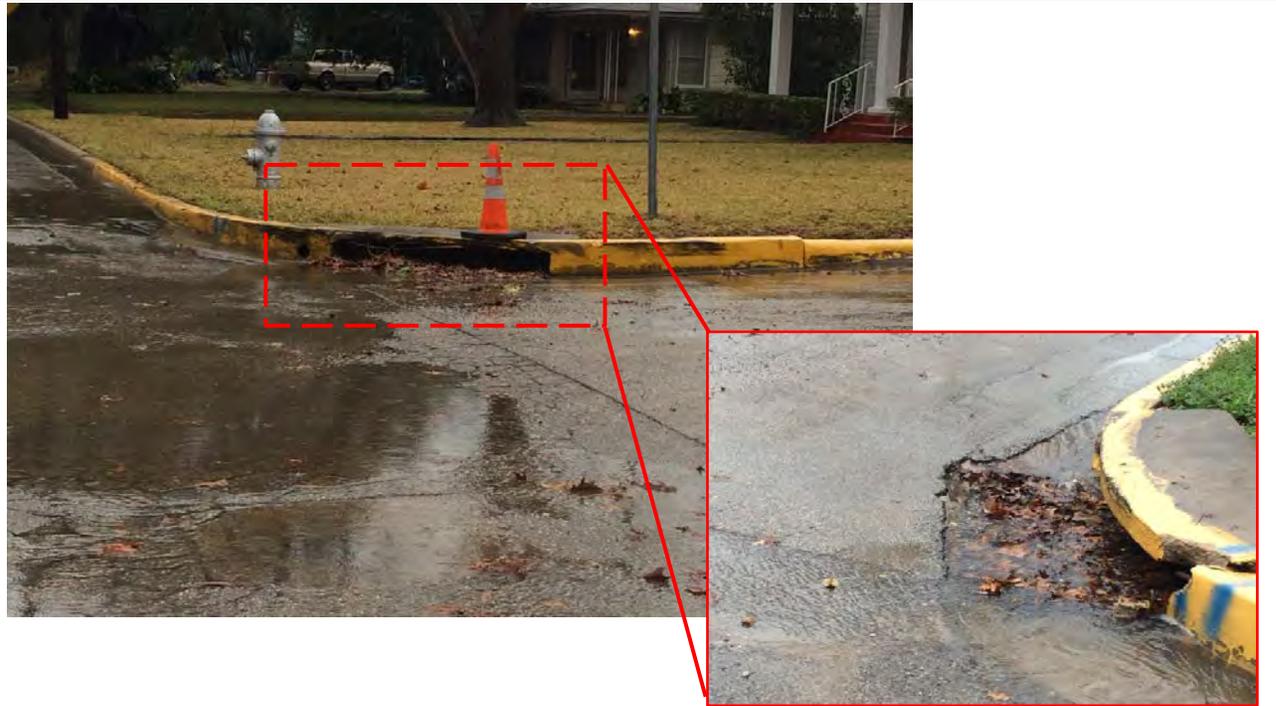
P3	<i>Inlets at San Antonio St and Mitchell Ave, looking SW and NE at the leaf debris</i>
----	--

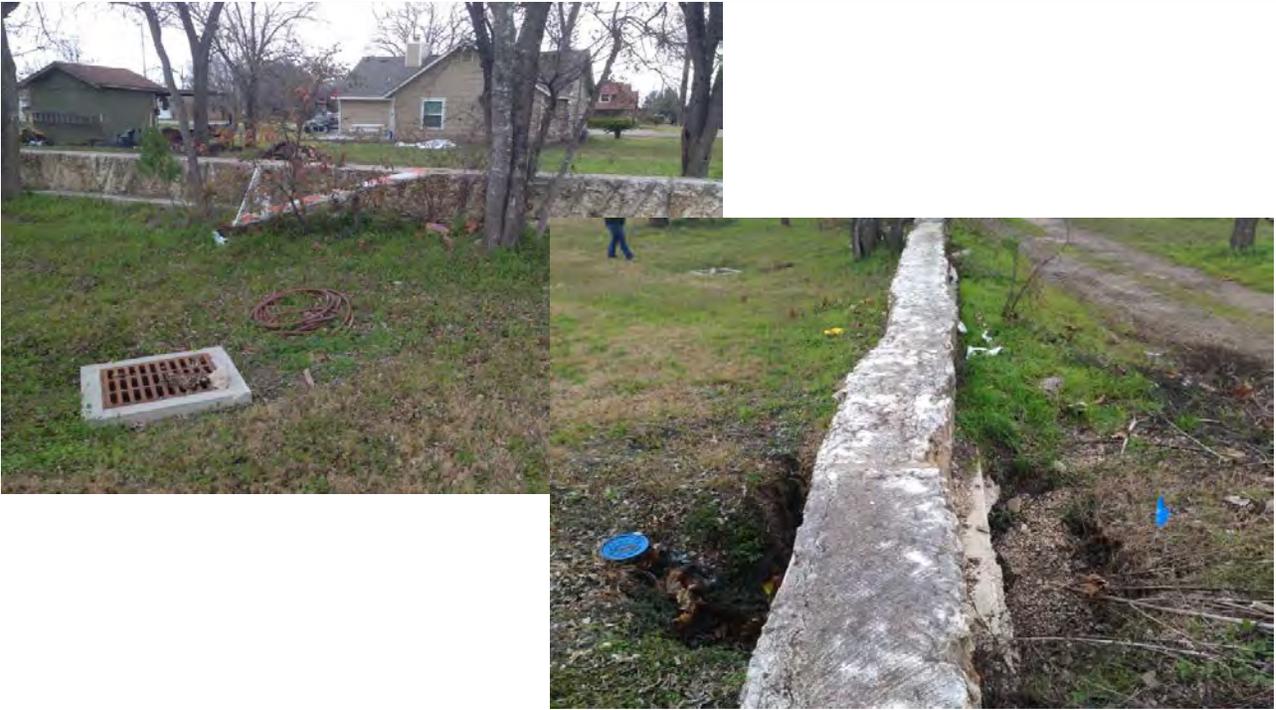
P4	<i>Existing inlet from Copper Beech Townhomes detention pond and erosion by inlet</i>
----	---

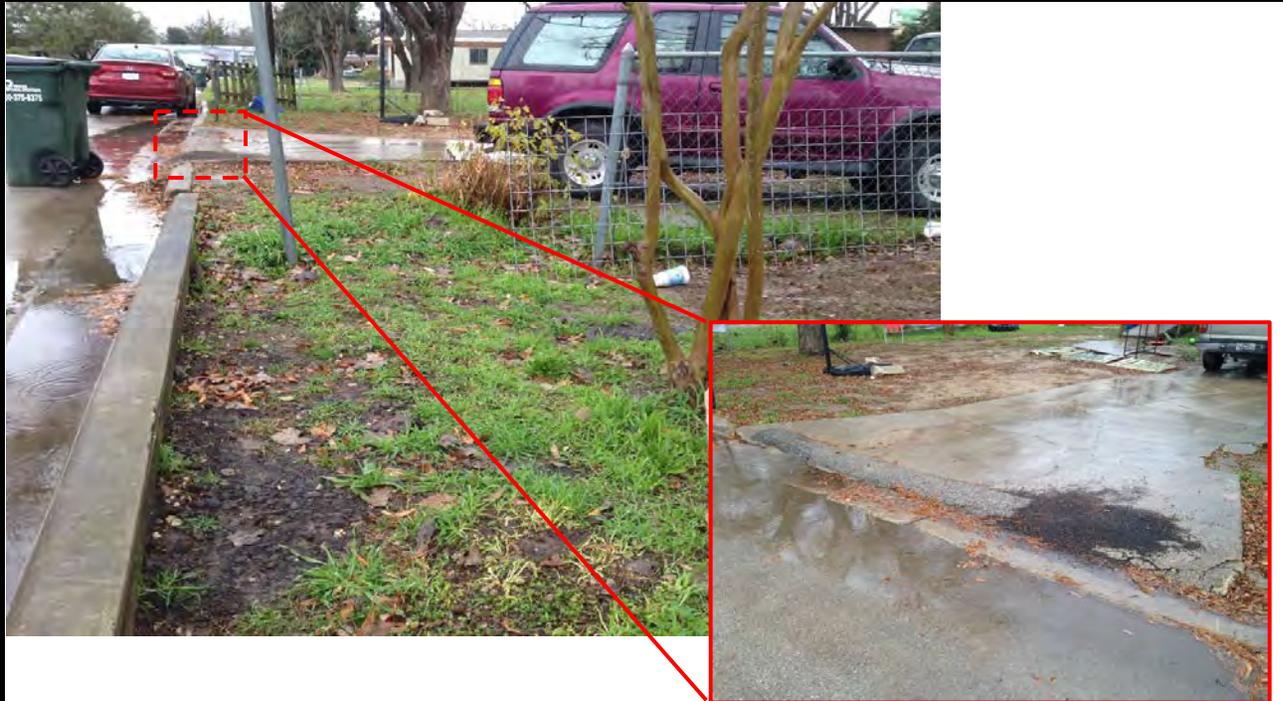
P2	Curb and berm in driveway at 1441 Harper Drive
----	--

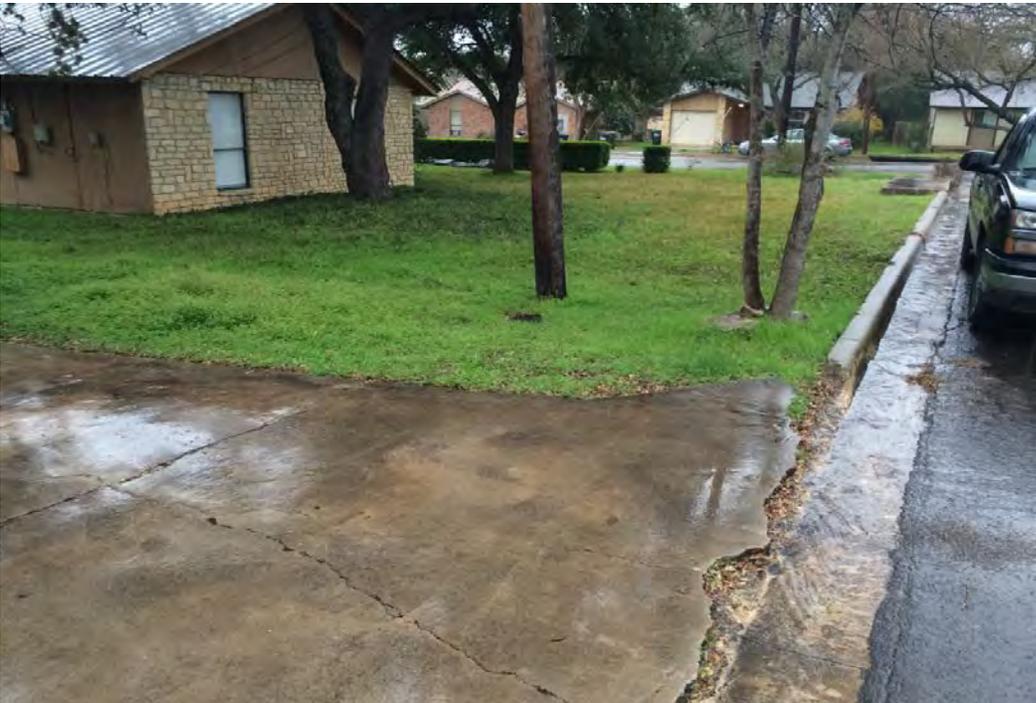
P2	Looking NW at driveway damage at 2027 Castle Gate Cir and lot at 2029 Castle Gate Cir
----	---
