**My Historic SMTX
City of San Marcos
Historic Resources Survey Report
Phase 1 – **DRAFT**
San Marcos, Texas**

January 2019

Prepared for
City of San Marcos

Prepared by
Hicks & Company
Elizabeth Porterfield, MSHP

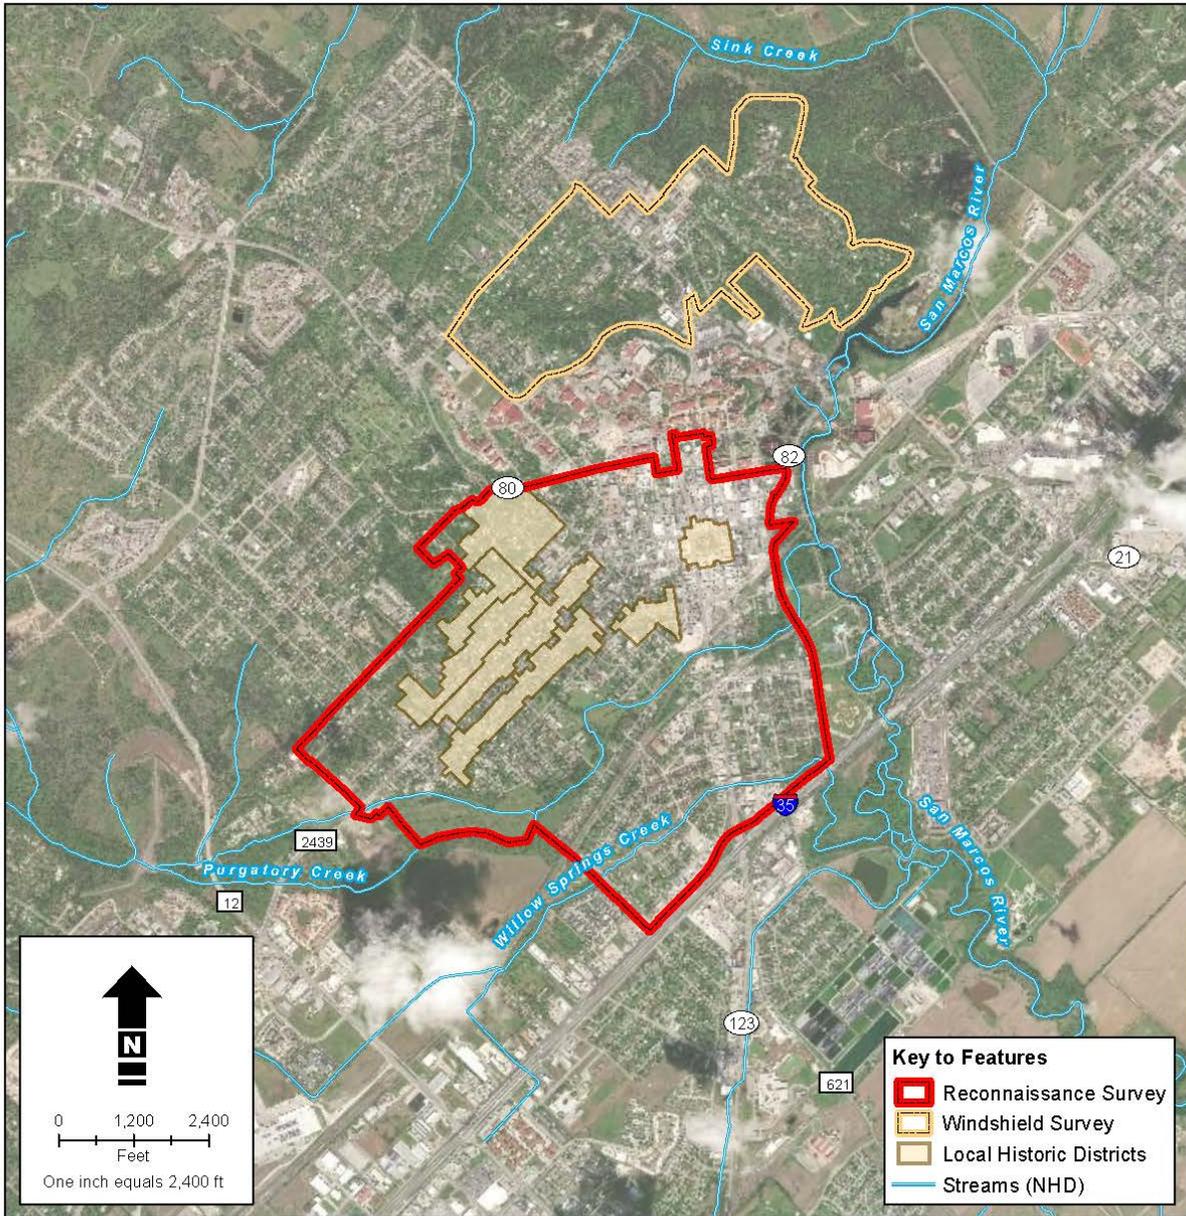
Figure 1

Figure 1. Reconnaissance and Windshield Survey Boundary Areas

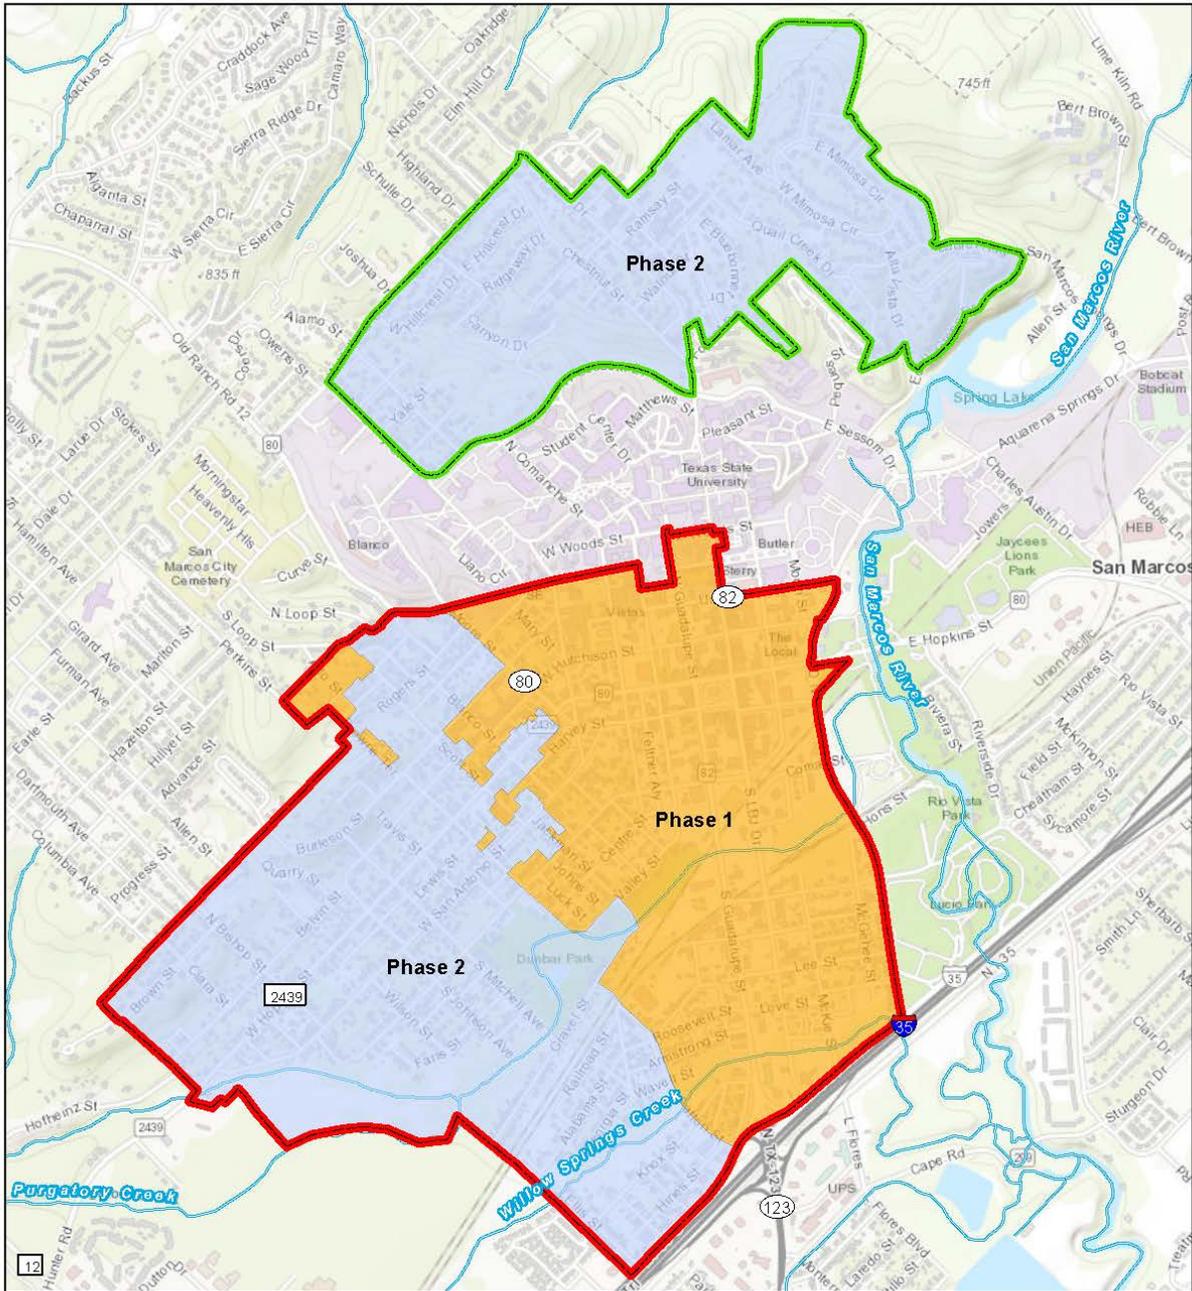
Figure 2

**Phase 1 and Phase 2
Survey Boundary Areas**

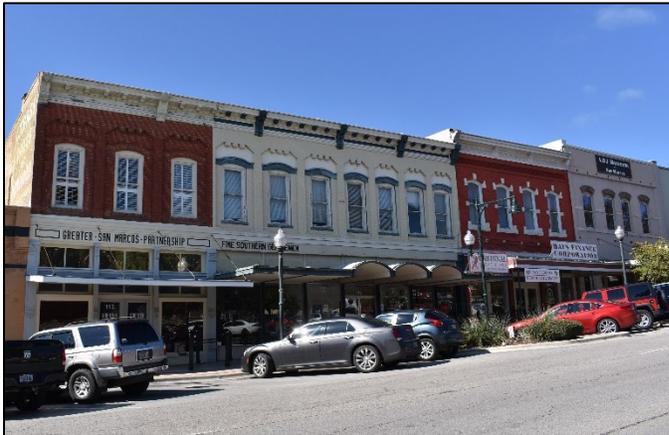
VI.C. Reevaluation of Downtown Historic District (1992 City of San Marcos Survey)

The Downtown Local Historic District evaluated in the 1992 *City of San Marcos, Texas, Historic District Survey* included the buildings within the district boundary along the four blocks of E. Hopkins Street, N. Guadalupe Street, E. San Antonio Street, and N. LBJ Drive fronting the courthouse and square. No preservation priority recommendations were provided, but the buildings were evaluated as contributing/non-contributing to the existing

district. At that time, a number of the surveyed buildings exhibited façade alterations, including slip covers, that undermined the integrity of the original design, materials, and workmanship. A number of the buildings within the district were recommended as non-contributing due to the extent of unsympathetic exterior changes. Although photographs from the 1992 survey report were not provided to the project team, survey forms with exterior photos of each district building were included in the 1986 City Council ordinance designating the local historic district. The 1986 photographs reveal a number of the identified façade alterations and slipcovers.

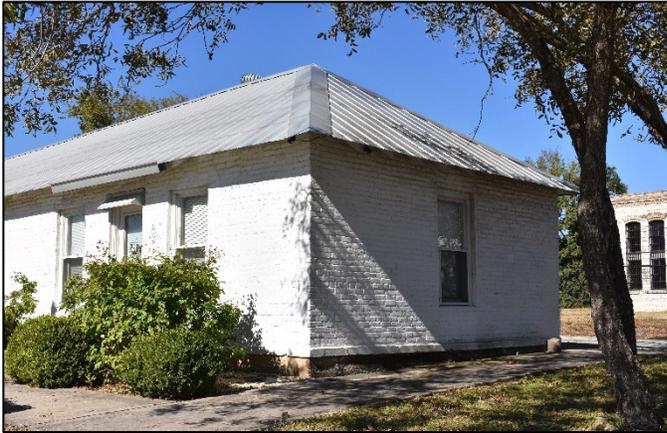
VI.D. Reevaluation of 1996 Dunbar and East Guadalupe Neighborhoods Survey

As previously noted in **Section II.B.2**, three areas were evaluated for potential historic district designation in the *1997 Historic Resources Survey of the Dunbar and East Guadalupe Neighborhood: MLK Drive and Centre Street (Dunbar neighborhood), S. LBJ Drive between Grove Street and IH 35 (East Guadalupe Street), and the railroad sector adjacent to the railroad tracks between Grove and Comal streets*. The area in Dunbar was identified as potential historic district and was

later designated as the Dunbar Local Historic District in 2003. The other two areas were recommended not eligible for historic district designation due to loss of contributing resources and non-historic-age infill development. These three areas were reevaluated as part of the current Phase 1 survey initiative, with no proposed changes to the Dunbar Local Historic District boundary and no recommendations for potential historic district designation within the East Guadalupe neighborhood or railroad area. Both the East Guadalupe neighborhood area along S. LBJ Drive and the railroad area between Grove and Comal Streets have experienced further non-historic-age infill and loss of original historic fabric. Much of the housing stock within the East Guadalupe neighborhood includes ca. 1970s infill construction from Urban Renewal efforts as well as more recent modern development. The Dunbar neighborhood, including the areas outside of the existing local historic district, has also experienced loss of historic resources and more recent infill development.

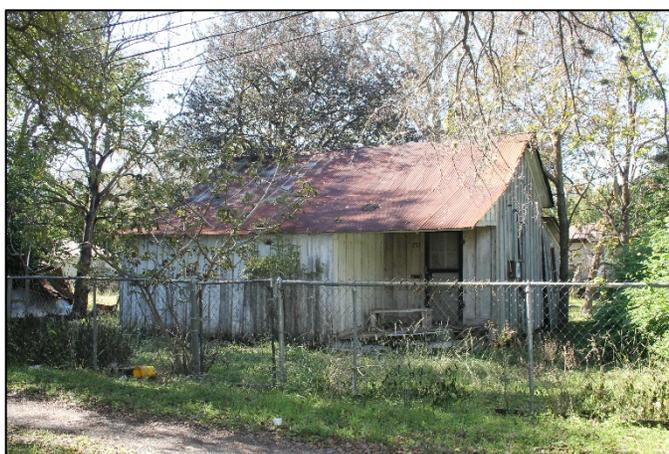
survey as medium preservation priority due to alterations over time. The residence at 233 Callahan's Alley is one of the oldest extant houses remaining within the railroad sector and has been identified for further study to determine if there are significant historical associations. The remaining portion of the Dunbar

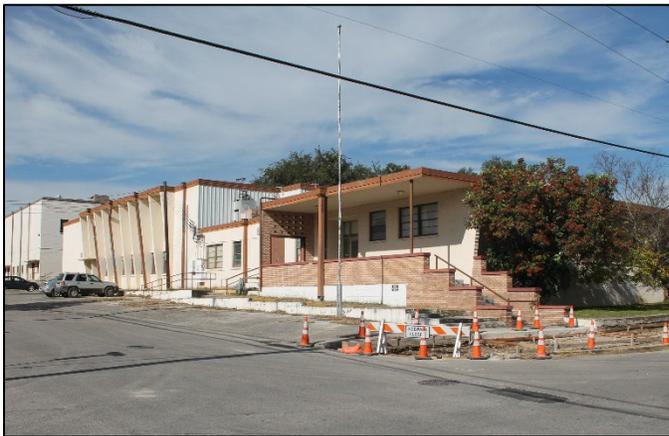
The small section of the 1997 survey area outside of the existing local historic districts and within Phase 1 of the current survey includes the blocks of Harvey and San Antonio Streets between Moore and Blanco streets, and Hutchison Street between Moore and Scott Streets. The area of Hutchison Street includes the former Lamar School at 500 W. Hutchison. Many of the resources outside of the existing historic districts were constructed post 1950 and were not evaluated in the 1996

survey, including the Lamar School. However, the 1996 survey identified a number of medium priority resources along this block of Harvey Street and several high and medium priority resources on this block of W. San Antonio Street. Both of these blocks have been reevaluated in the current Phase 1 survey as eligible for potential historic district designation or as an extension of the existing San Antonio Street local historic district, pending further evaluation of the existing district during Phase 2 of the survey (refer to **Section VII.B.5** below). Additionally, the Lamar School has been evaluated in the current survey as high preservation priority as an intact example of mid-twentieth-century modern school design and for its association with early integration of public schools in Texas (refer to **Table 5** and the high priority survey forms in **Appendix B**).

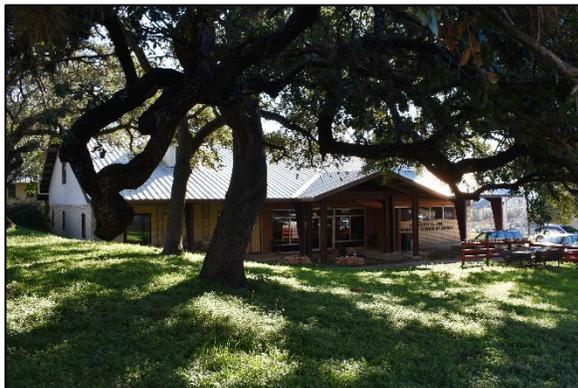
The three contributing resources are significant and largely intact examples of mid-century-modern design. According to the organization’s website, the McCarty Student Center was completed in 1963 and has been in continuous operation as a student center for the University Church of Christ since that time. The student center was named for local rancher and philanthropist Tom McCarty who left his estate to the University Church of Christ.¹⁵¹ The building reflects mid-century-modern design elements, but it is

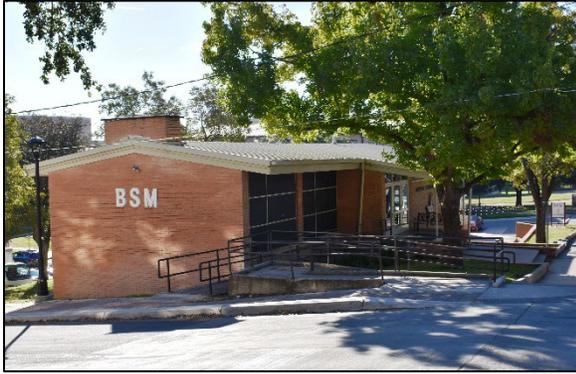
The Baptist Student Center, at 518 N. LBJ Drive, was constructed in 1953 by the Austin Engineering Company.¹⁵³ Today, the building serves as the Texas State Baptist Student Ministry of San Marcos. The building remains an intact and significant example of mid-century-modern design with its large fixed-glass and clerestory windows and the use of narrow Roman brick on the façade. Together, the three buildings represent a cohesive collection of mid-twentieth-century modern architecture and are significant for their lengthy association with religious ministry and outreach through Texas State University.

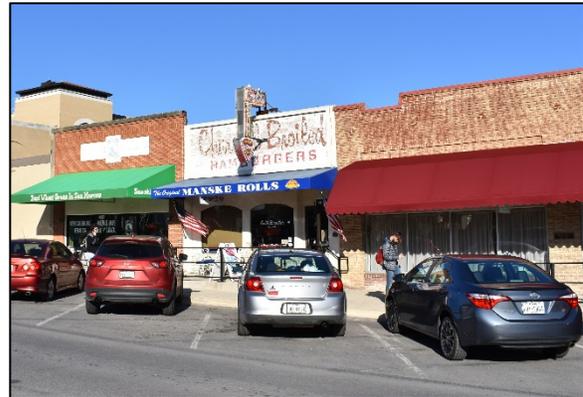
The Downtown Local Historic District, designated by the City in 1986, corresponds to the boundaries of the NRHP-listed Hays County Courthouse Historic District (designated in 1992), with the exception of three additional resources not listed in the NRHP district: the former San Marcos Fires Station and City Hall at 224 N. Guadalupe Street (Property ID R41619), a two-part commercial block building at 101 S. LBJ Drive (Property ID R41496), and a one-part commercial block building at 101 W. San Antonio Street (Property ID R41529). The NRHP nomination noted the district as a “cohesive collection of the late 19th and early 20th century commercial and governmental buildings encompassing a county courthouse and the four blocks that surround it.” The nomination further described the district as “the most concentrated and intact collection of commercial historic buildings in the community.” The period of significance for the NRHP district was established as 1879–1942, and the district was recommended eligible under Criterion C in the area of Architecture.

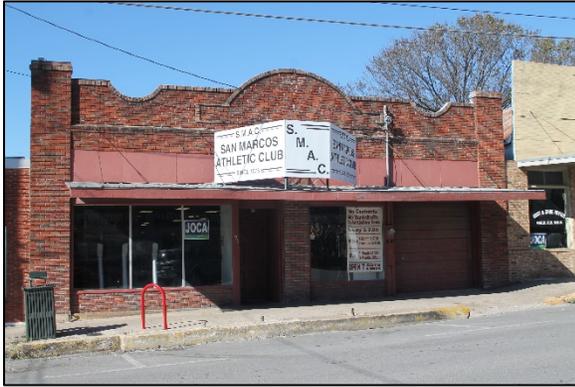
The majority of resources located within the area of N. and S. LBJ Drive are one-part commercial block buildings ranging in age from ca. 1920 through the 1950s, with a small percentage of infill development from the 1960s and 1970s. While not as old as the commercial buildings flanking the court house square, the resources along both sides of N. LBJ from E. Hopkins Street to University Drive and on S. LBJ Drive from E. San Antonio Street reflect the evolution of the commercial development of San Marcos from the early

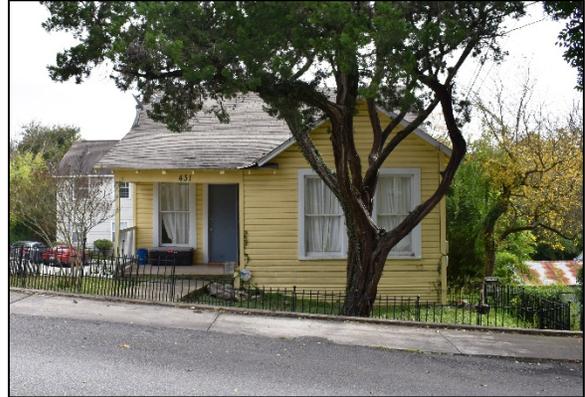
VII.B.4. Potential Residential Historic District or Expansion of Lindsey Rogers Historic District

An additional eligibility recommendation for potential historic district designation is an approximate four-block area roughly bounded by Moore, W. Hutchison, North, and Lindsey Streets. The primarily residential streets reflect a variety of early twentieth-century styles including Craftsman bungalows, Minimal Traditional, and Queen Anne-style houses, as well as the Gothic Revival-influenced First Presbyterian Church on W. Hutchison Street. Some of the resources within this proposed district were evaluated as high preservation priority, while most were evaluated as medium preservation priority and are considered contributing to a potential district. Although many of medium priority residences have experienced some alterations such as replacement windows or cladding material, the majority of resources have retained a fair degree of integrity, and the area as a whole continues to convey the feeling of an intact early twentieth-century neighborhood.

The potential district is immediately adjacent to the Lindsey-Rogers local historic district that will be surveyed and evaluated as part of Phase 2 of the current survey initiative. At this time, it is recommended that the potential district be further assessed during Phase 2 for its association and relationship to the Lindsey-Rogers Historic District and as a potential expansion of the existing district. The resources within the boundary identified as potentially eligible for historic district designation or as an expansion of the existing Lindsey Rogers Historic District are listed below in **Table 8**.

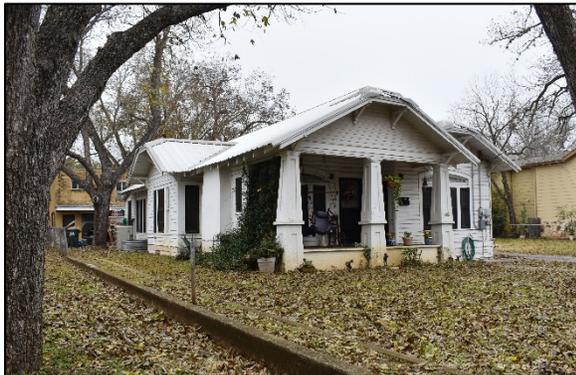
VII.B.5. Potential Expansion of San Antonio Street Historic District

Similar to the resources identified above, a group of seven residences in the 500-block of W. San Antonio Street (between North and Blanco streets) and one residence immediately south at 113 Nance Street are recommended as high preservation priority. This block is adjacent to the eastern boundary of the San Antonio Street Local Historic District and may be eligible for inclusion in a potential expansion of the existing historic district. The San Antonio Street Local Historic District will be reevaluated during Phase 2 of the

current survey initiative, and a definitive recommendation of potential district expansion may be made at that time. The contributing resources within this area of W. San Antonio Street include 1920s Craftsman bungalows, an early twentieth-century Classical Revival-style residence, and two Minimal Traditional-style houses. These resources are identified in **Table 9** below.

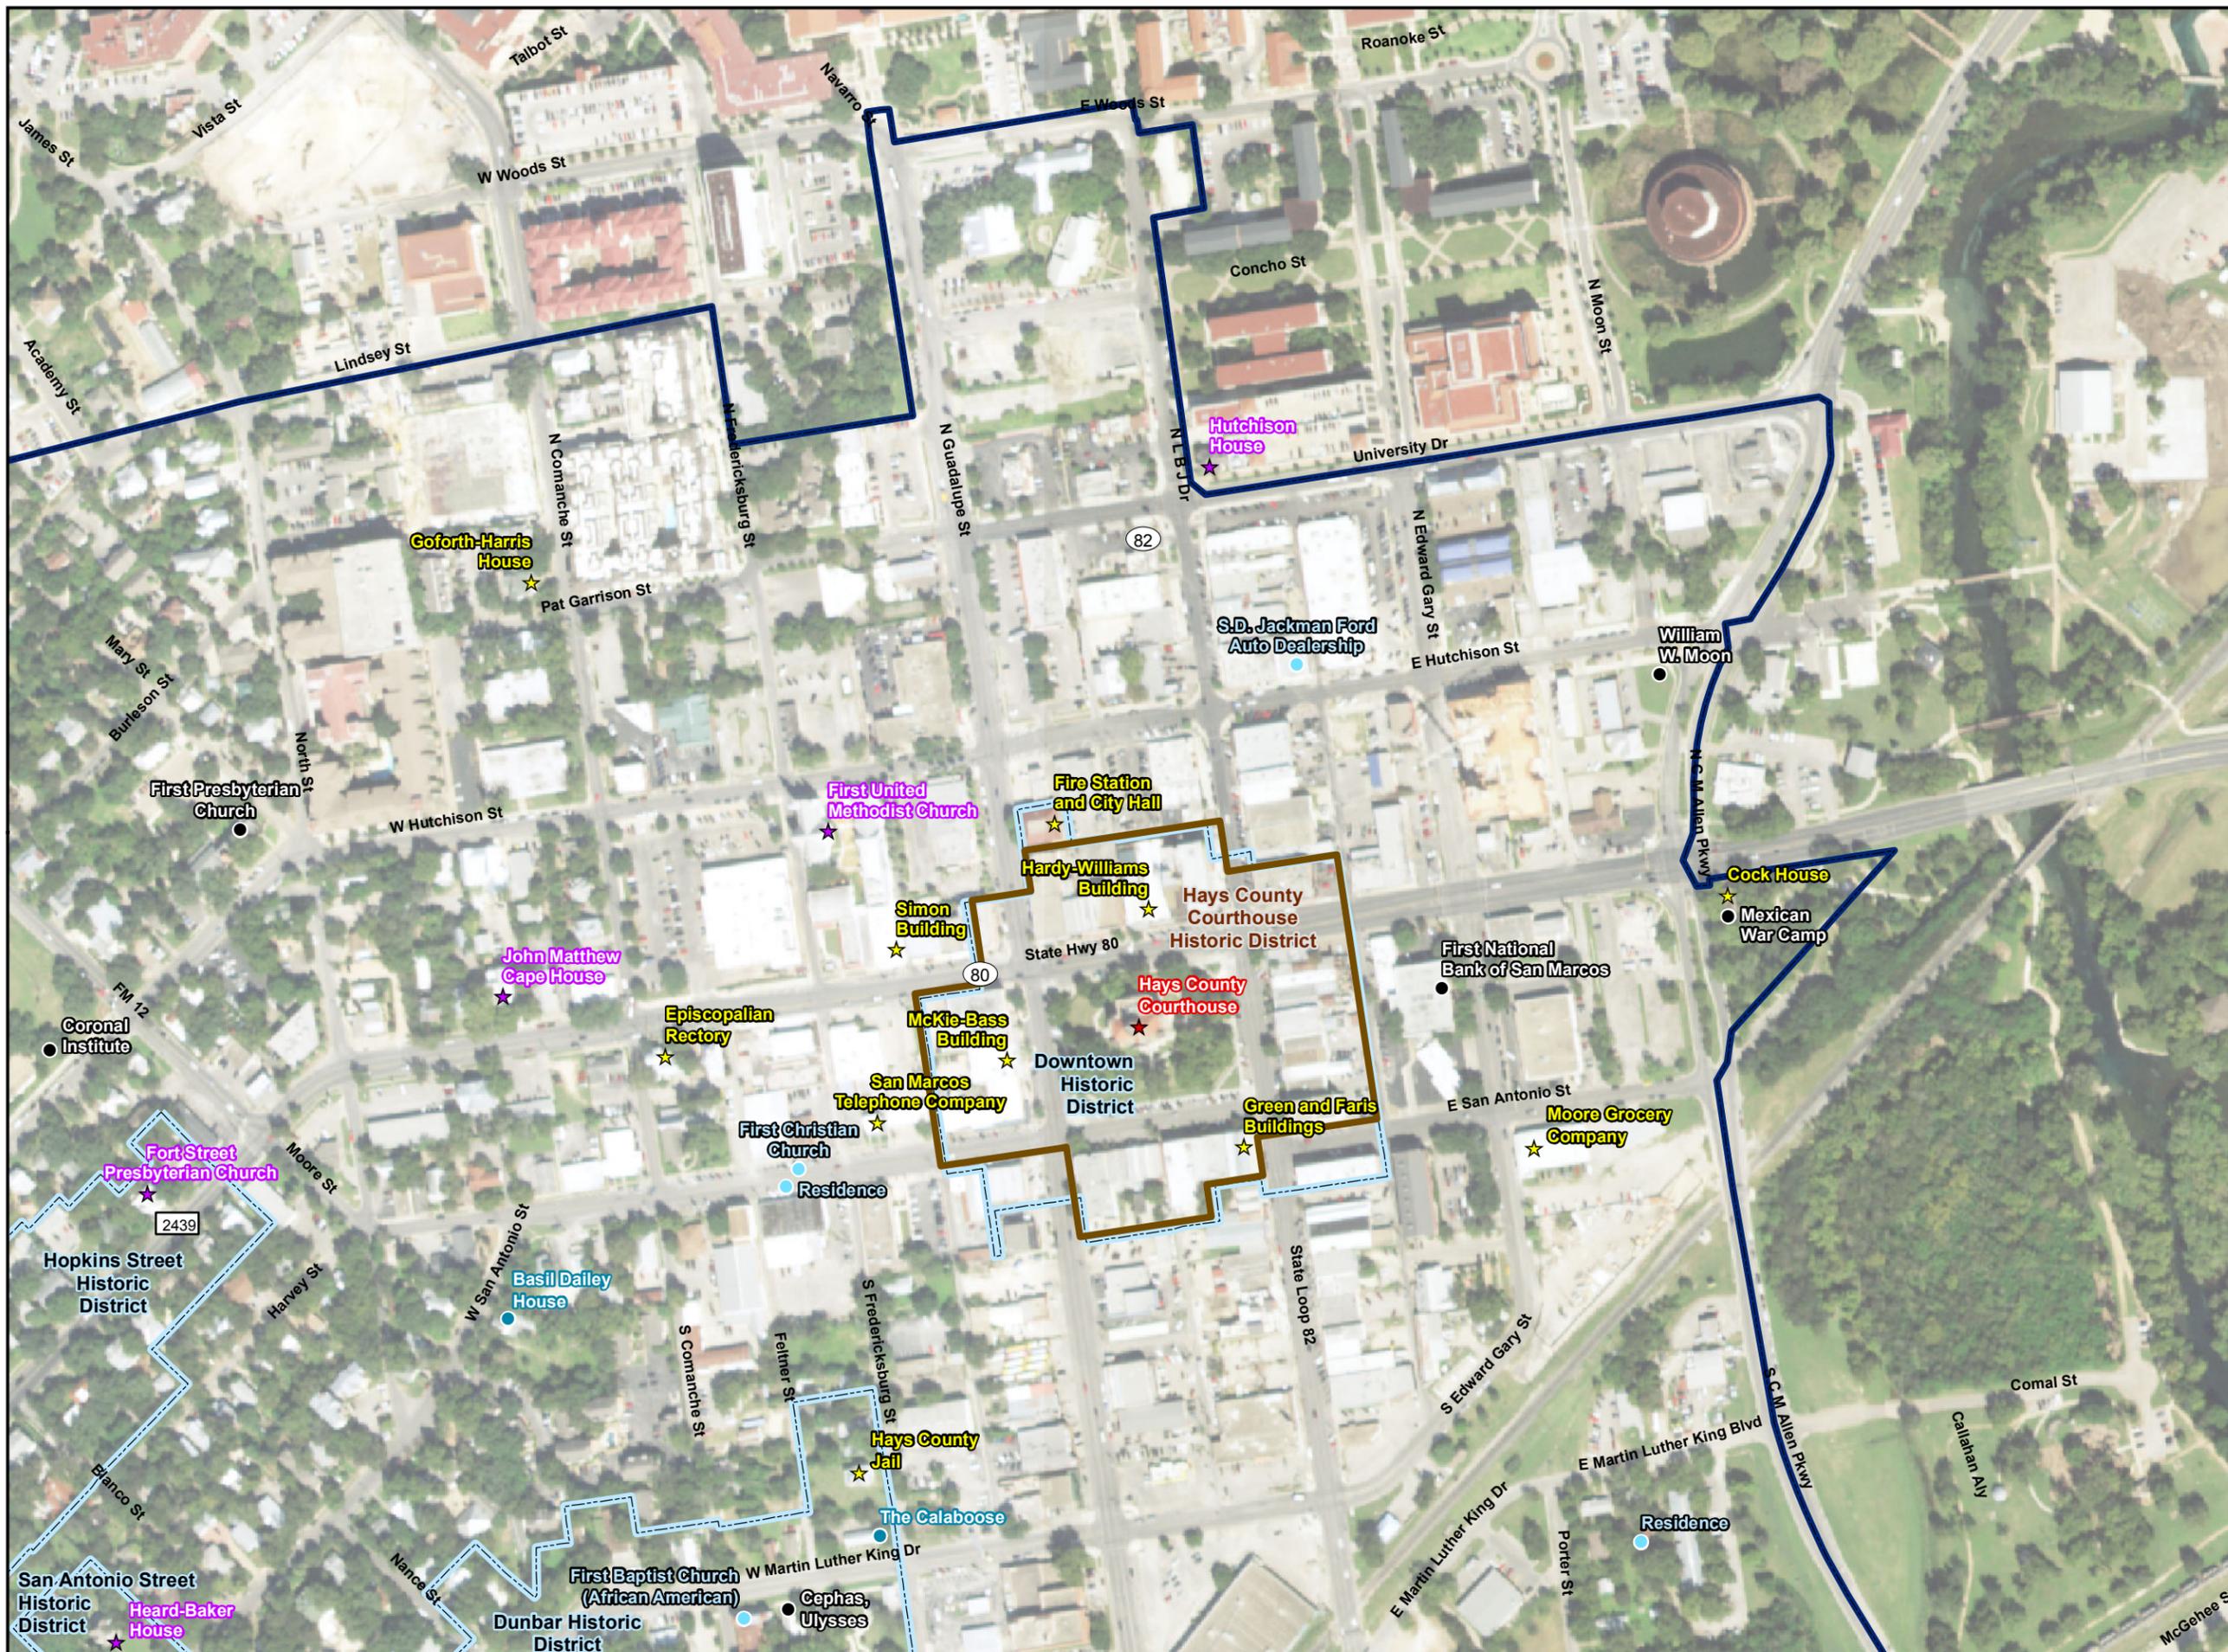
Figure 3-3

**Previously Identified
Historic Resources within
the Survey Area**

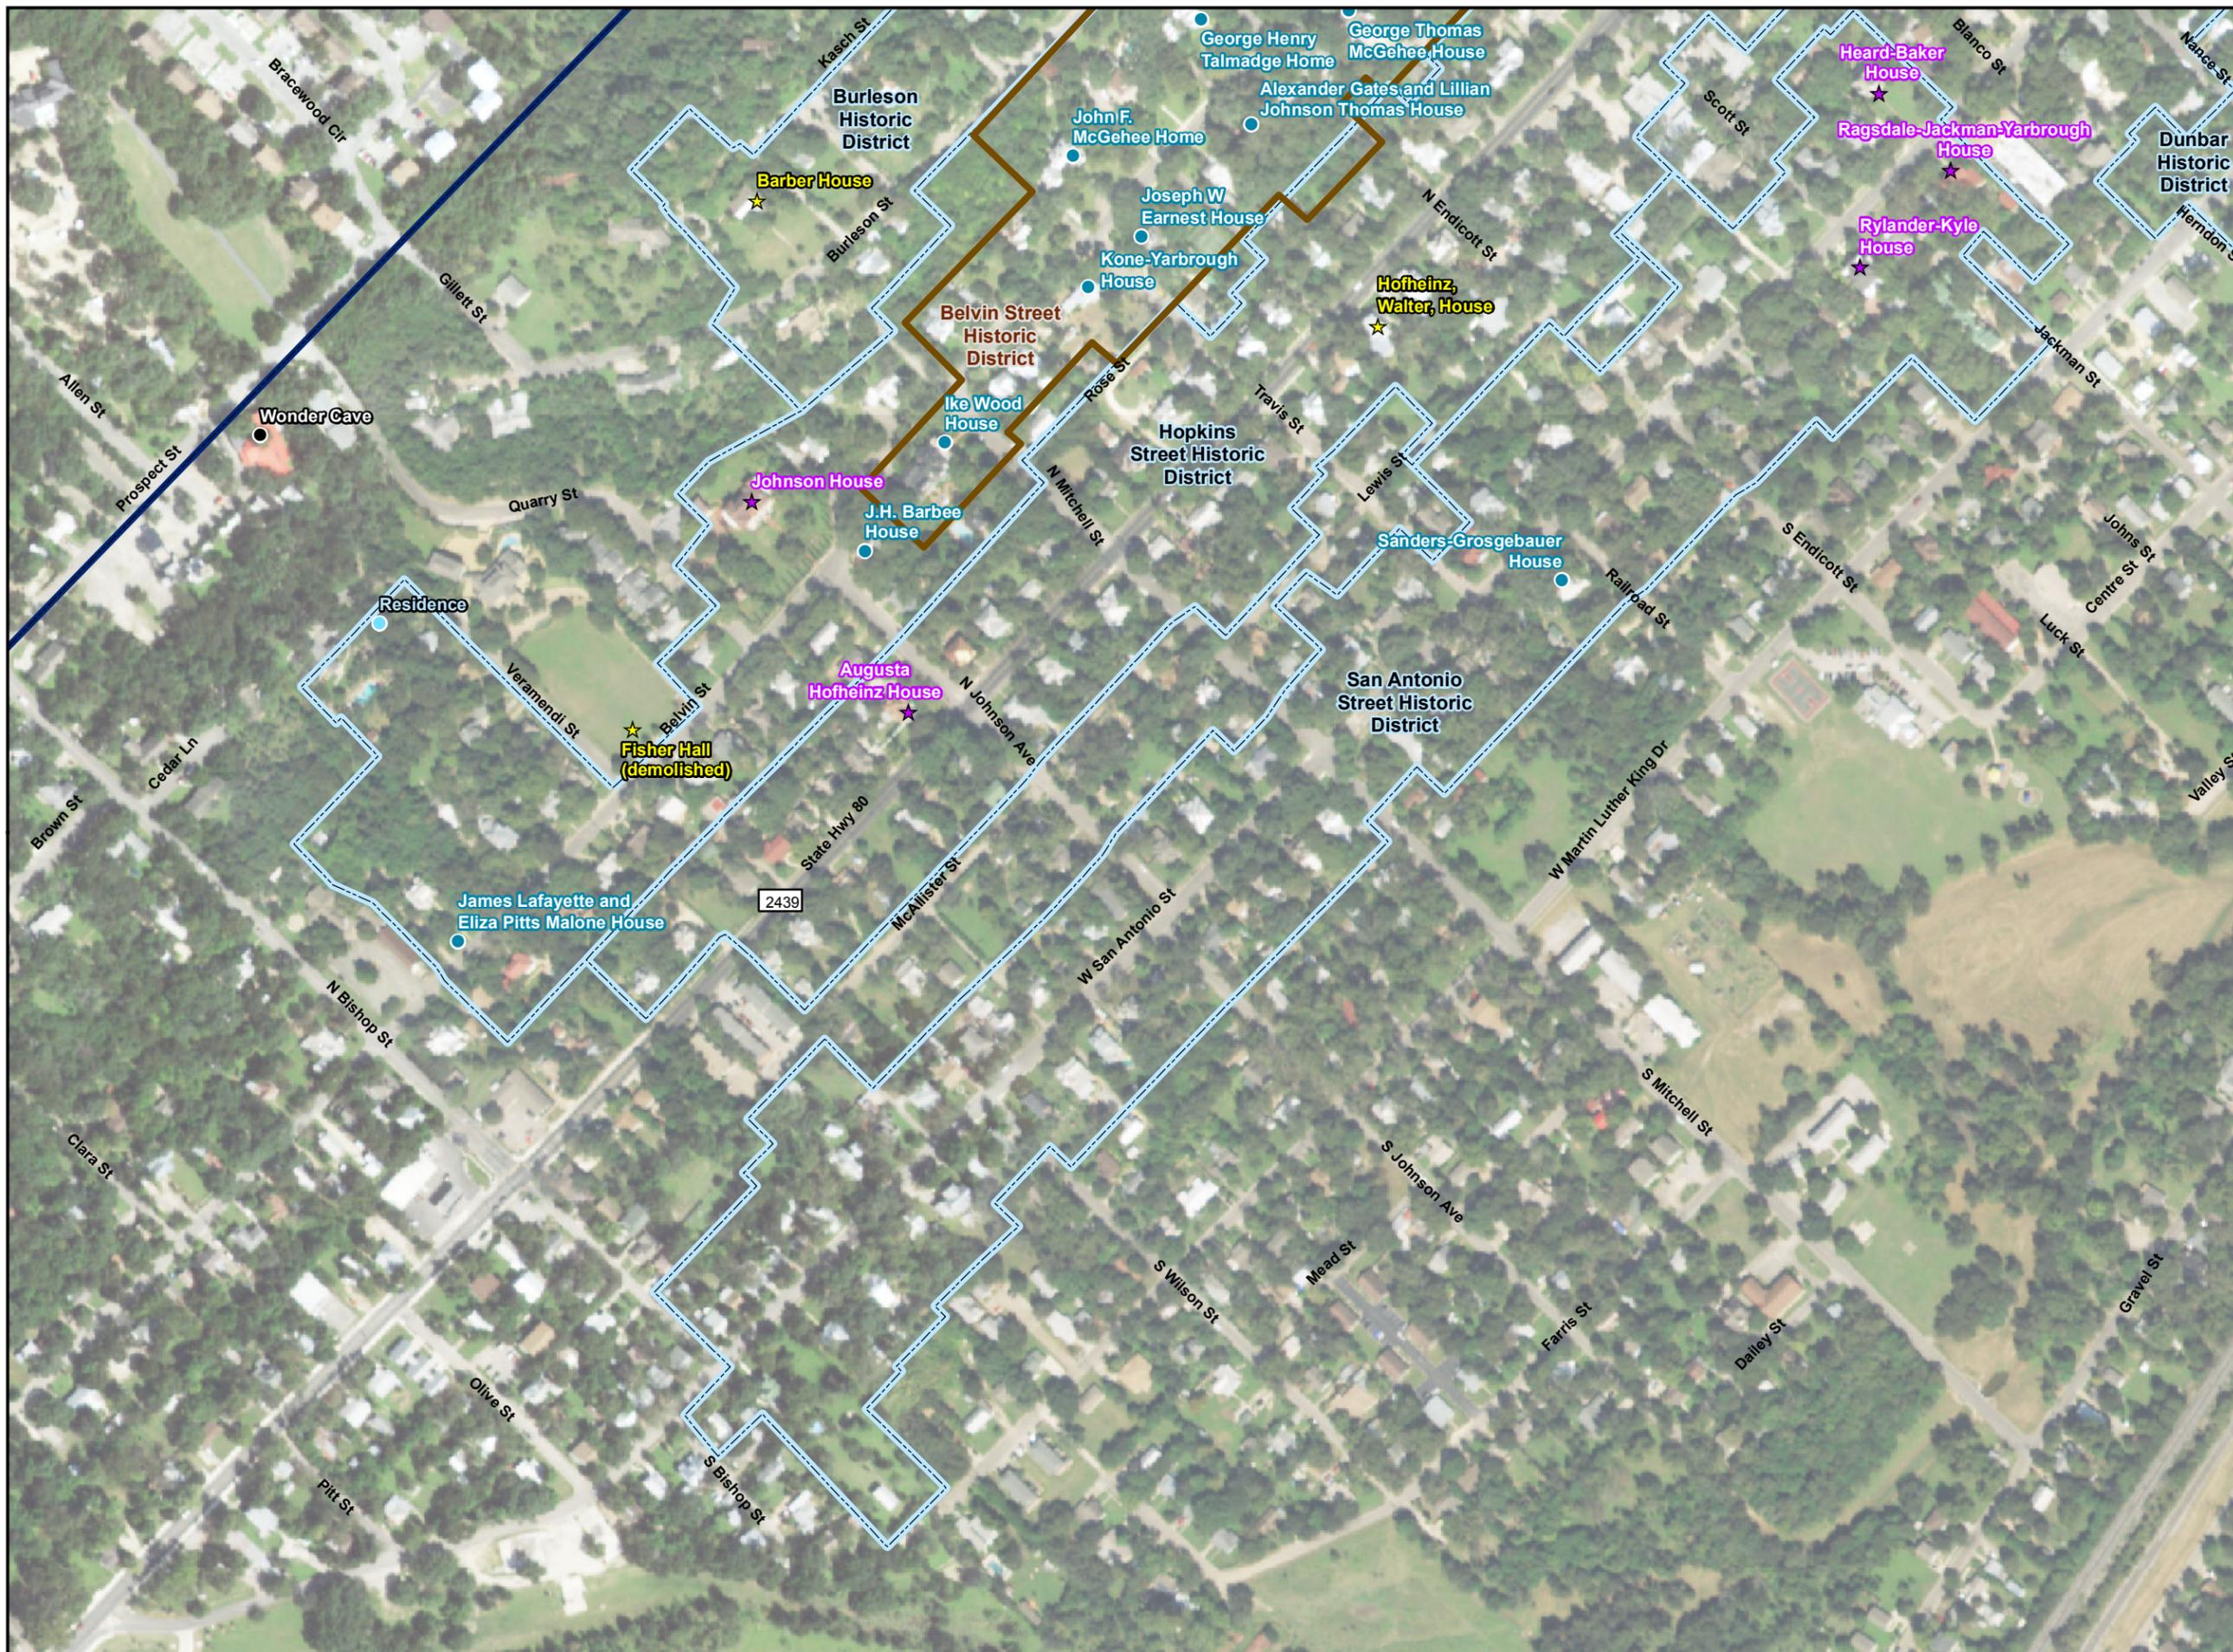
Figure 3-4

**Previously Identified
Historic Resources within
the Survey Area**

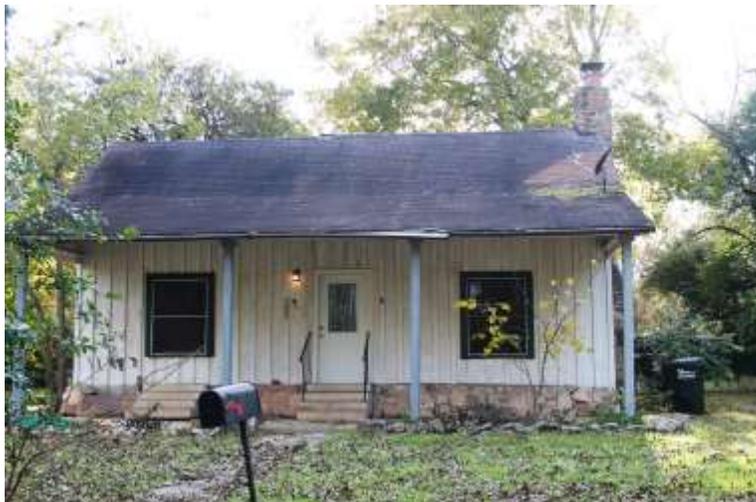
Additions, modifications **Explain:** rear additions (of historic age); replaced front door

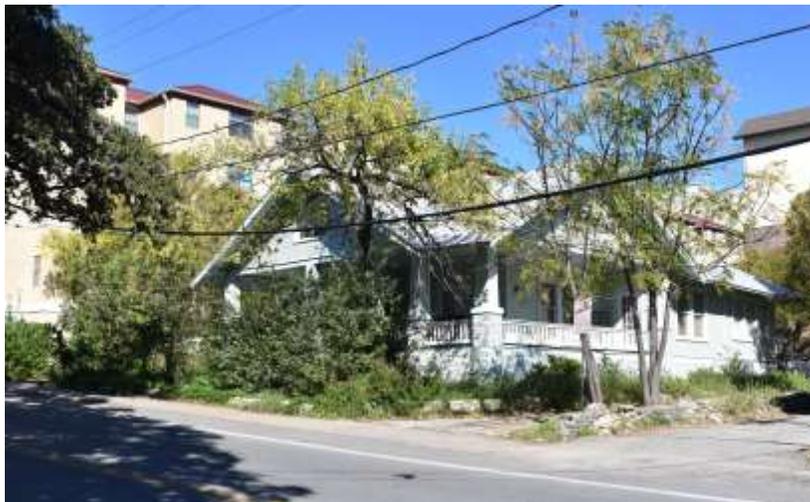
Ca. 1920 Craftsman bungalow with cross-gabled metal roof, original wood siding and windows, and a wrapped front porch with Craftsman-style supports; rear addition of historic age; replacement front doors, but otherwise very intact; one of few remaining residences of this age in the vicinity; surrounding area has been altered by recent large-scale residential development

Additions, modifications Explain: rear addition (historic age); replacement front doors

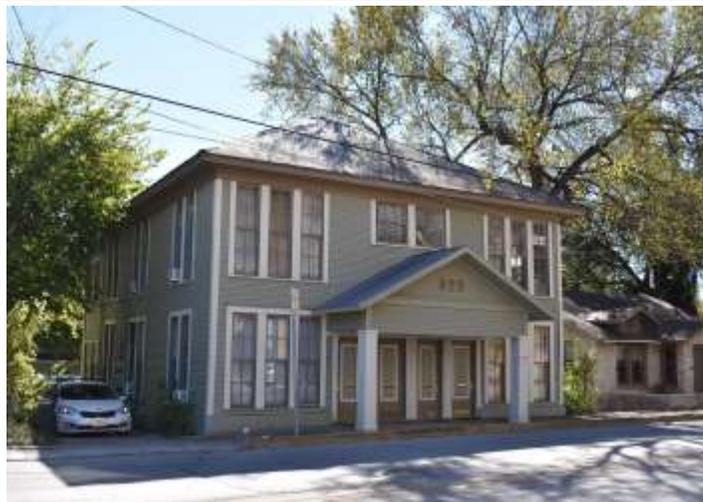
Ca. 1925, 2-story, multi-family (4-plex) residential building; hipped metal roof, original wood siding and 4/4-light wood-framed windows; apparent rear double-height porch enclosed ca. 1935; non-historic-age rear deck addition; replacement front doors but with original transoms; not evident on 1922 Sanborn map, but visible on 1930 Sanborn and identified as "Flat"

Additions, modifications **Explain:** enclosed rear inset porch (historic age), rear deck (not historic), replaced front doors

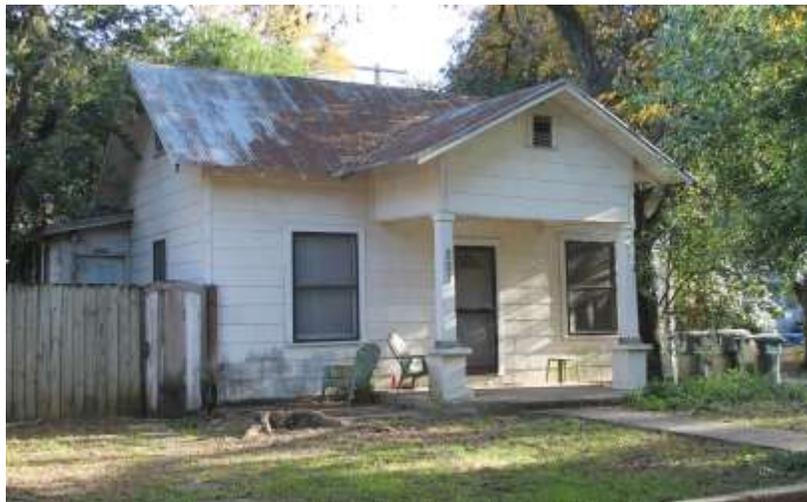
Additions, modifications **Explain:** shed-roof side and gabled rear additions (historic age); replaced front door; asbestos siding

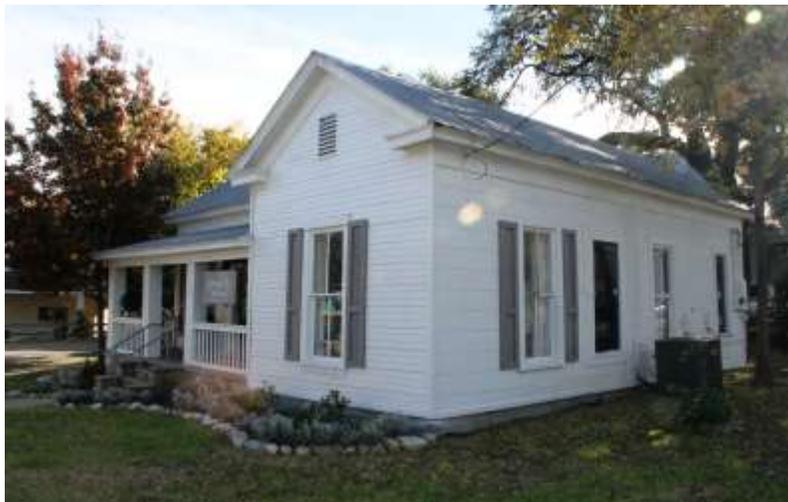
Additions, modifications **Explain:** two fixed-light windows on side elevation, brick porch supports (not historic); replaced door
 Relocated **Explain:**

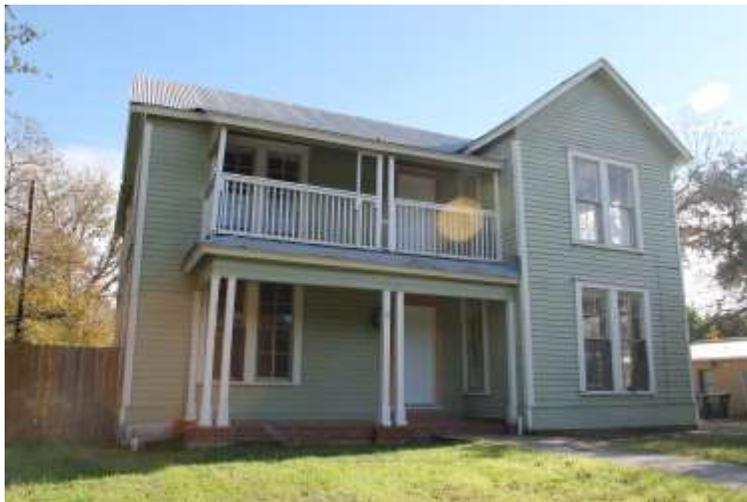
Ca. 1910 two-story, L-plan residence; original 4/4-light wood windows and wood siding; 2-story gabled rear addition/ell (historic age), shed-roof rear addition (not historic), small rear deck; some replacement vinyl windows on rear elevation; two-story porch on façade; replaced front doors on both floors; identified in 1997 San Marcos Heritage Neighborhood survey as medium priority with plywood siding (no longer in place)

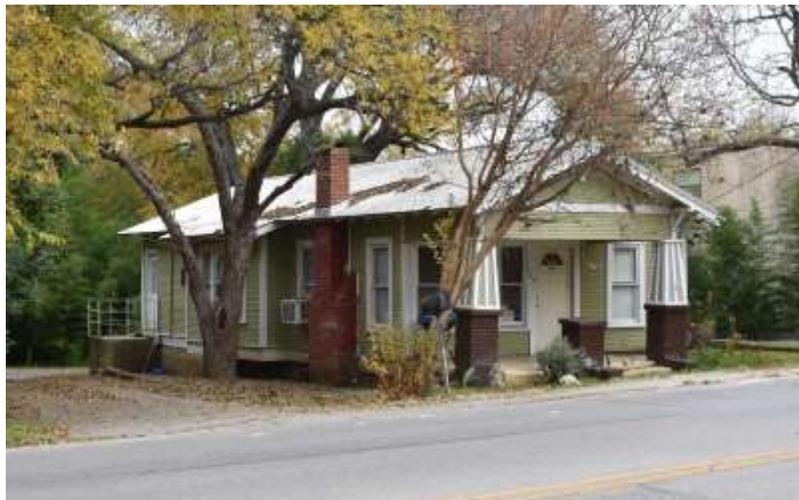
Additions, modifications **Explain:** replacement front door

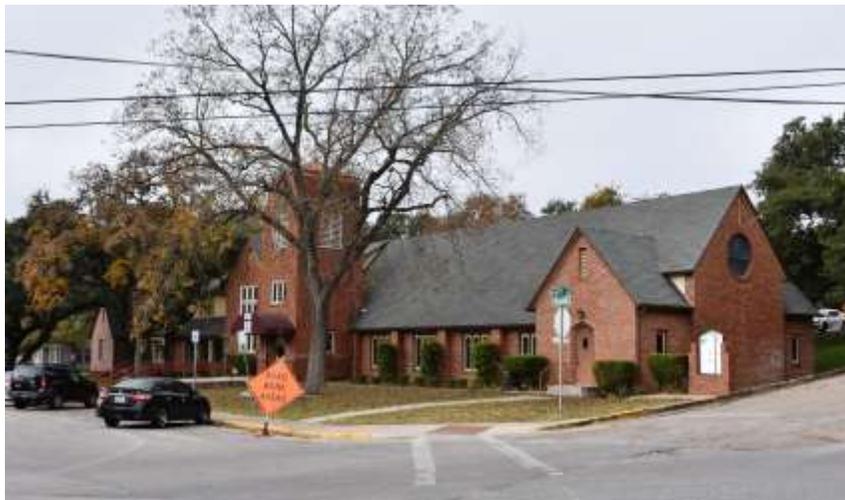
English Gothic-Revival influenced design; replaced earlier Presbyterian church on site; per website, congregation has been at this location for over 115 years; cornerstone at entrance reads "Cornerstone from old building on west wall;" square bell tower at entrance; church offices and Fellowship Hall in 2-story west wing of similar design with metal casement windows and a recessed porch entrance

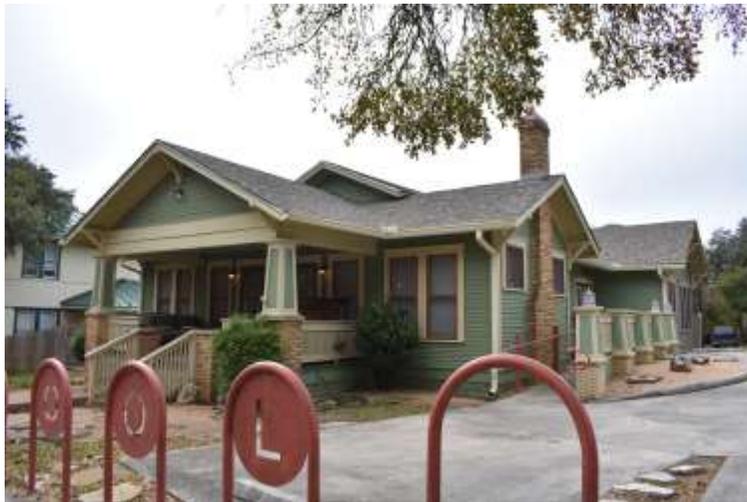
Cross-gabled Craftsman bungalow originally a duplex; per current resident, residence served as dentist office at one time; non-historic wheelchair ramp with Craftsman-styled railing/supports on side elevation with replacement French door; possible side-gabled rear addition (of historic age); original wood siding, wood windows and screens, brackets, and battered porch supports

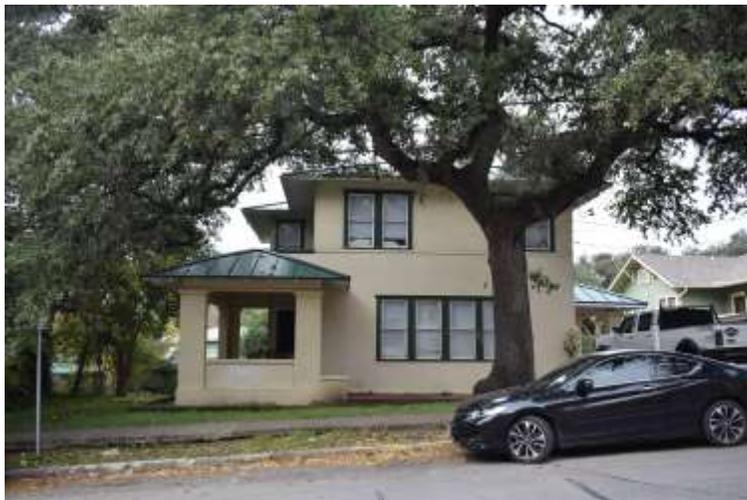
Ca. 1925 Prairie/Craftsman-style residence; 2-story; original wood windows and Craftsman-style front door; hipped roof front/side porch and port-cochere at driveway with square supports; stucco cladding; not a typical style observed within the area

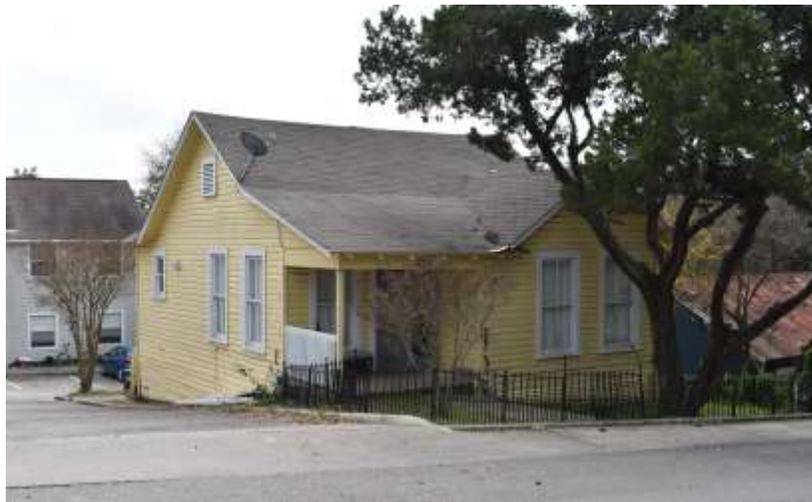
Ca. 1910 National Folk-style residence; retains original wood siding and 2/2-light wood windows; replaced front door; intact and representative example of style; shares parcel with non-historic-age apartment building at rear of lot (427 Lindsey Street)

Additions, modifications **Explain:** replacement front door

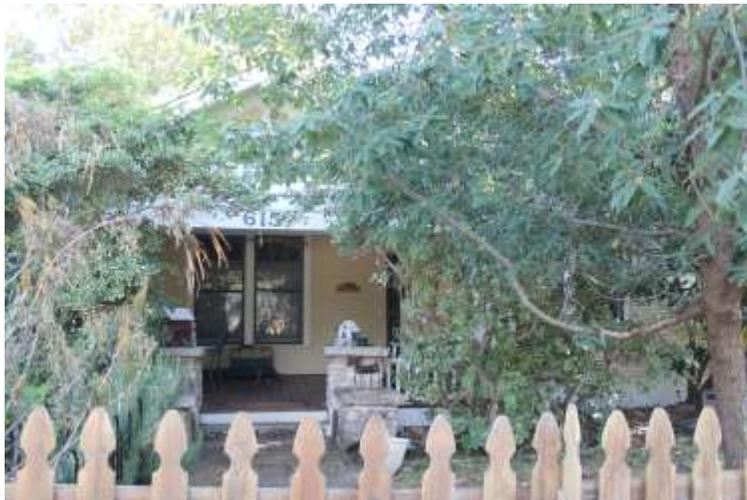
Ca. 1925 Craftsman bungalow with original wood siding, 6/1-light wood windows, original screened door, and stone piers at porch; small shed-roof side/rear addition of historic age and small side deck addition (not historic); significant and intact example of style; identified as high priority in the 1997 San Marcos Heritage Neighborhood survey (Keystone Architects); noted in 1997 survey as evident on 1922 Sanborn map

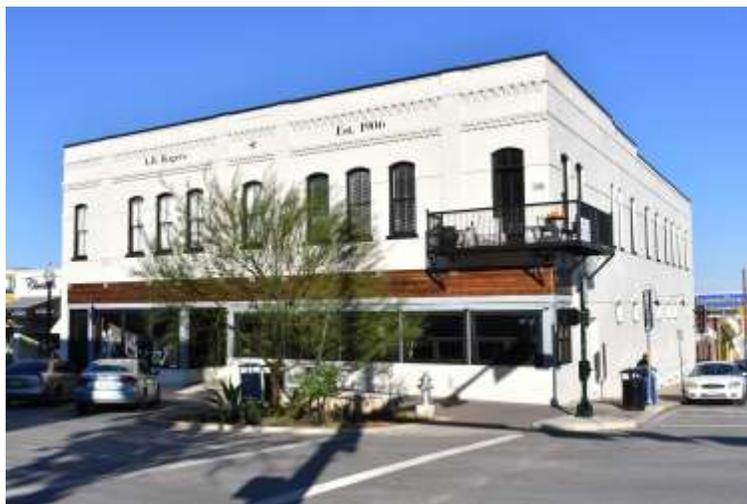
Ca. 1906 two-part block within Downtown LHD and NRHP Hays Co. Courthouse Hist. Dist. (contributing resource); upper level windows boarded at time of local district designation (1986); original 2/2-light wood windows on upper floor exposed/restored; dentiled and corbelled cornices; original transoms covered, replacement windows/doors on first floor; original brick on building has been painted; anchors corner of district

Additions, modifications Explain: replacement windows/doors (first floor); painted brick

Integrity of materials somewhat altered by window replacements on ground floor and painting of exterior brick

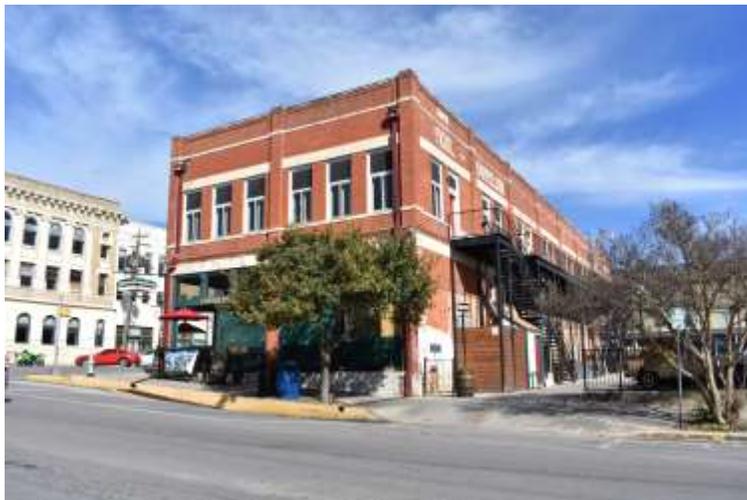
ca. 1885 two-part block; originally had three stories but third floor burned sometime between 1912-1922 (per 1985 survey); served as grocery in 1885-1869, furniture store in 1902, general store in 1912, and a furniture store (1st floor) and lodge hall (2nd floor) in 1922; intact example of two-part commercial block

Additions, modifications **Explain:** third floor reportedly burned between 1912-1922 and was removed
