**My Historic SMTX
City of San Marcos
Historic Resources Survey Report
Phase 1 – **DRAFT**
San Marcos, Texas**

January 2019

Prepared for
City of San Marcos

Prepared by
Hicks & Company
Elizabeth Porterfield, MSHP

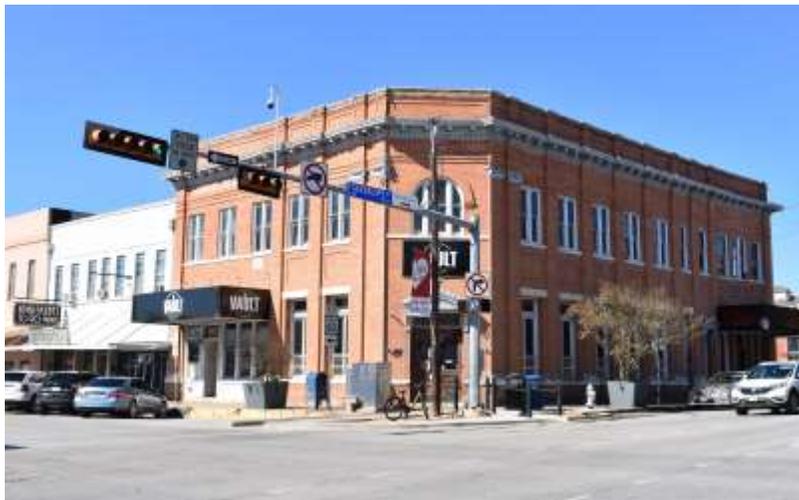
ca. 1891 two-part block with Classical Revival-style ornamentation including a dentiled cornice, brick pilasters with Classical capitals, bracketed pediment at angled corner entry; original wood 1/1 windows on upper floor, replaced windows and original transoms on ground floor; housed dry goods, clothing, and general stores in 1891, was bank by 1912 (per 1985 survey); contributing resource to NRHP-listed Hays Co. Courthouse Hist. Dist. and Downtown Local Historic District

Additions, modifications **Explain:** Some replacement windows on first floor

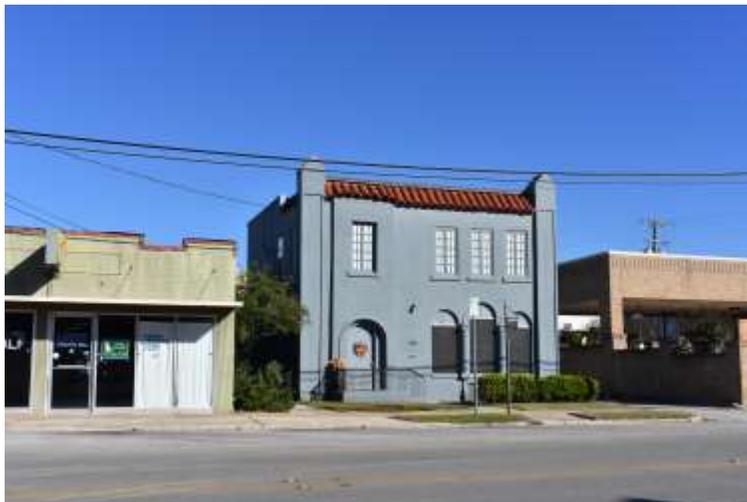
1928 Spanish Eclectic-style building with tile parapet, pilasters, and decorative columns at first floor window surrounds; constructed as office for the San Marcos Telephone Company (SMTC); SMTC remained in building until 1955; SMTC reportedly significant for the establishment of local and long distance calling in San Marcos and was first in the US to create a computerized operator system that replaced switchboards

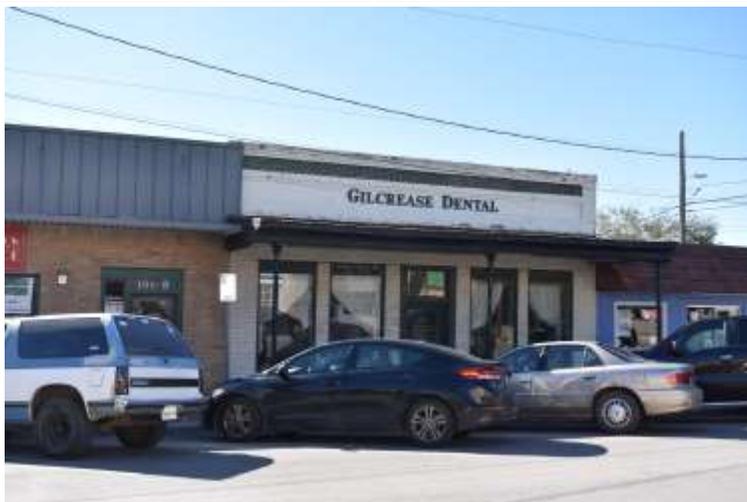
Ca. 1910 one-part commercial block with corbeled brick parapet, ornate pressed tin awning, and original transom over front entrance; windows have been replaced with fixed glass but original wooden window frames remain in place

Additions, modifications **Explain:** Replacement fixed-glass windows

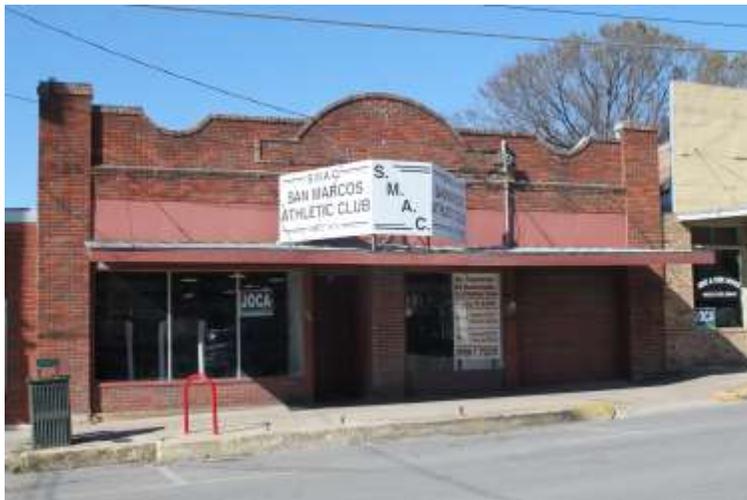
Ca. 1925 one-part block; arched brick parapet and brick corner pilasters; original transoms appear intact but covered, single-bay garage door may be original as bldg. is on 1930 Sanborn map (sheet 4) as Auto Sales and Auto Repair; windows replaced but retain wood frames; one of the most intact and architecturally significant examples remaining in this block of S. LBJ and contributing to potential historic district expansion

Additions, modifications **Explain:** replacement windows and door; rear CMU addition (ca. 1970s)

Materials altered somewhat by replacement windows and door but overall façade retains integrity

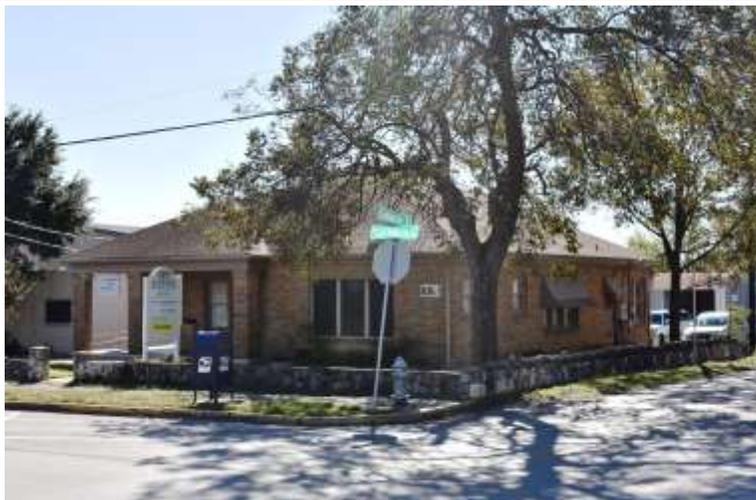
Hipped roof bungalow, ca. 1935; not visible on 1933 Sanborn map but present on 1945 Sanborn (Sheet 7) and noted as veneered; significant as one of the only brick bungalows within the survey area and has retained integrity

Additions, modifications Explain: concrete wheelchair ramp and steps at front entrance; one replaced front door
 Relocated Explain:

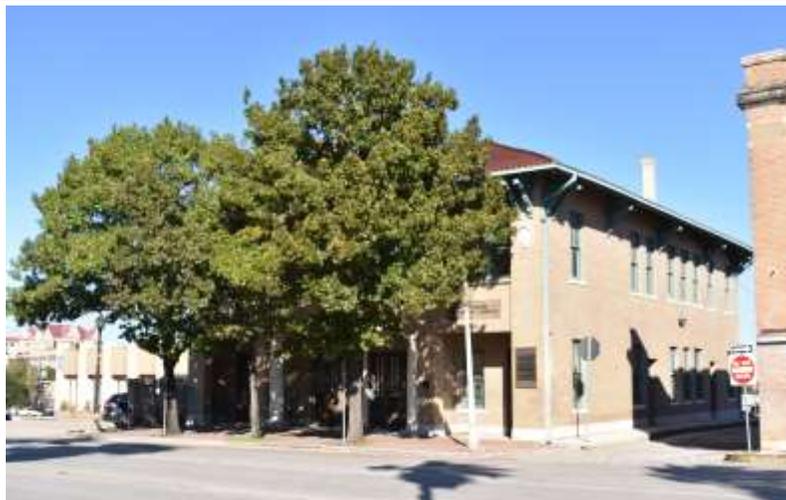
1915 former City Hall and Fire Station, now part of Texas State Univ.; Craftsman-style detailing, large Classical columns at central bay; wood windows, restored/replaced wood doors; second cornerstone noting restored in 1985 by L. W. Davis; small marble memorial at front of bldg. "In Memory of Jack" (SMFD mascot killed 12/27/1922); NRHP listed; contributing to Downtown LHD

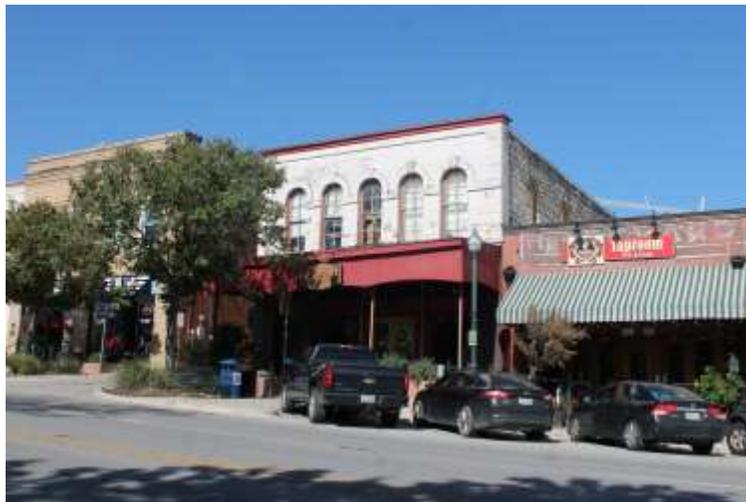
Ca. 1885 two-part block of stone construction with dressed limestone façade, arched 4/4-light wood-framed windows with hood molds/keystones on second floor, transoms and wood-framed fixed glass windows on storefront with decorative iron columns; replacement doors and non-historic wooden awning; grocery store (1885), dry good store (1921), drugstore (1922) per 1985 survey; NRHP listed (Hardy-Williams Bldg.) and contributing resource to NRHP Hays Co. Courthouse Hist. Dist. and Downtown LHD.

Additions, modifications **Explain:** Non-historic wood awning; replaced doors

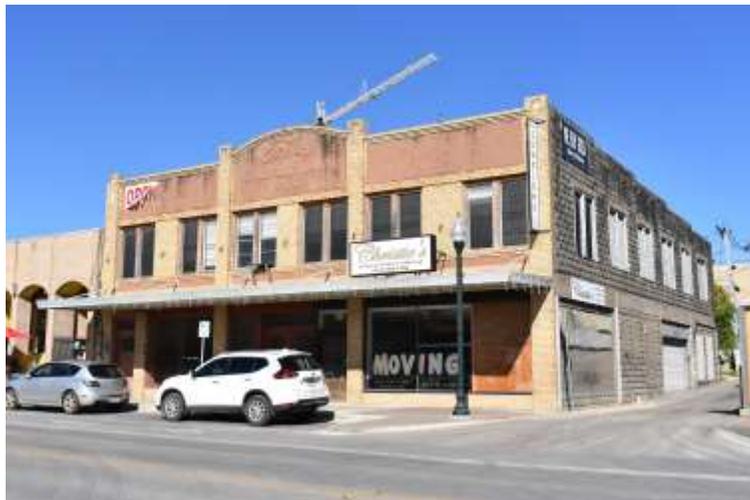
1920 two-part commercial block built for S.D. Jackman Ford; largely intact façade with high degree of integrity; rusticated concrete block on side elevation and garage bay; replacement windows on second floor; original double door entrance and transoms at ground floor

Additions, modifications Explain: replacement windows on second floor

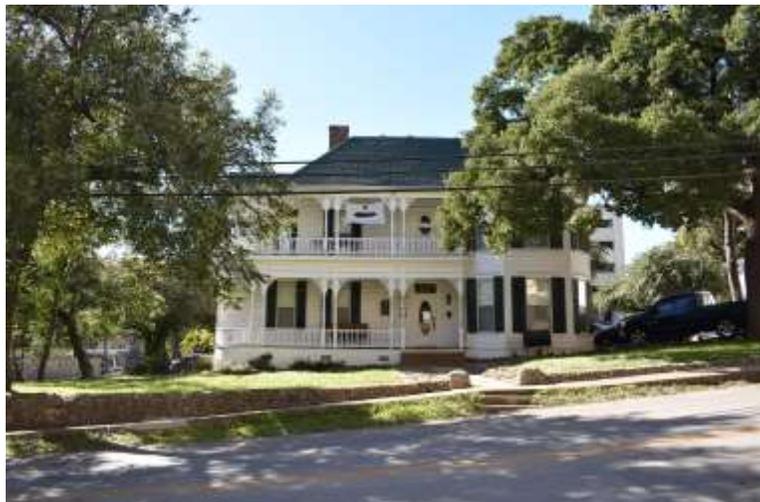
Residence built for J.T. Goforth ca. 1905; founded Goforth School with two others (in former town of Goforth approx. 12 miles NE of San Marcos); house sold to Thomas Green and Lon Harris in 1913; Harris became first president of Southwest Texas Normal School (1903) and later second president of San Marcos Baptist Academy (1911); house converted into apartments ca. early 1980s; good integrity despite replacement windows

Additions, modifications Explain: vinyl replacement windows
 Relocated Explain:

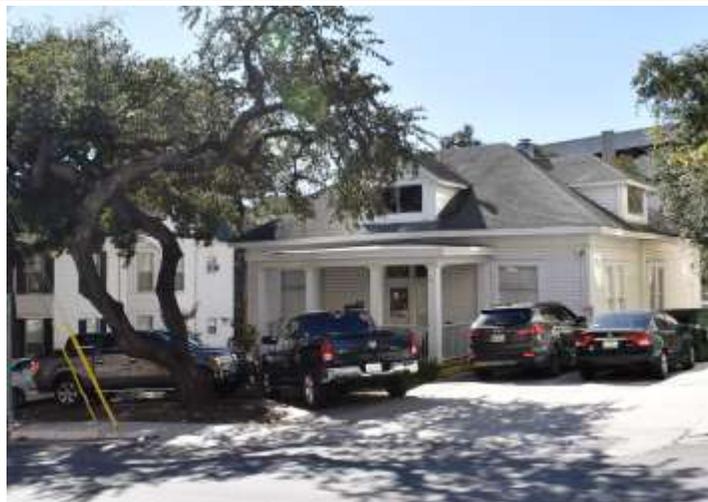
ca. 1910 hipped-roof, central-hall residence; original wood siding, 1/1-light wood-framed windows, and original transoms and sidelights at entrance; replacement aluminum windows in dormers; pressed tin rusticated skirting; rear addition of historic age with partial basement

Additions, modifications **Explain:** rear addition (historic age); replacement aluminum windows in dormers

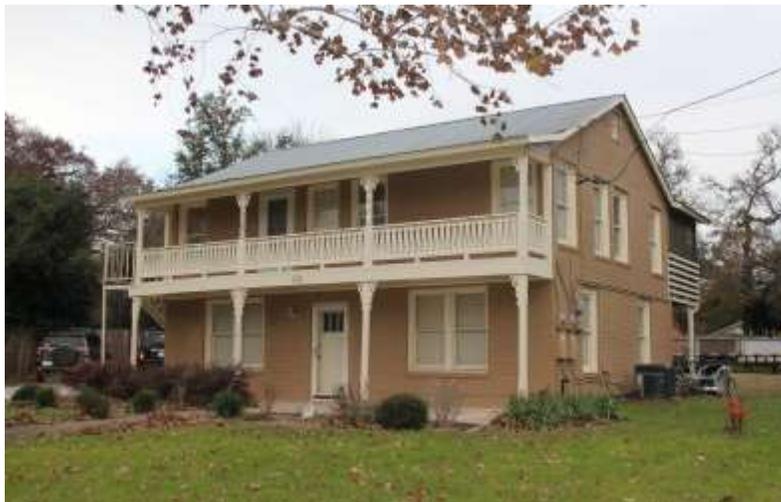
Ca. 1950 two-story, side-gabled duplex; identified in 1997 San Marcos Heritage Neighborhood survey as low priority with construction date of ca. 1970; actual construction date undetermined; parcel is vacant on 1945 Sanborn map (Sheet 11) but entries for 110 and 110-1/2 N. Endicott were found in a 1953 San Marcos telephone directory; resource appears to date to ca. 1950 based on style and materials

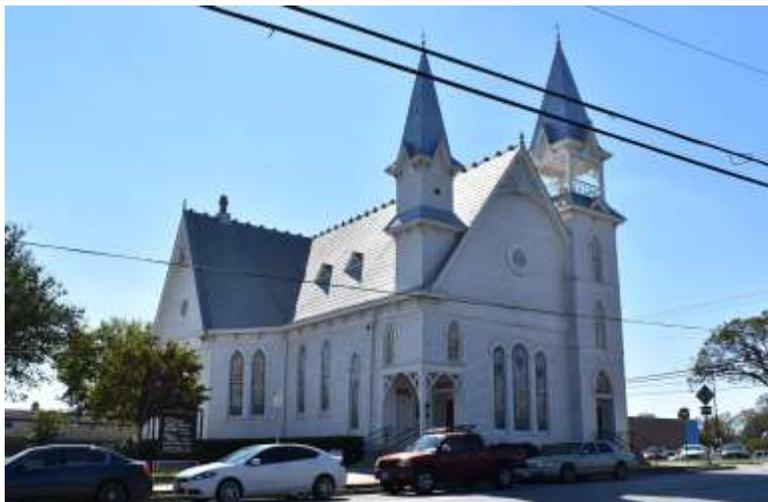
Const. in 1893; third church built on site (first in 1855, second in 1872); congregation org. in 1847 in home of early settler John D. Pitts; building is significant example of Gothic Revival style with elaborate exterior wood ornamentation; per NR nom, interior remodeled in 1939 (including addition of 20 stained glass windows); adjacent Fellowship Hall added in 1951

Additions, modifications **Explain:** Interior renovations and addition of 20 stained glass windows (1939)

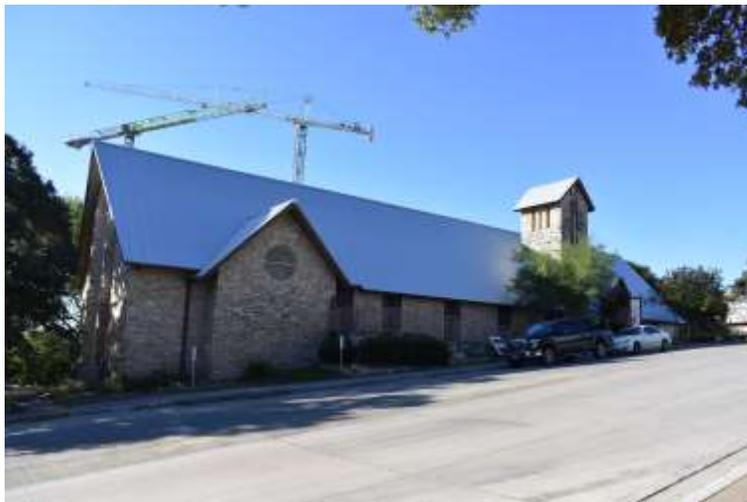
Mid-century church originally built for St. Mark's Episcopal congregation; church relocated in 2010 and church became Christ Chapel at Texas State University; serves as ministry for students sponsored by both the Episcopal and Lutheran churches; intact example of mid-20th century modern design and with adjacent McCarty Student Center and Baptist Student Center is recommended for potential district designation

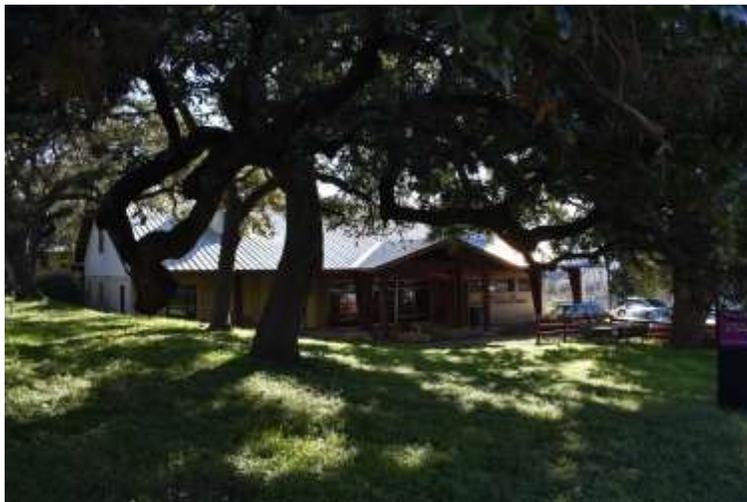
Student center for University Church of Christ at Texas State University; constructed in 1963 and named for local rancher/philanthropist Tom McCarty who left his estate to the church; reflection of mid-century-modern design elements but is experiencing ongoing renovations; with adjacent Christ Chapel and Baptist Student Center, is recommended eligible as a potential historic district

Additions, modifications **Explain:** replacement roof and addition of dormers
