<p>The City of San Marcos Engineering and Capital Improvements</p>	<p>CURRENT AS OF 1/1/2021</p>	<p>ABANDONMENT LINE AT ACTIVE MANHOLE</p>	
<p>RECORD COPY SIGNED BY LAURIE MOYER, P.E.</p>	<p>11/18/2014 <u>ADOPTED</u></p>	<p>THE ARCHITECT/ENGINEER ASSUMES RESPONSIBILITY FOR APPROPRIATE USE OF THIS STANDARD</p>	<p>506S-15A-SM N.T.S. STANDARD DETAIL</p>

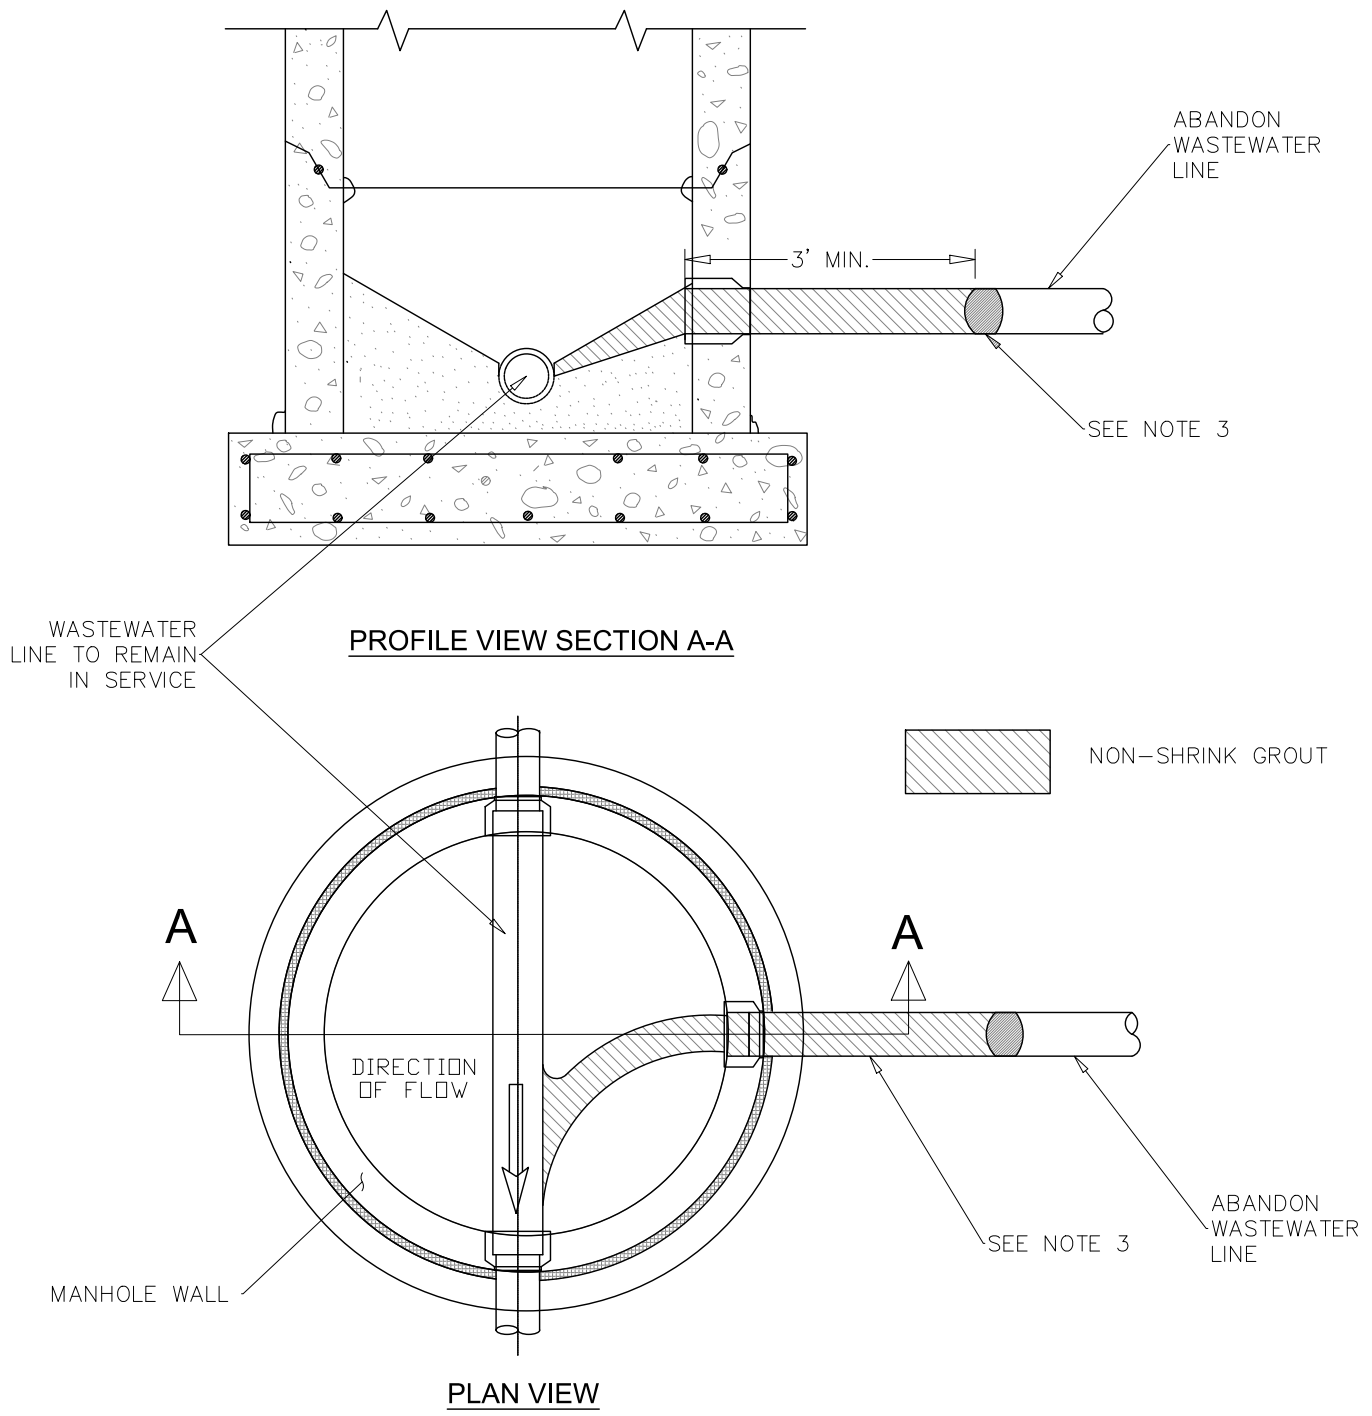
1. RESTORE DAMAGED MANHOLE LINING PER CURRENT SPL WW-511, 511A, 511B.
2. ABANDONED INVERTS WILL BE FILLED WITH NON-SHRINK GROUT AND MATCH EXISTING SLOPE FROM MANHOLE WALL TO REMAINING INVERTS.
3. PUSH APPROPRIATE SANDBAG OR APPROVED PLUG A MINIMUM OF 3 FEET INTO THE PIPE TO BE ABANDONED BEFORE FILLING PIPE COMPLETELY WITH NON-SRINK GROUT.
4. ALL REMAINING ACTIVE U INVERTS AND ALL GROUT SLOPING TO INVERTS WILL BE REGROUTED WITH NON-SHRINK GROUT TO HAVE A SMOOTH FINISH AND BE REPAIRED IF DAMAGED.
