Field Assessment Report (Hot Spots)

Site No.: 1 Location: 700 Blk McKie St (Willow Springs Creek)

San Marcos Comprehensive Watershed Master Plan
Field Assessment Form - Local Flood Complaints

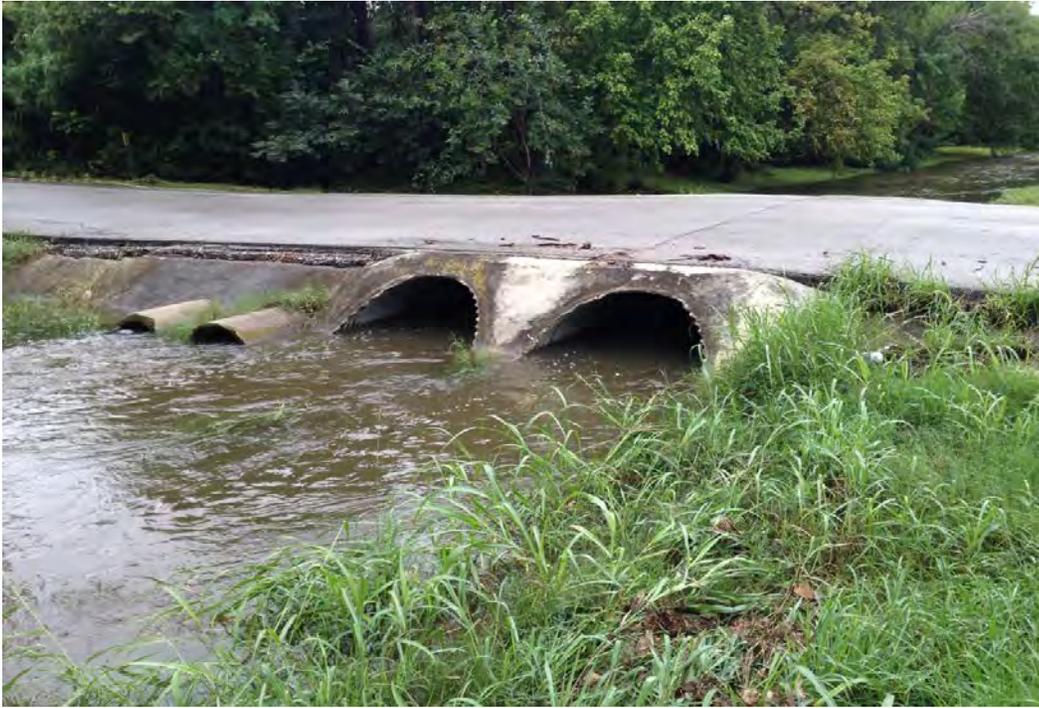
Site No.: 1		Location: 700 Blk McKie St (Willow Springs Creek)		BACK TO MAP
SITE PHOTOGRAPHS	Photo #	Caption		
	P1	<i>From NE of crossing; looking SW towards D/S face</i>

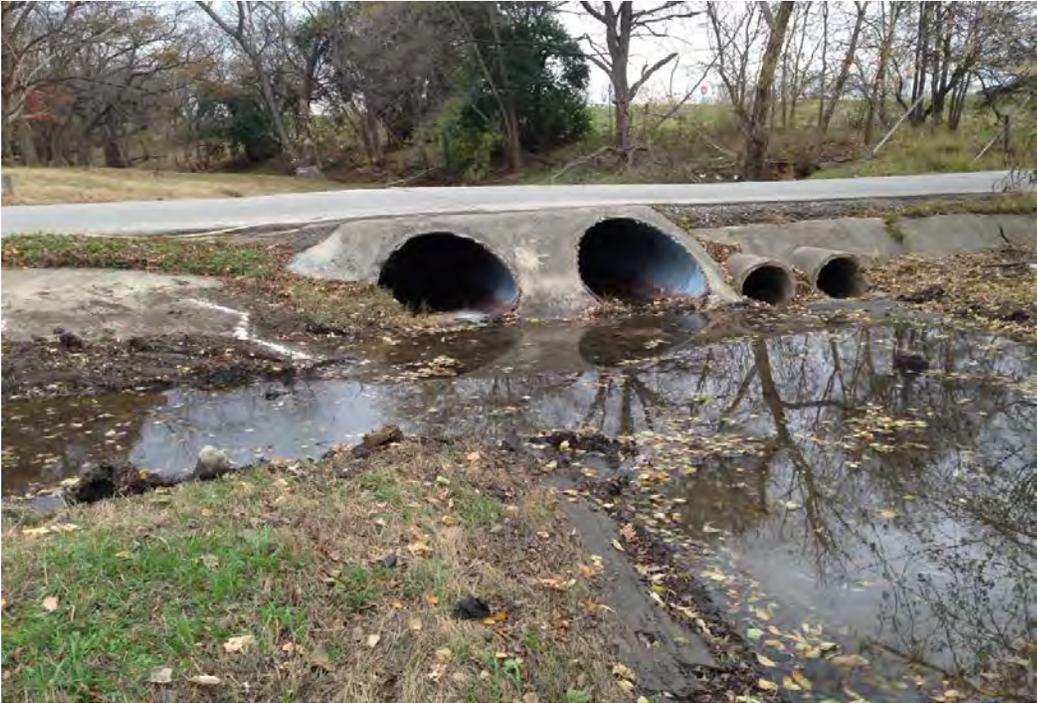
Photo #	Caption		
P2	<i>From W of crossing; looking E towards U/S face</i>

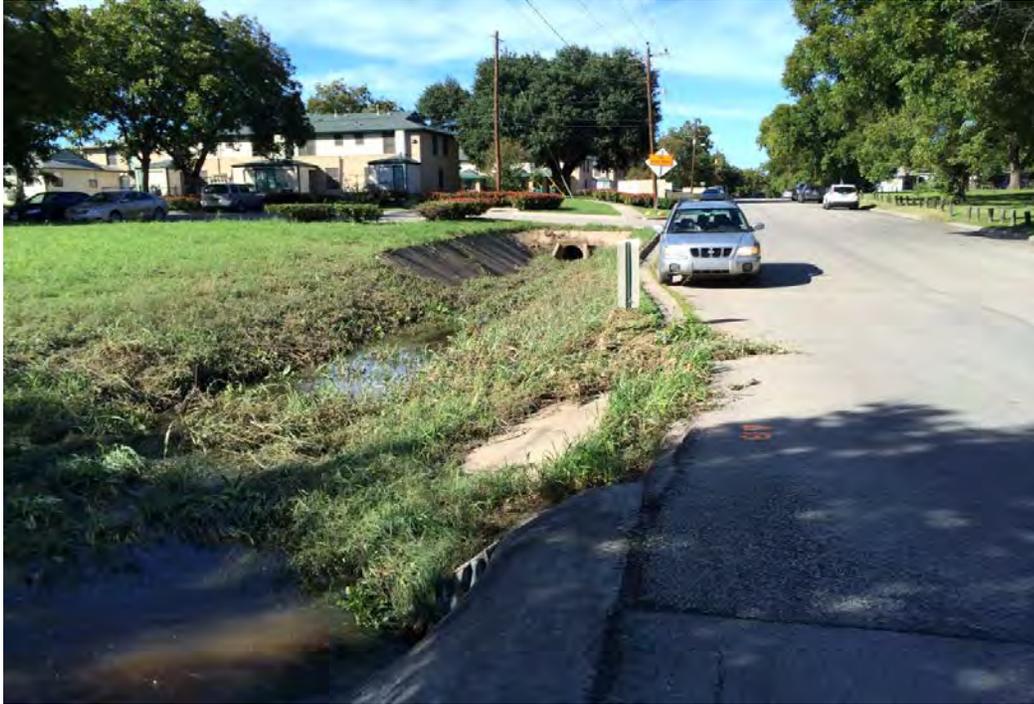
P3 *From W side of crossing; looking N toward storm drain outlet U/S of McKie*

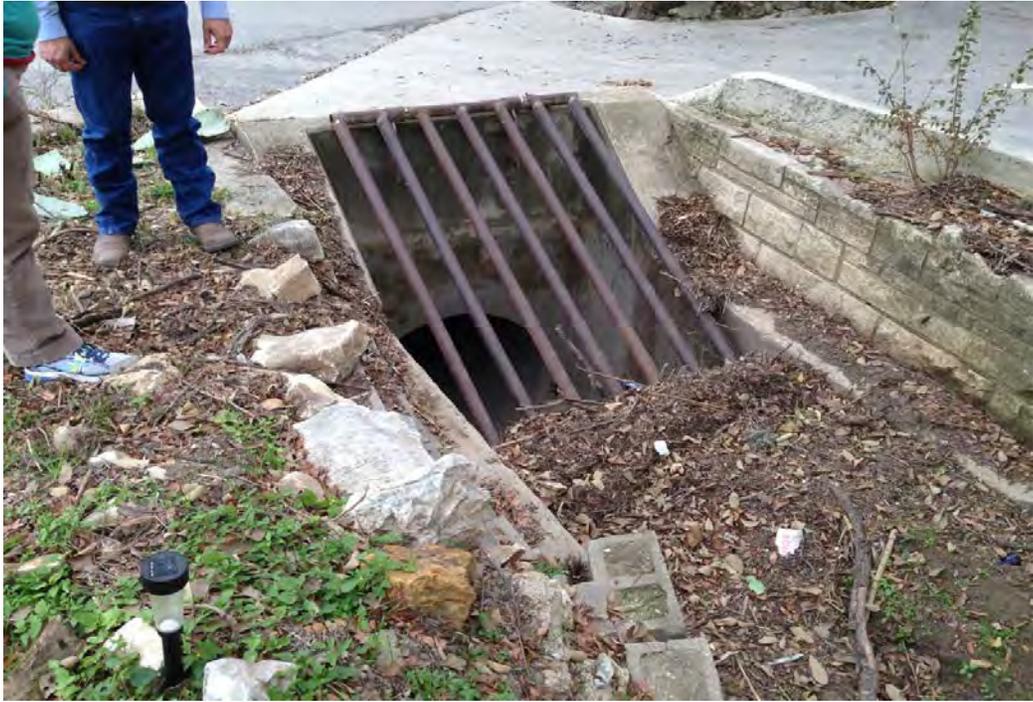
Cause of Flooding: Debris accumulation on the inlet grate clogs the inlet during every rain event

P1	<i>Debris accumulation on grate inlet (12/20/13)</i>
----	--

Notes: Vegetation mgmt. recommended to reduce bamboo and other debris accumulation
Repair of stone channel walls near 613 Moore is recommended
Extension of existing 54" SD to Blanco St may intercept stormwater U/S of channel

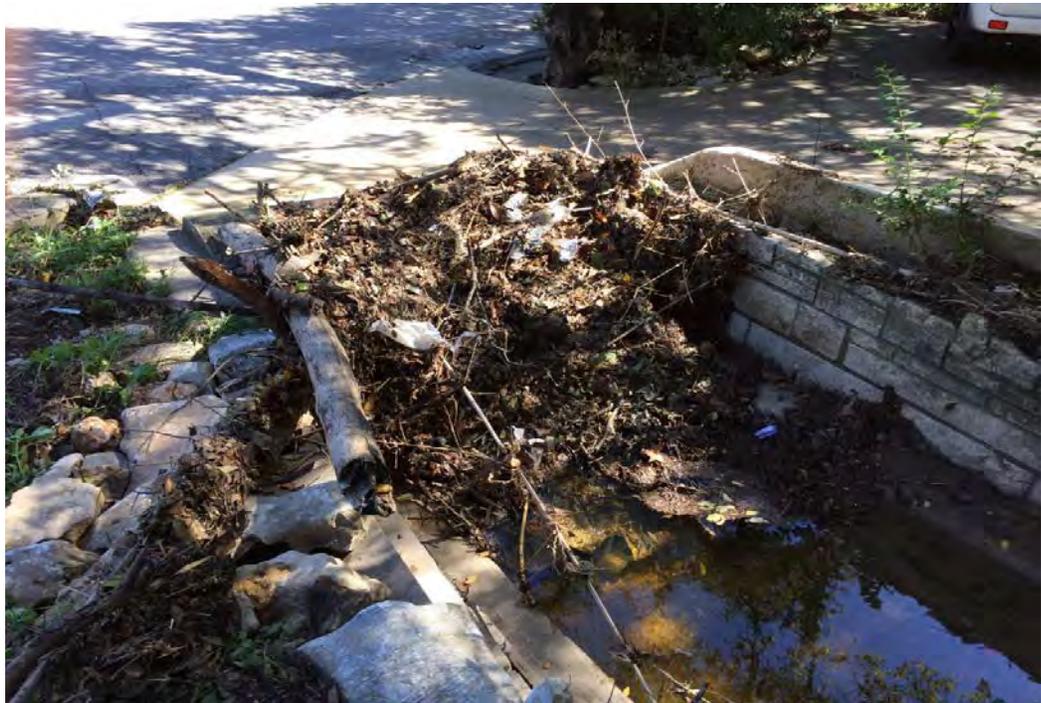
P2	<i>Completely clogged grate inlet after Oct 31, 2013 storm event</i>
----	--

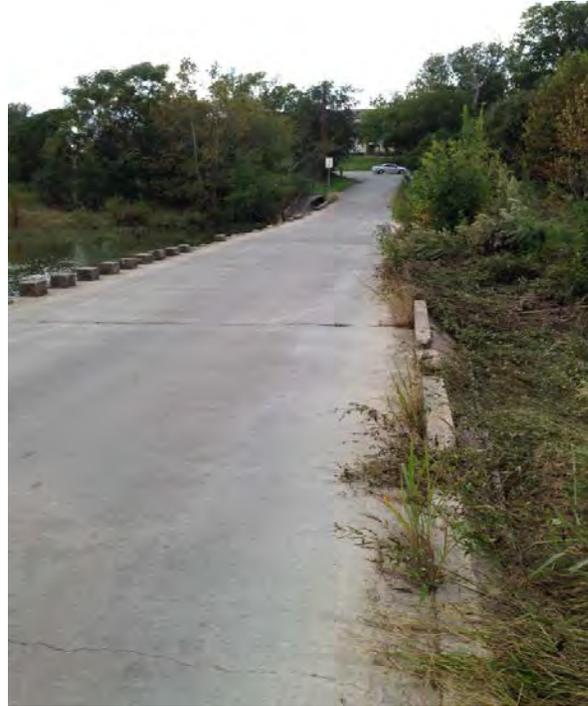
P1	<i>Uhland Road and Blanco River</i>
----	-------------------------------------

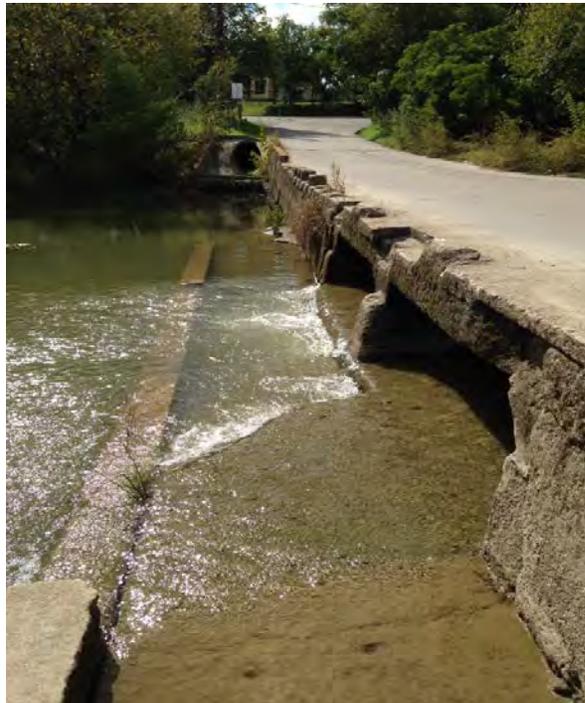
P2	<i>Outlet of culvert under Uhland Road</i>
----	--

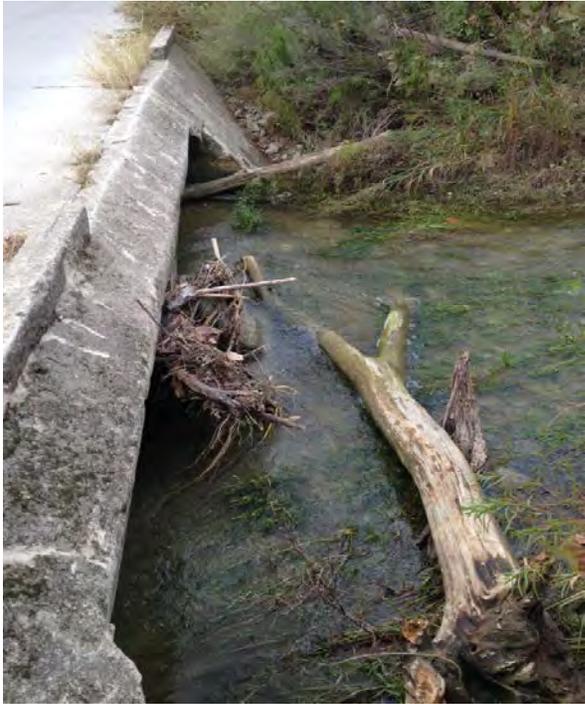
Site No.: 3 Location: 1800 Bld Uhland Rd (Blanco River)		BACK TO MAP
SITE PHOTOGRAPHS	Photo #	Caption
	P3	<i>Inlet of culvert under Uhland Road</i>

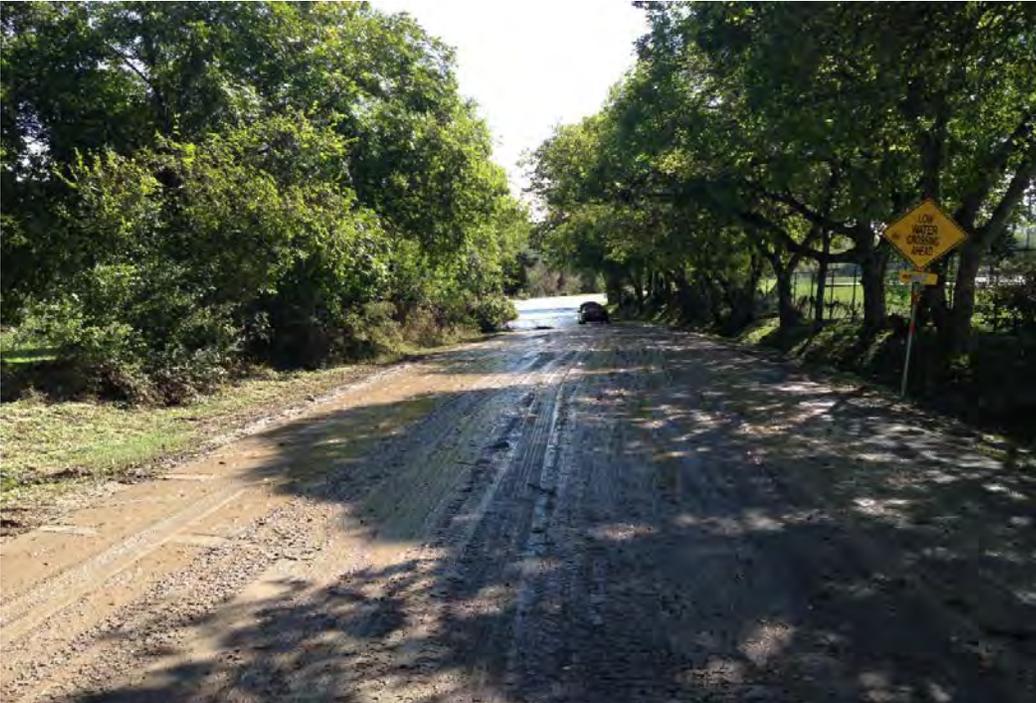
SITE PHOTOGRAPHS	Photo #	Caption
	P4	<i>Roadway closure during the 10/31/13 storm event</i>

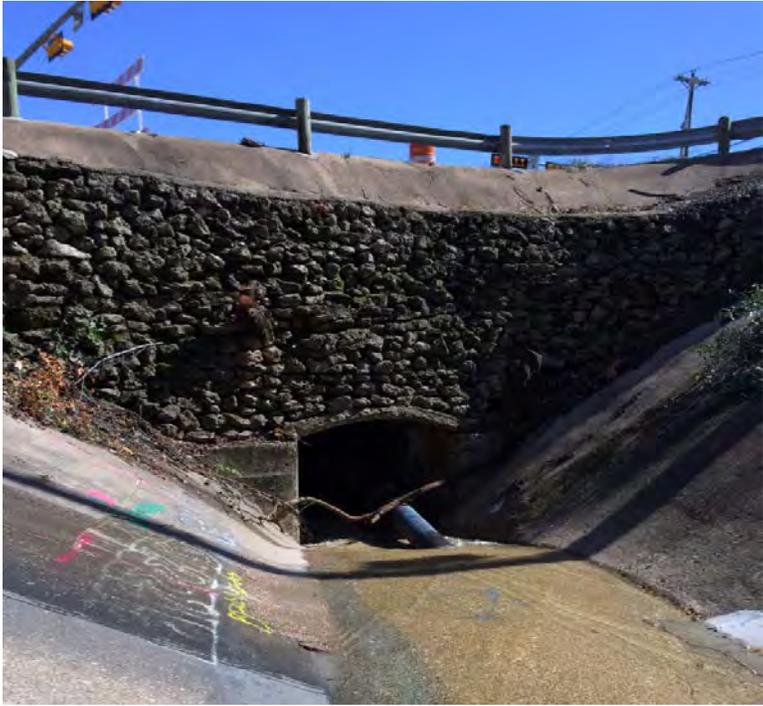
<i>P1</i>	<i>Upstream side of culvert running under MLK Drive</i>
-----------	---

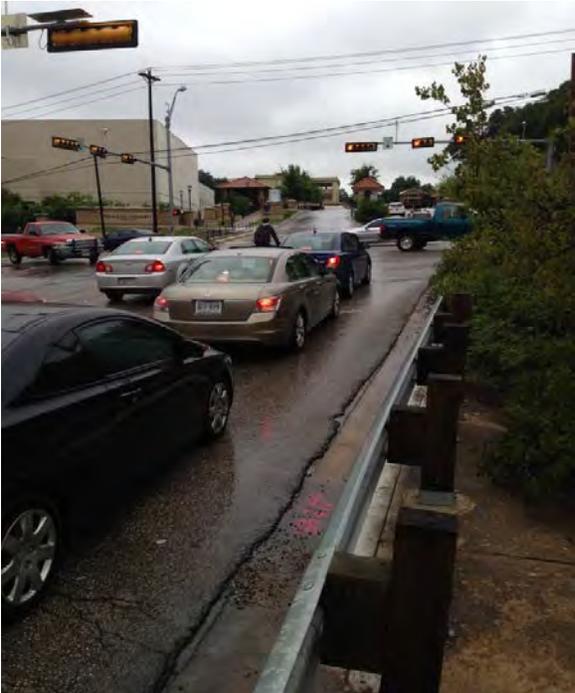
<i>P2</i>	<i>Intersection of Sessom Drive and MLK Drive</i>
-----------	---

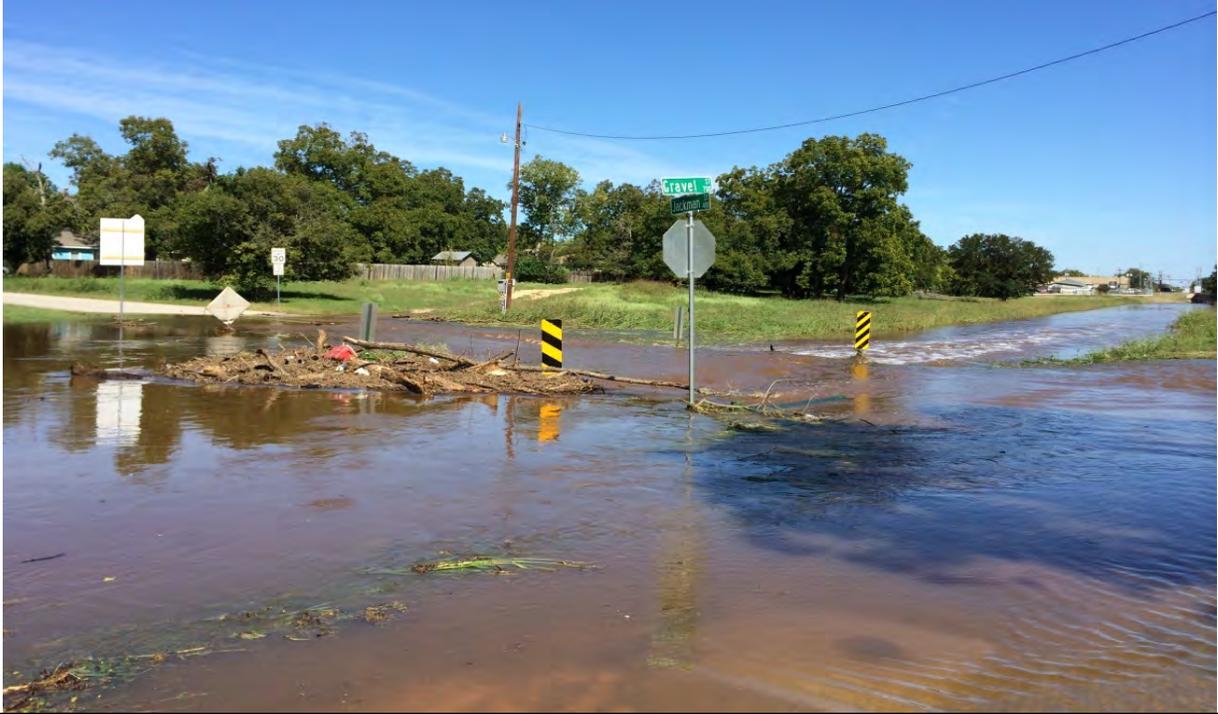
Site No.: 6		Location: 400 Bld Jackman (Purgatory Creek)		BACK TO MAP
SITE PHOTOGRAPHS	Photo #	Caption		
	P3	<i>Looking E from Gravel St; Jackman overtopped/closed, heavy debris/clogging (10/31/13)</i>

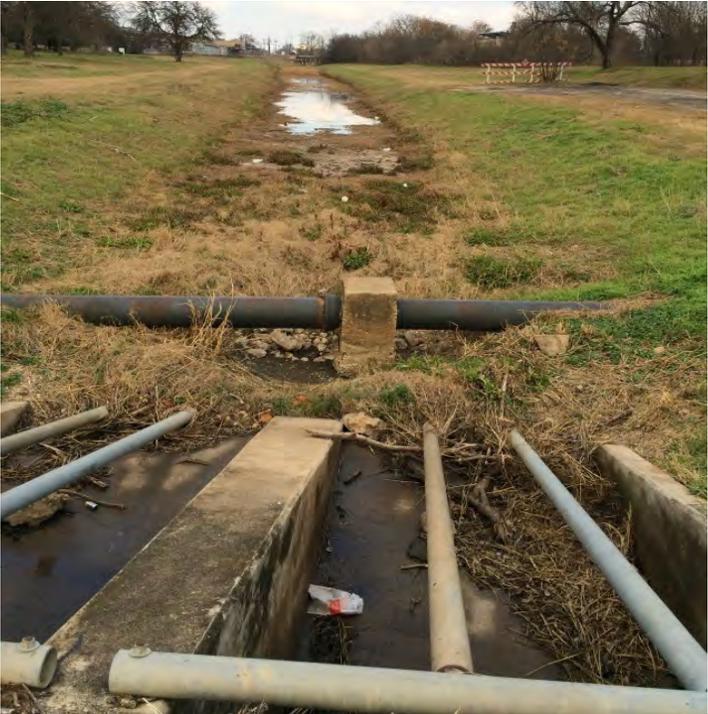
SITE PHOTOGRAPHS	Photo #	Caption		
	P4	<i>Looking E from crossing; debris removed from grates & WW x-ing, ponding D/S (1/9/13)</i>

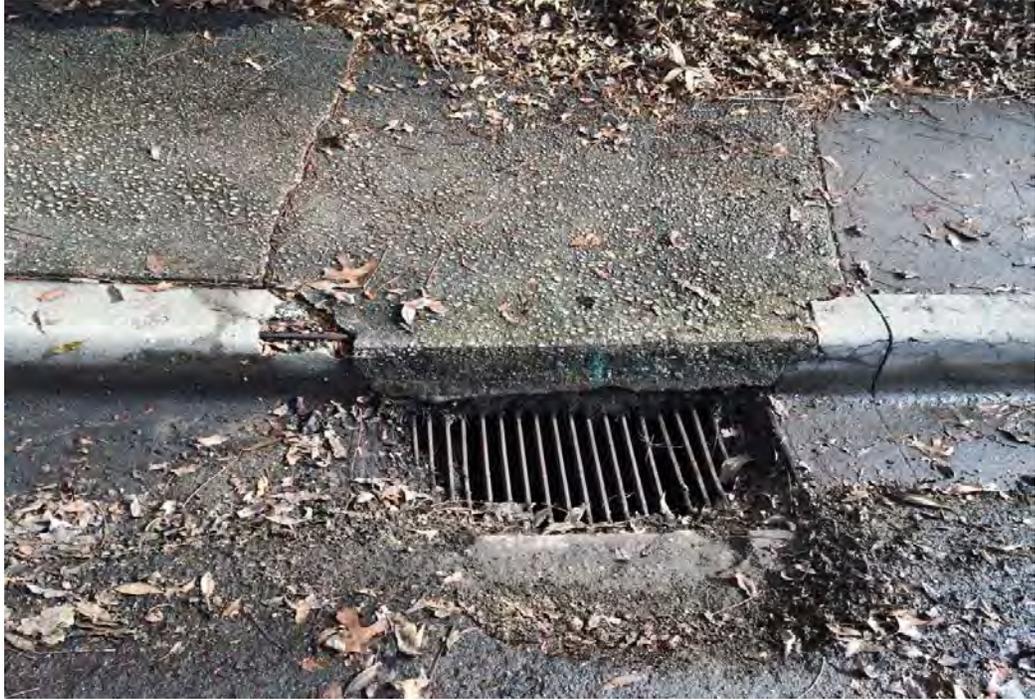
P1	
----	--

Cause of Flooding: Two small grate inlets in local sag area clog and flood roadway and adjacent properties nearly every rainfall event; Large drainage area

Notes: Replace two grate inlets with one or more curb inlets to reduce clogging/flooding frequency

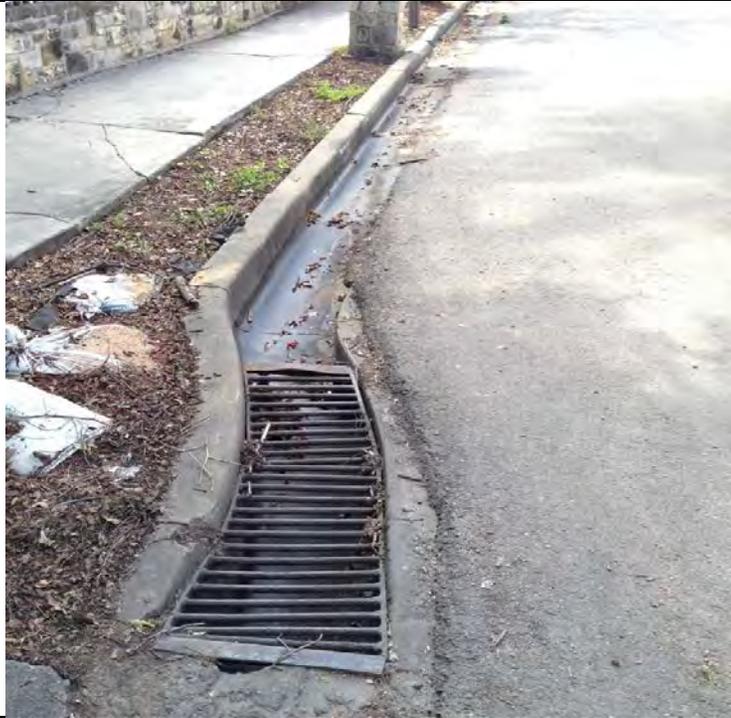
P2	<i>Looking SW at south grate inlet that drains to open channel (10/26/13)</i>
----	---

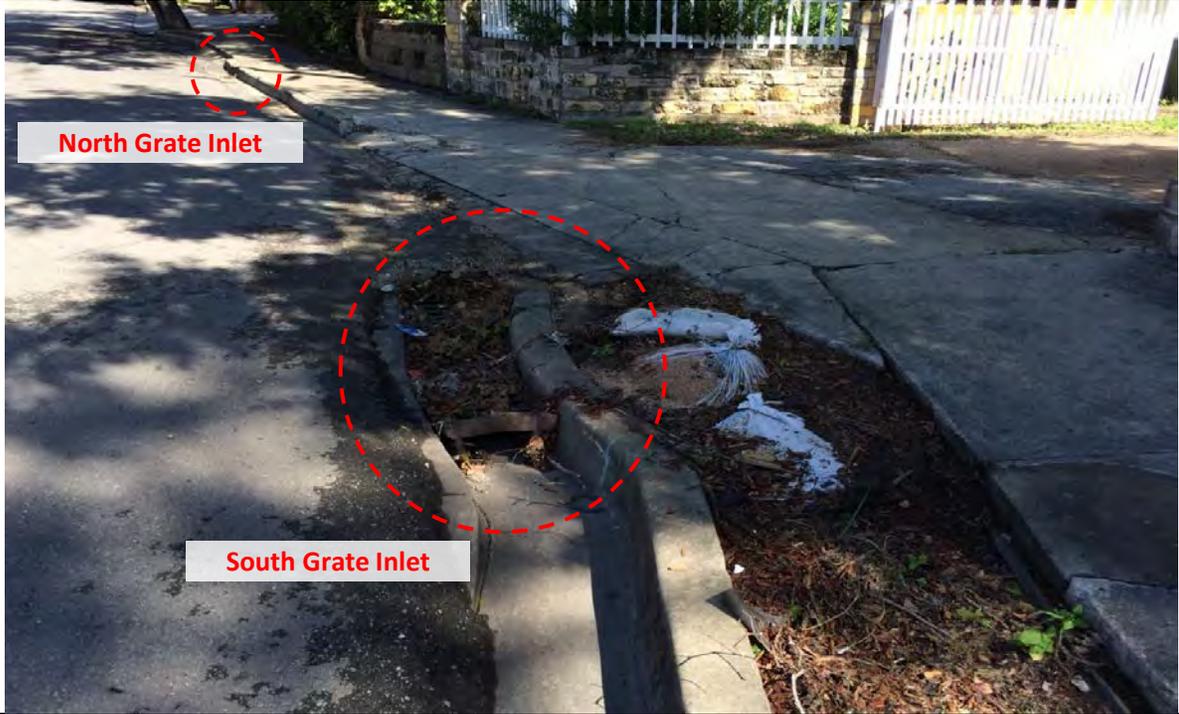
P3	<i>Looking N at both grate inlets after flooding; leaves/debris/standing water (10/31/13)</i>
----	---

Replace two grate inlets with curb inlet(s) to reduce clogging/flooding frequency.

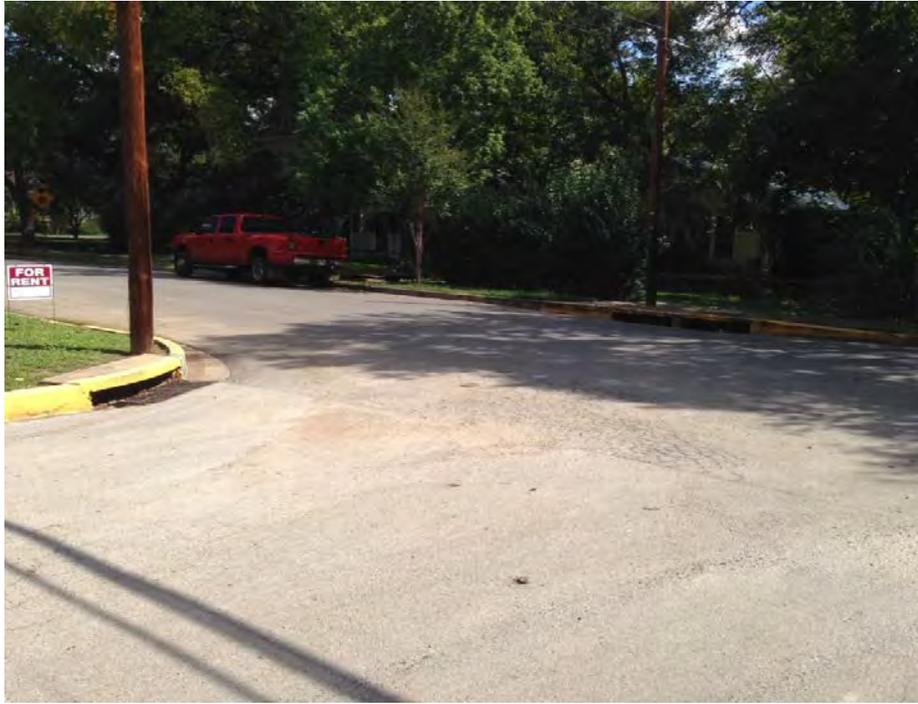
<i>P1</i>	<i>From W corner of Travis / San Antonio intersection looking E towards Site</i>
-----------	--

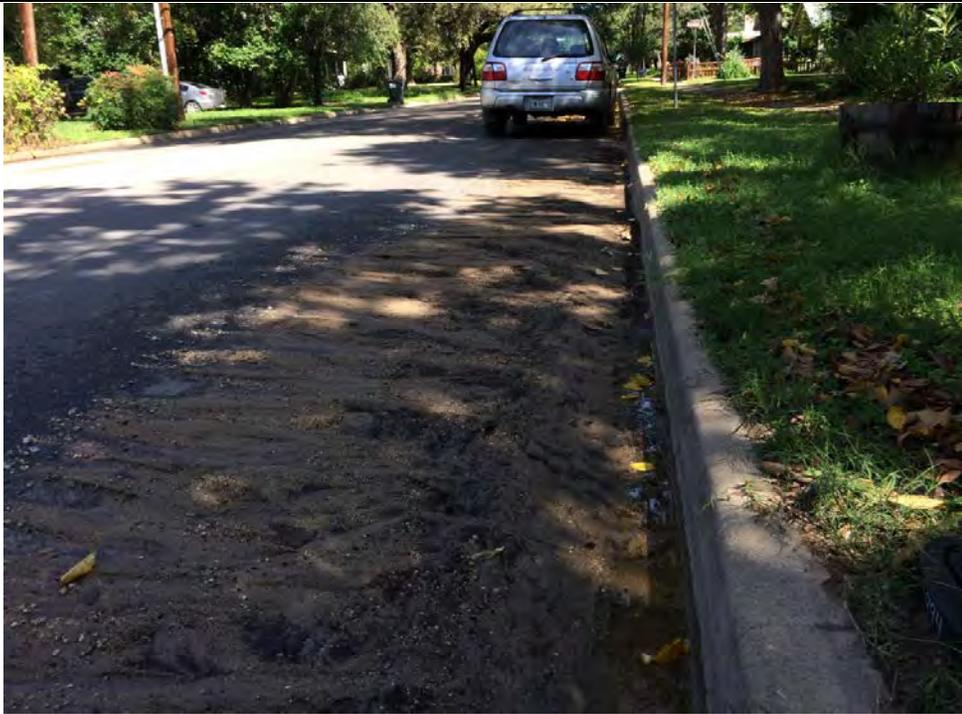
<i>P2</i>	<i>Site frontage looking NE; sediment deposits</i>
-----------	--

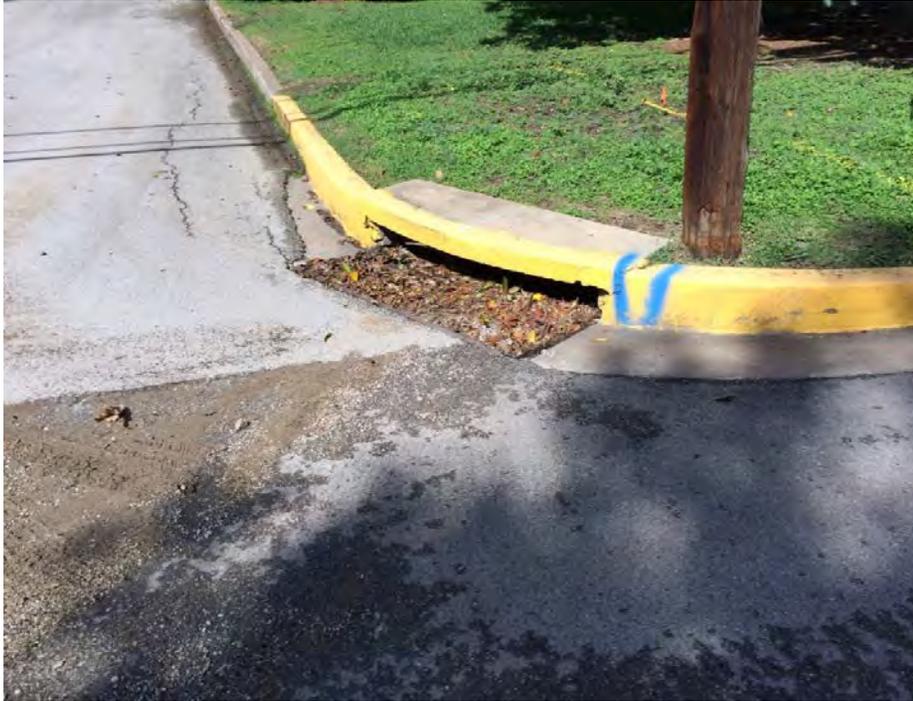
P3	<i>From Travis / San Antonio intersection; looking at N corner; clogged grate inlet</i>
----	---

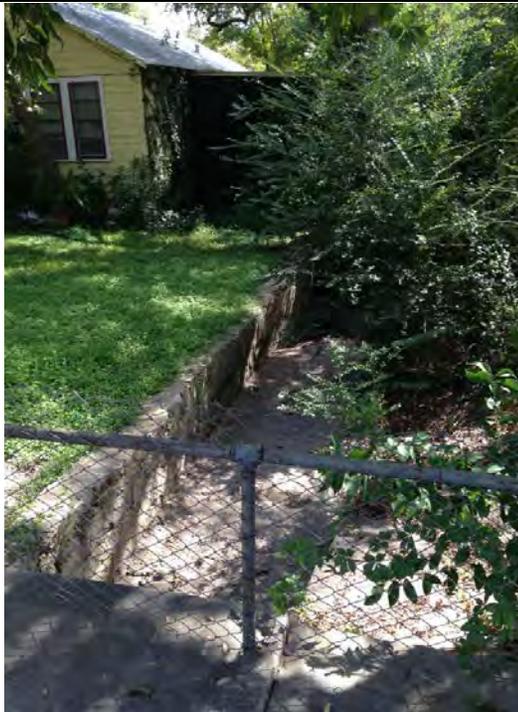
P4	<i>From Travis / San Antonio intersection; looking SE at private drainage channel</i>
----	---

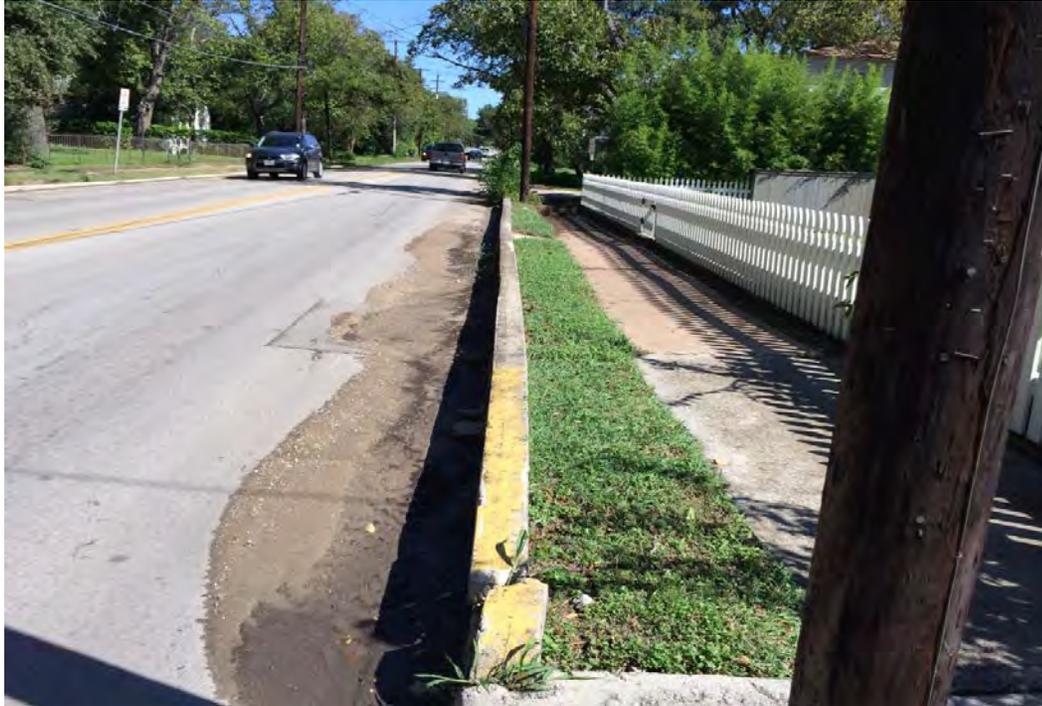
P1	<i>From E corner of Hopkins/Travis; looking towards NE at sediment deposit in local sag area</i>
----	--

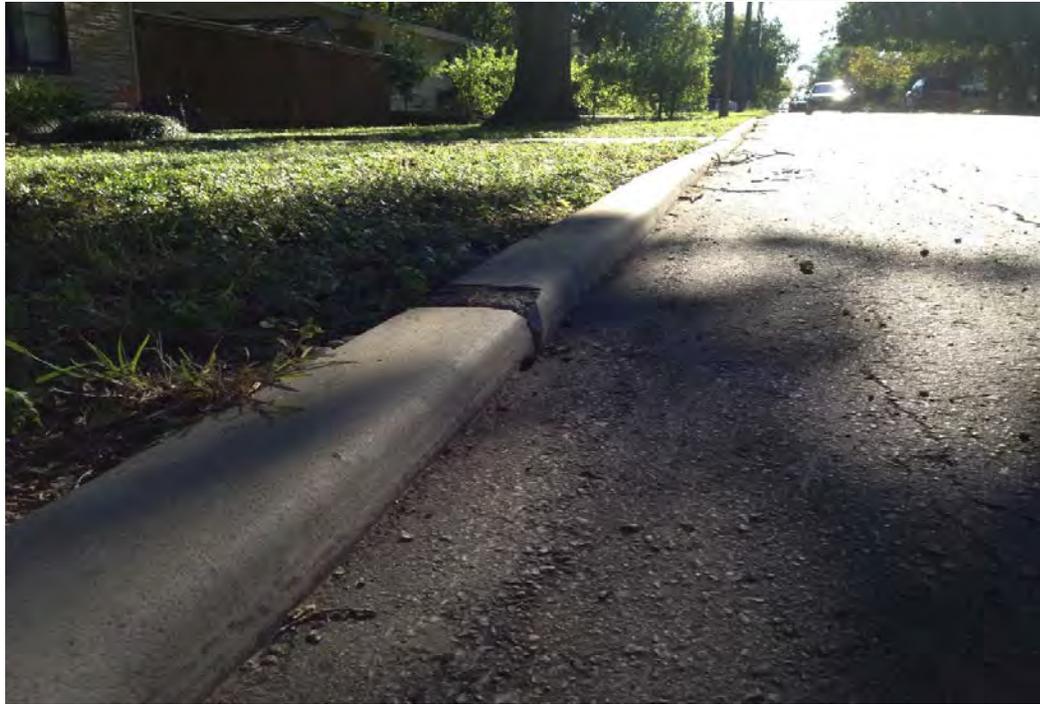
P3 *From S corner of Hopkins/Johnson; looking SW at minimal (1-2") curb depth*

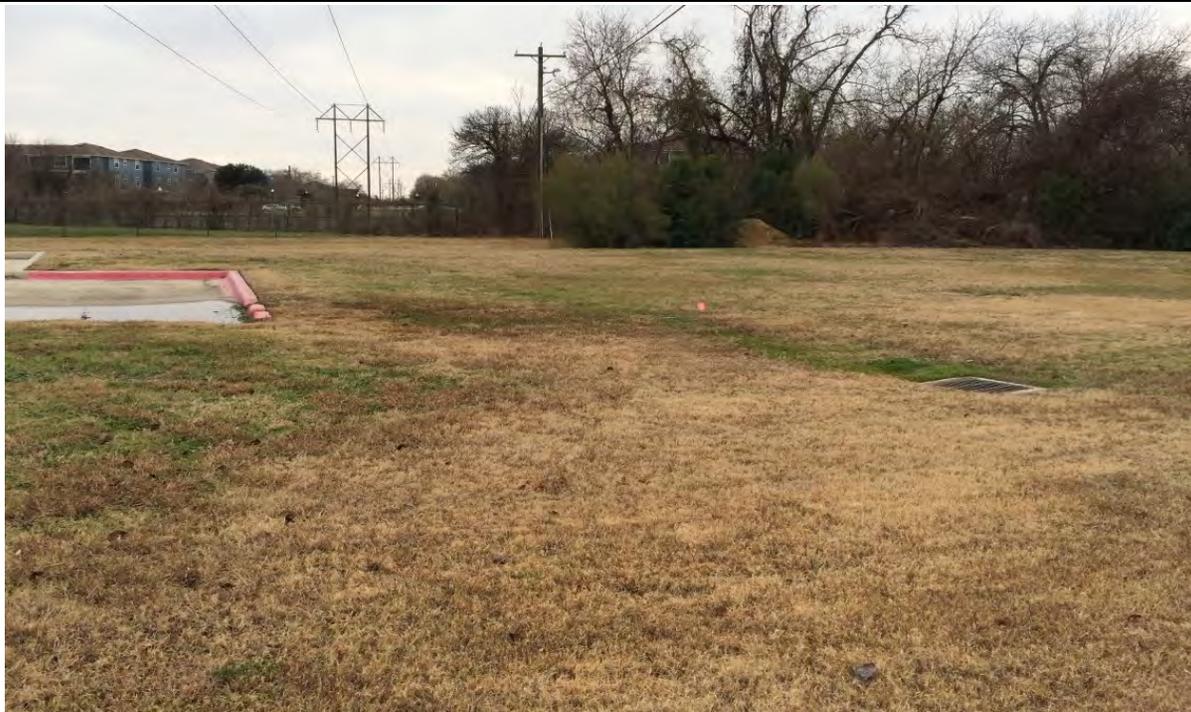
P4	<i>Looking S thru apt complex fence at grate inlet; detention pond in distance (1/9/14)</i>
----	---

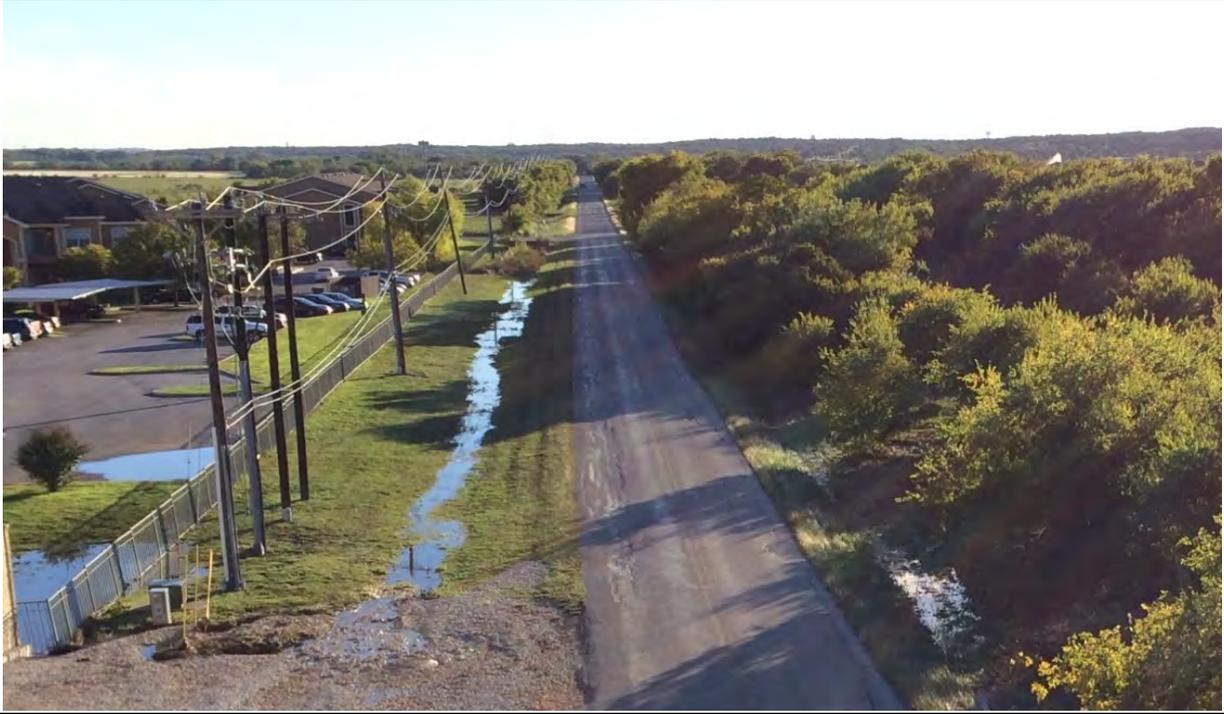
P3	<i>Looking SW along Post Rd from Yarrington Rd bridge; standing water (10/31/13)</i>
----	--

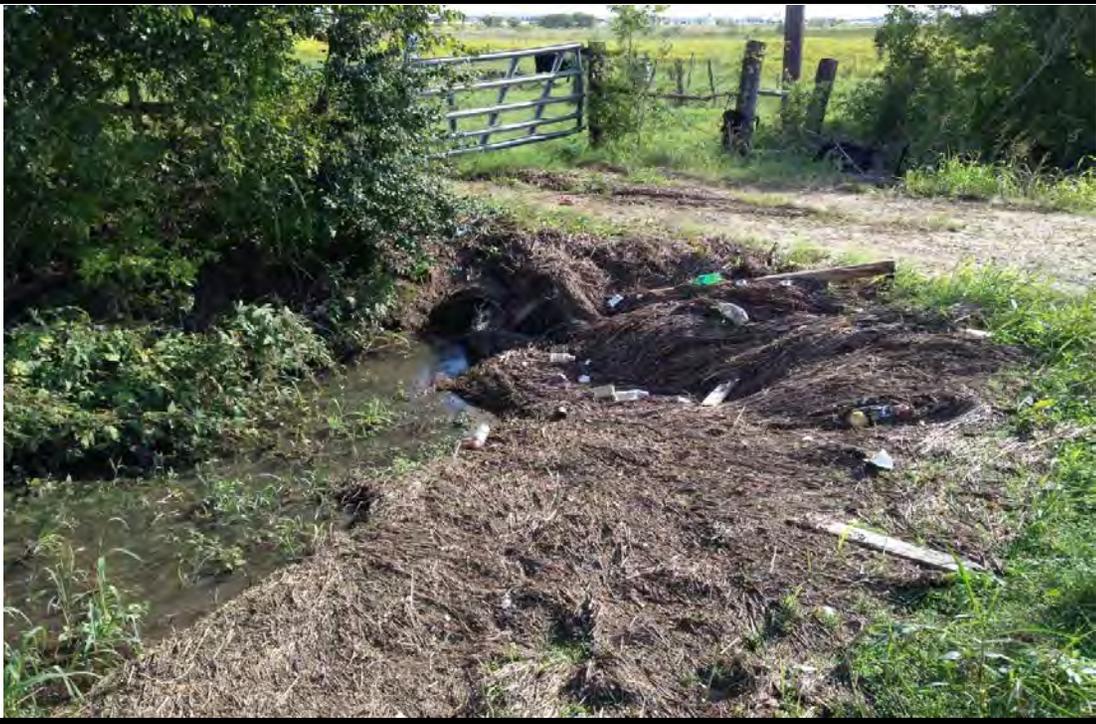
P4	<i>Looking SE at driveway/culvert S of lift station; clogged pipes, heavy debris (10/25/13)</i>
----	---

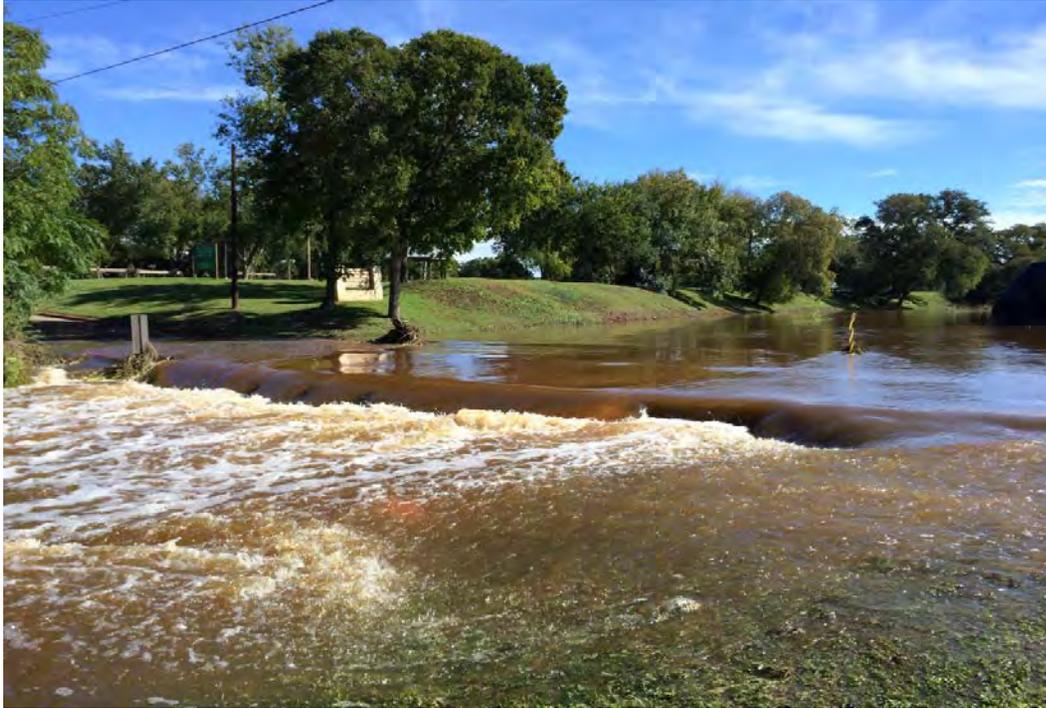
P1	<i>Looking SE toward D/S side of crossing; Flooded crossing during October 31, 2013 storm</i>
----	---

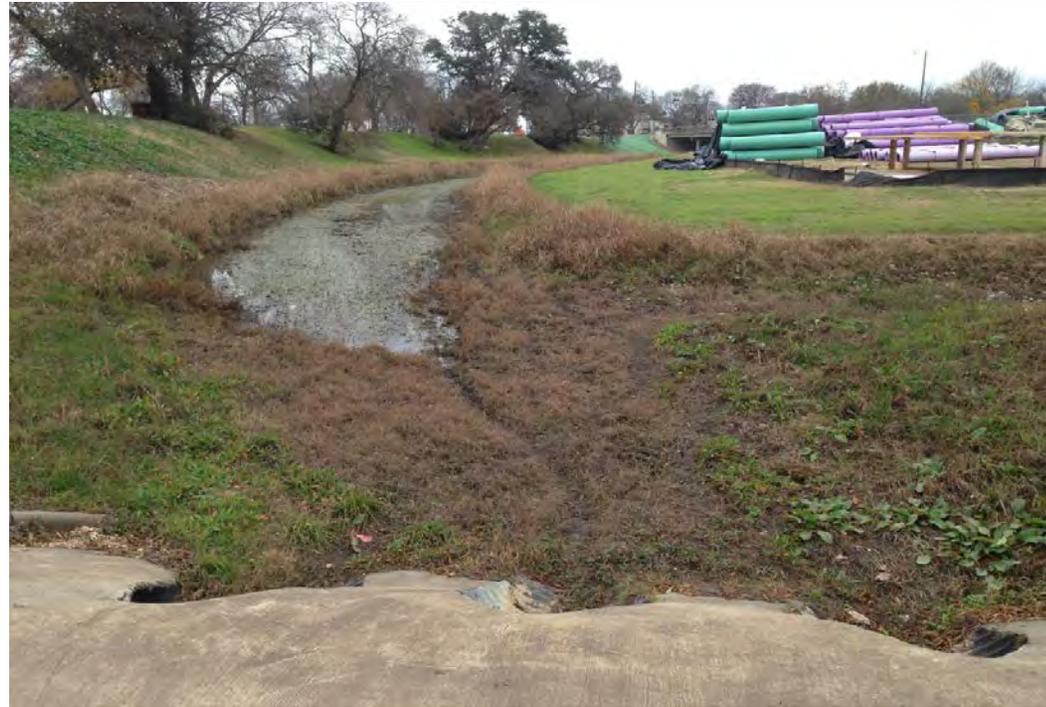
P2	<i>Looking S from crossing; standing water in low spot U/S of crossing</i>
----	--

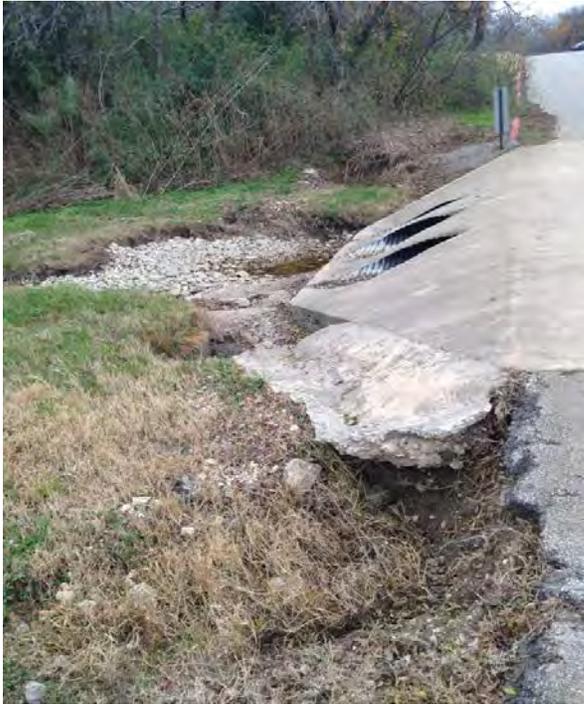
P3	<i>Looking E at D/S face of crossing; significant erosion and structure undermining</i>
----	---

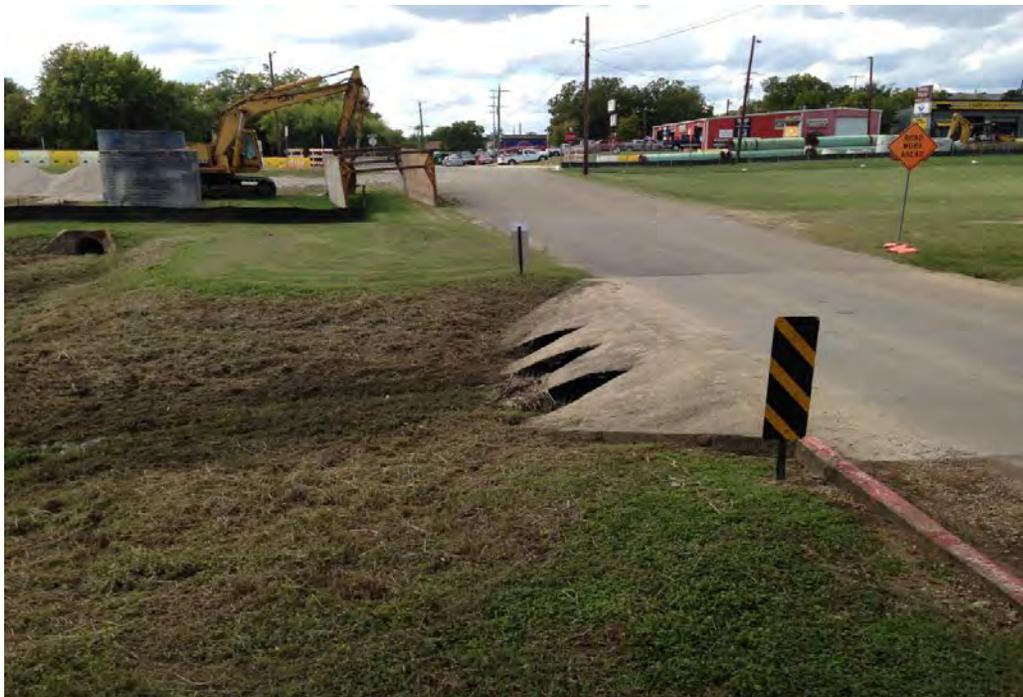
P4	<i>Looking West at the upstream face of crossing; 30" storm drain outfall</i>
----	---

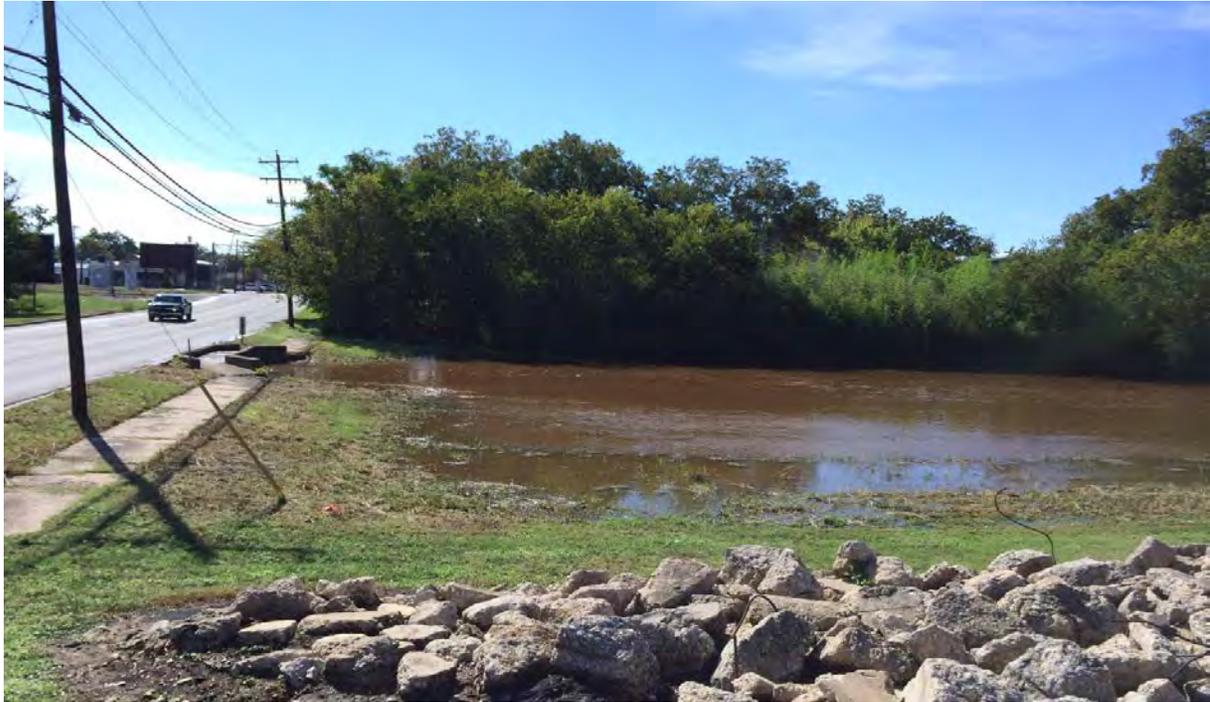
Cause of Flooding: Large drainage area, limited bridge conveyance capacity
Roadway Elev ~572.8'; 2yr WSE = 574.1'; 10yr WSE = 575.6'; 25yr WSE = 576.1'

P1	<i>Looking S at U/S side of crossing during Oct 31, 2013 flood event</i>
----	--

Improve conveyance by upgrading bridge. Replace/stabilize retaining wall

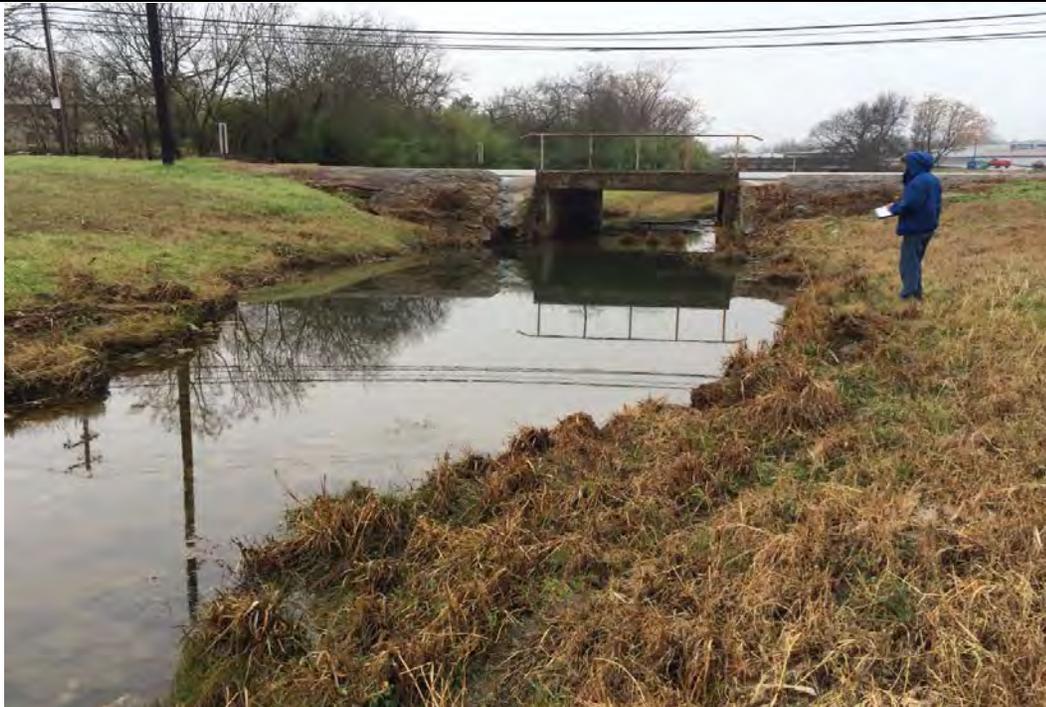
P2	<i>Looking W towards large scour hole on D/S side of crossing</i>
----	---

Notes: Channel improvements to stabilize scour hole. Structural repair for U/S face of retaining wall, bridge upgrade to reduce overtopping frequency.

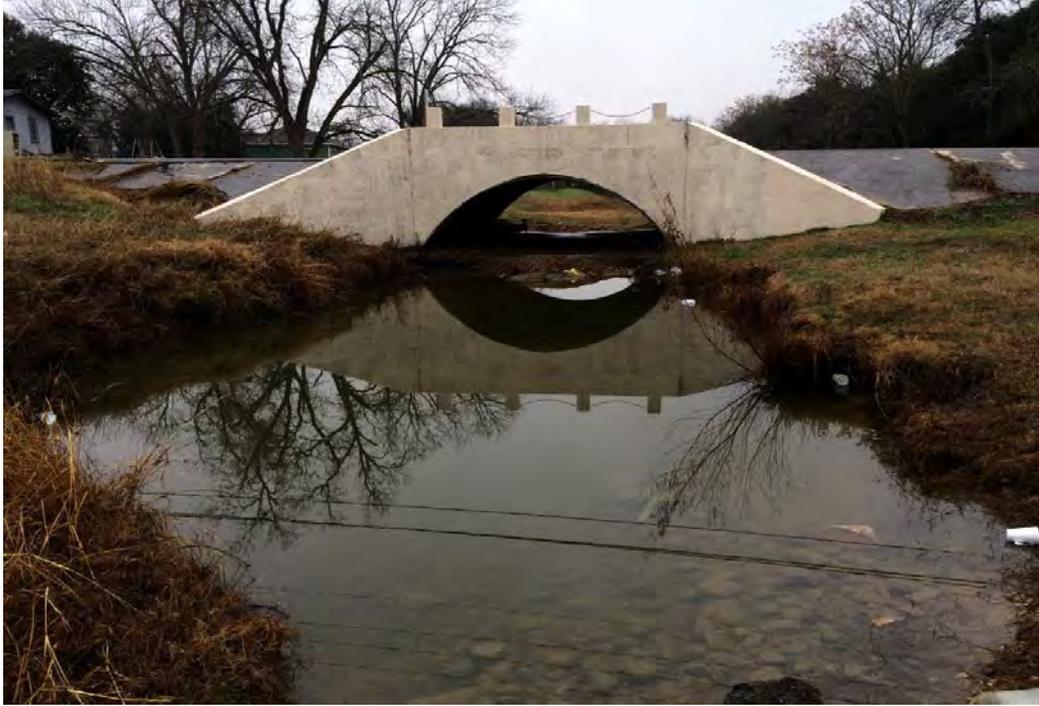
P3	<i>Looking SW at D/S side of crossing; large scour hole and stading water</i>
----	---

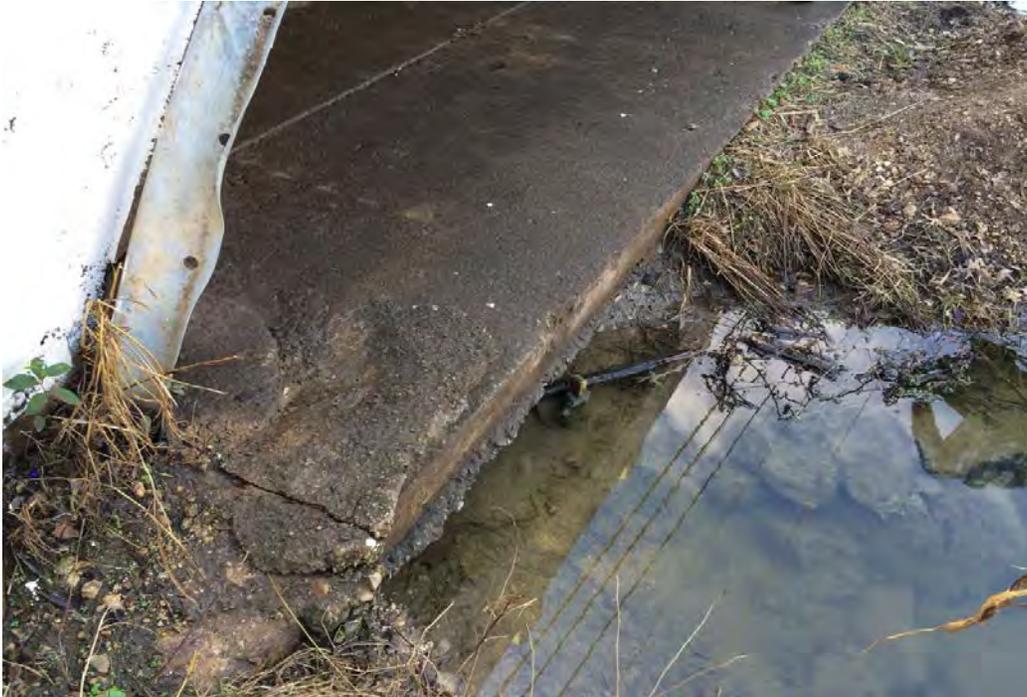
P4	<i>Looking W at D/S side of crossing; potential undermining of concrete culvert bottom</i>
----	--
