Field Assessment Report (Hot Spots)

Site No.: 1 Location: 700 Blk McKie St (Willow Springs Creek)

San Marcos Comprehensive Watershed Master Plan
Field Assessment Form - Local Flood Complaints

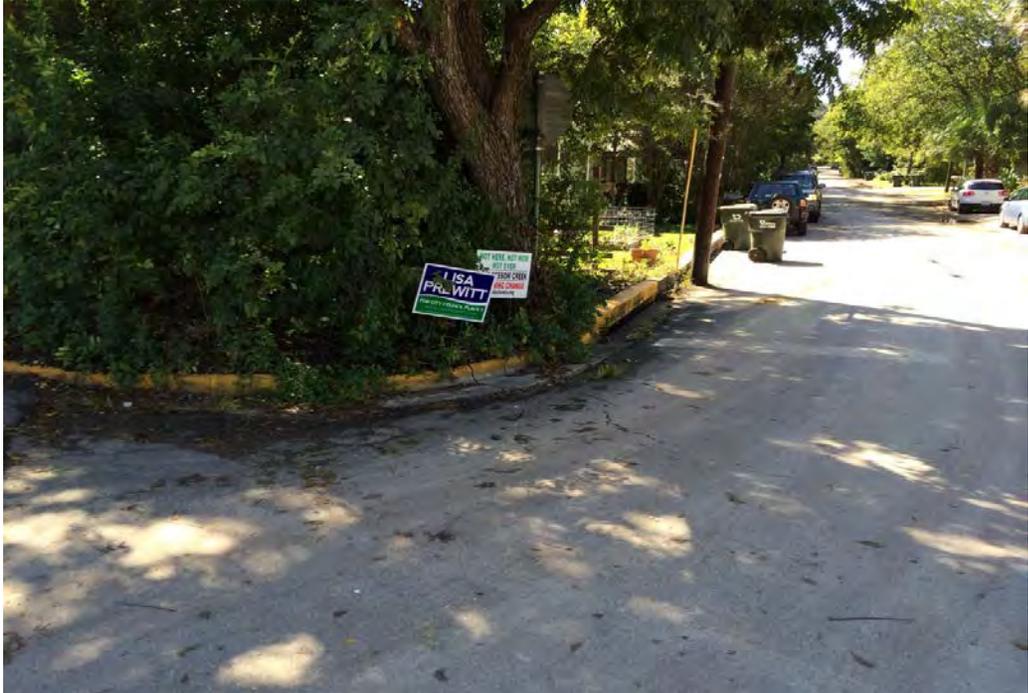
P1	<i>Inlet on SE side of Harvey Street, looking SE towards 503 Harvey Street</i>
----	--

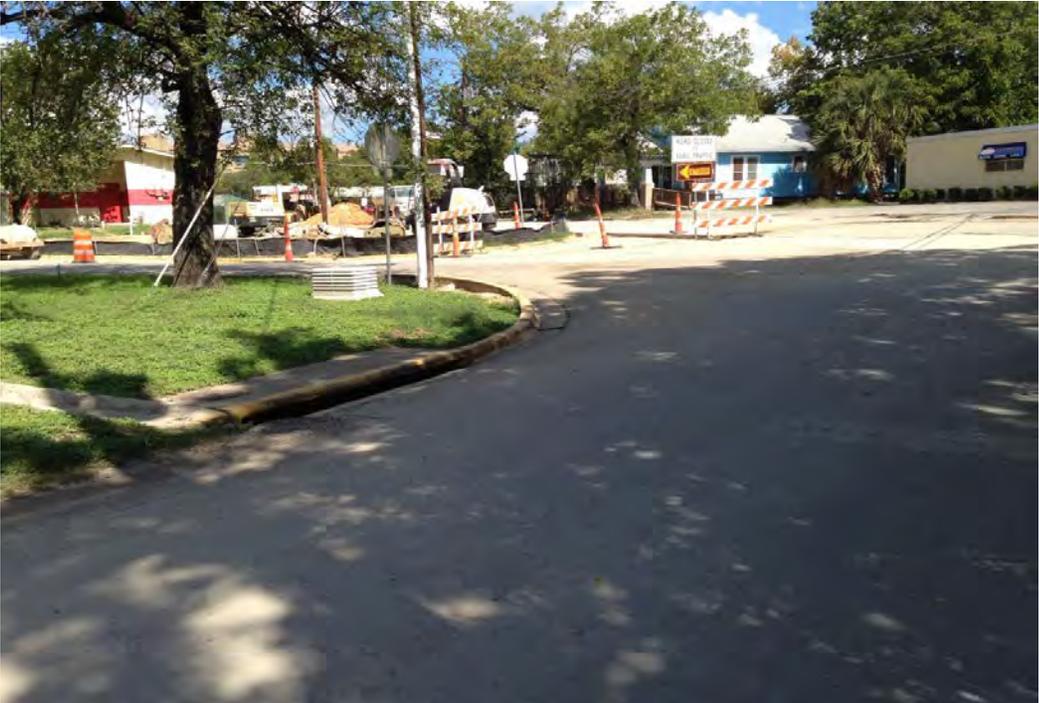
P2	<i>Inlet on NW side of Harvey Street, looking NE towards North Street</i>
----	---

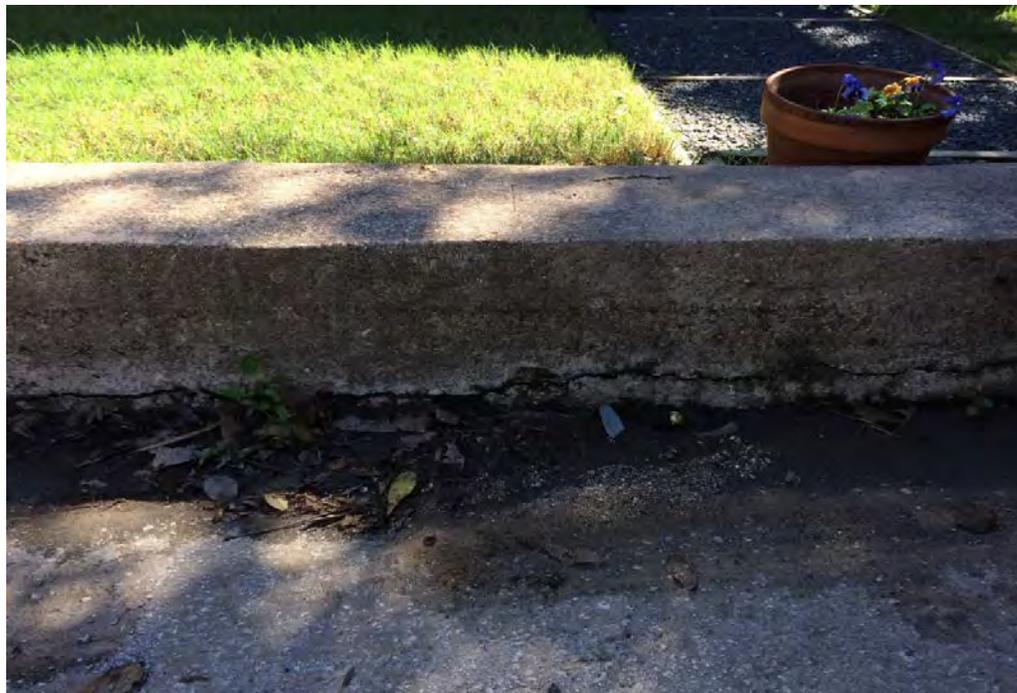
<i>P4</i>	<i>Tall curb on SE side of Harvey Street</i>
-----------	--

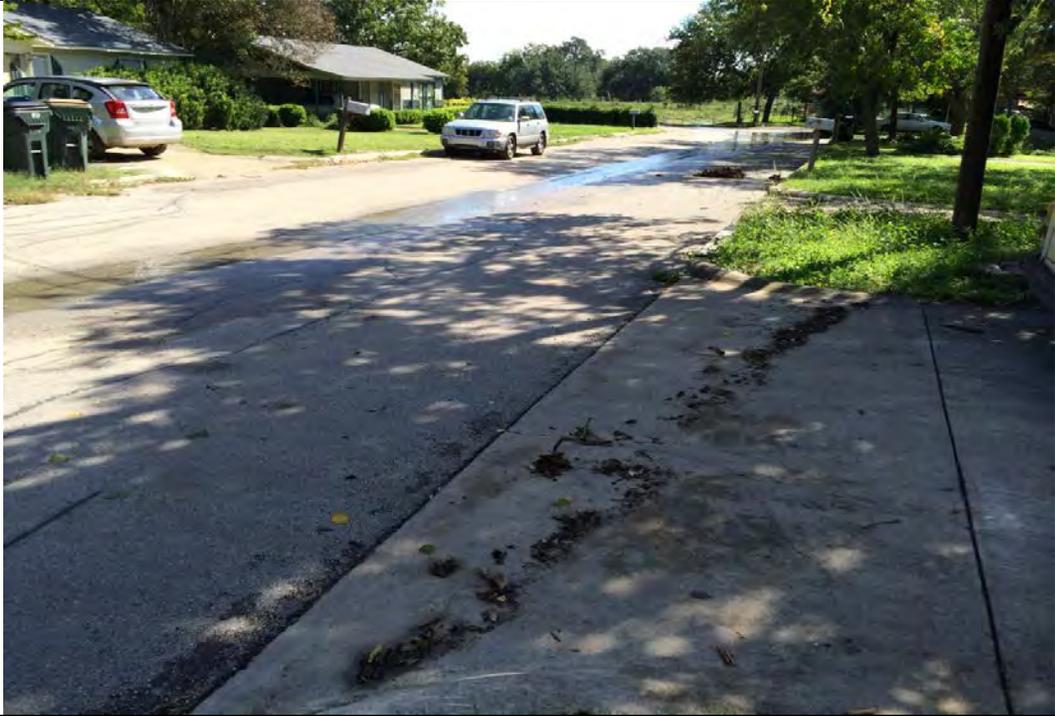
P1	<i>Looking SE from 413 Faris; road/channel flow and debris/high water mark (10/31/13)</i>
----	---

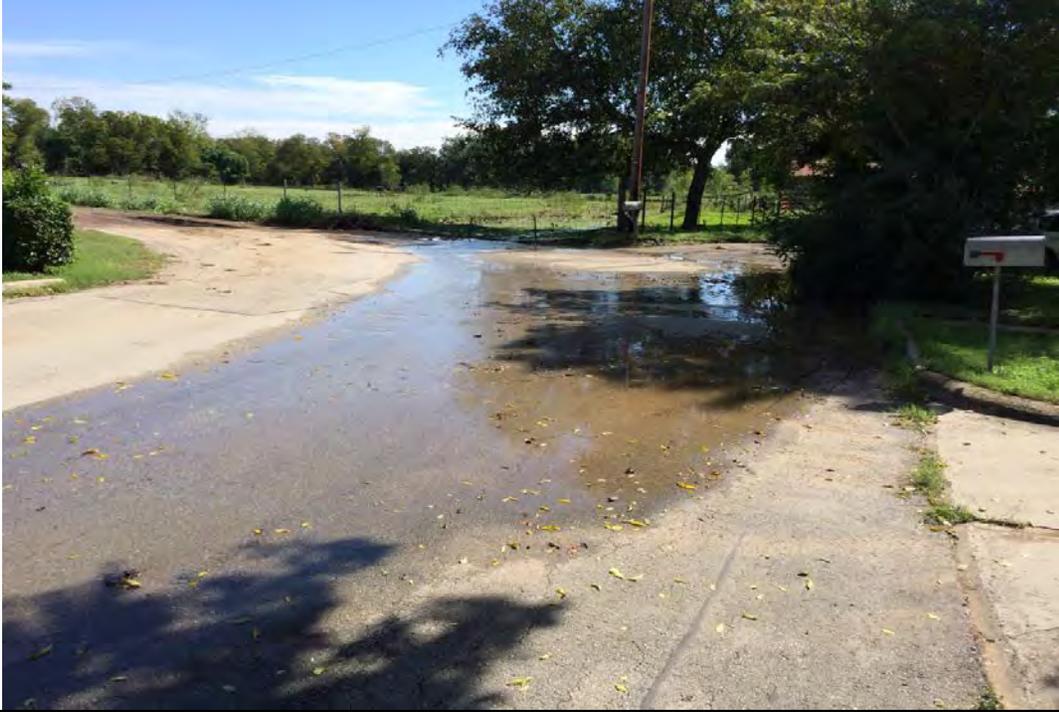
P2	<i>Looking SE from 401 Faris; flow and standing water in flat area near outfall (10/31/13)</i>
----	--

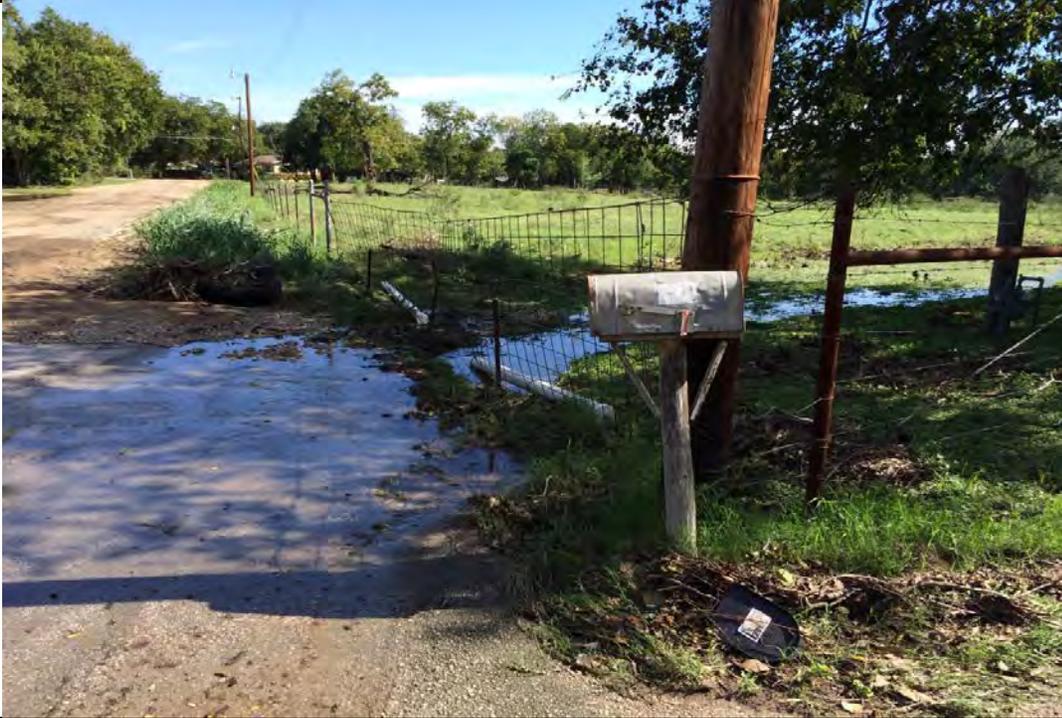
P3	<i>Lkg E from 313 Faris; poorly defined outfall channel and debris accumulation (10/31/13)</i>
----	--

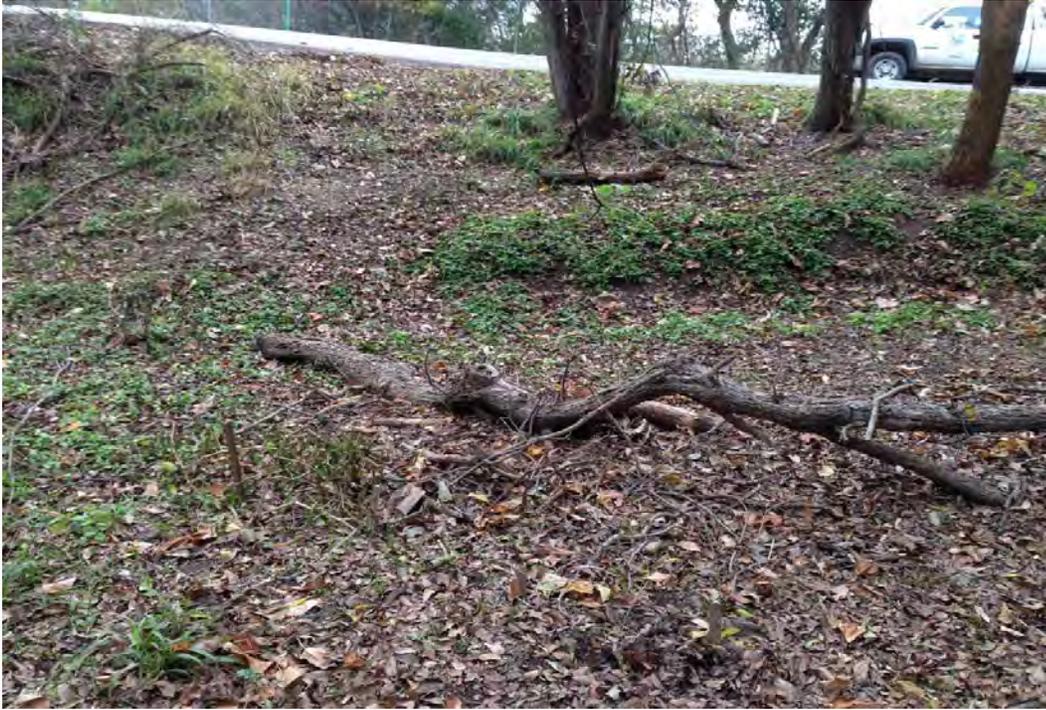
Cause of Flooding: Grate inlet in sag clogs & floods roadway & property during every rainfall event

P1	<i>Looking E towards grate inlet covered in leaves and debris; rebar marks grate location</i>
----	---

Replace existing grate inlet with a four-sided area inlet to reduce clogging frequency

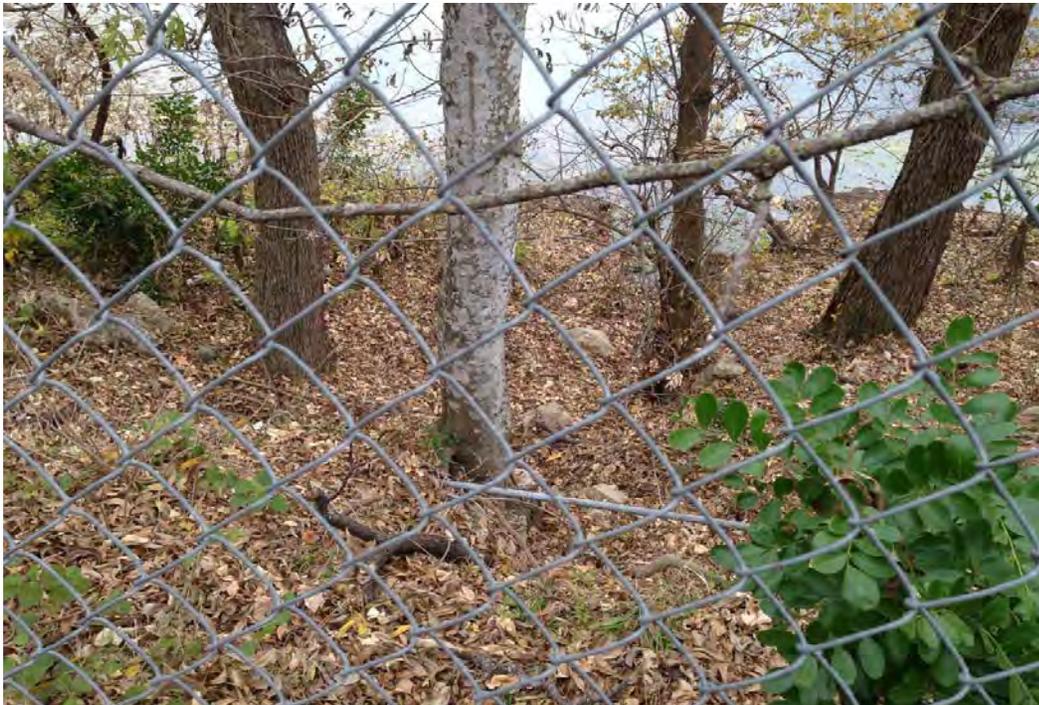
P2	<i>Looking SE from Alta Vista Dr; existing storm drain outfall location at Spring Lake</i>
----	--

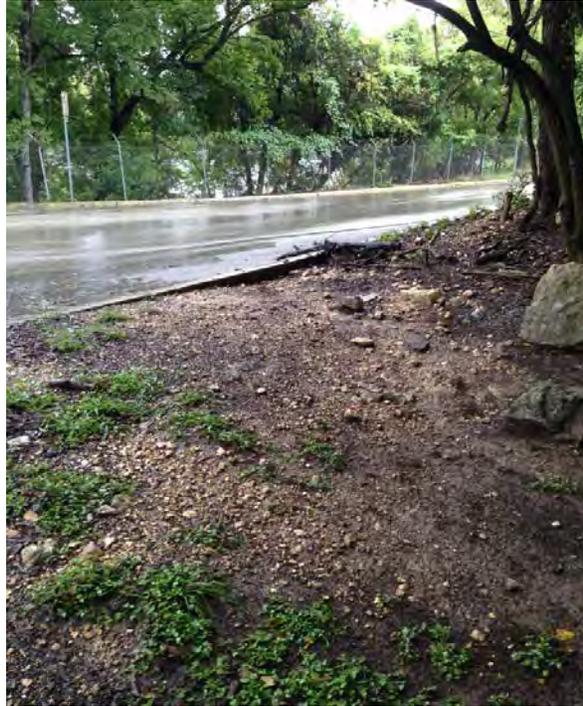
P3 Looking S from grate inlet; low point along curb where storm water overtops onto road

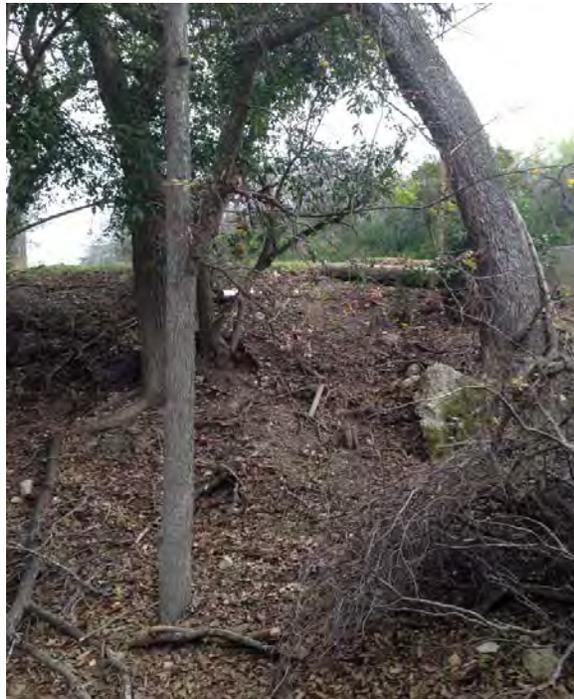
P4 Looking N from grate inlet; outfall of 4" PVC french drain that runs along Ed Green

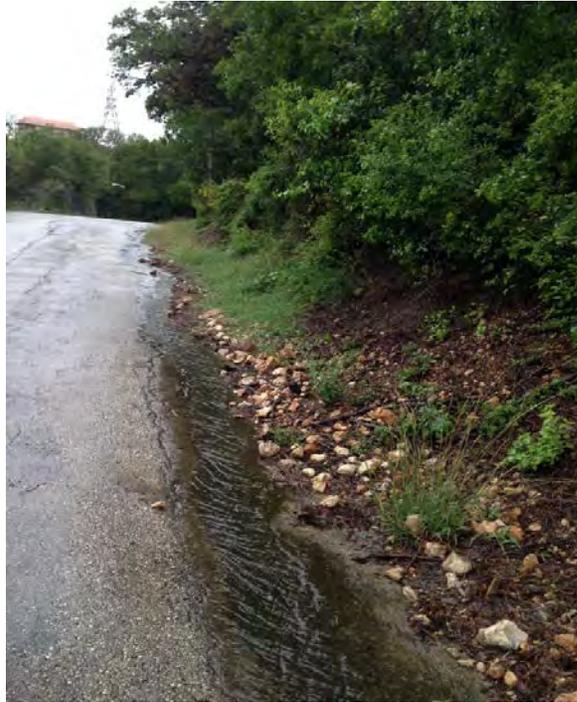
Cause of Flooding: Flooding is not primary concern. Driver safety along Ed J L Green is endangered by algae growth (very slick pavement) along W side of roadway. Algae growth is promoted by constant groundwater along slope W of Ed J L Green Dr.

P1	<i>Looking SW along right side of Ed J L Green; shallow concentrated flow and algae growth</i>
----	--

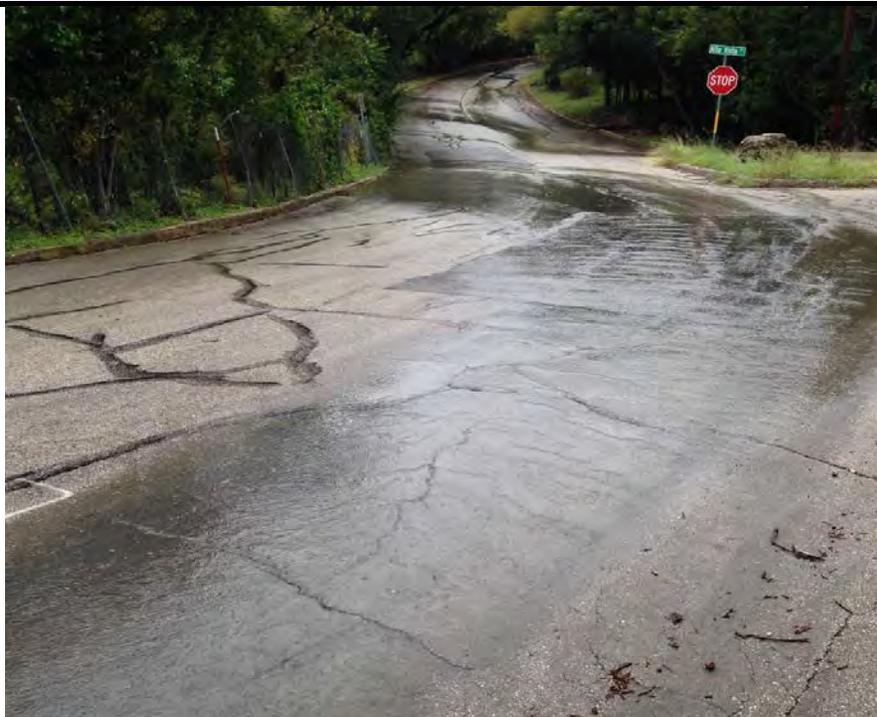
P2	<i>Looking S at Ed Green/Alta Vista; flow/slick pavement thru intersection</i>
----	--

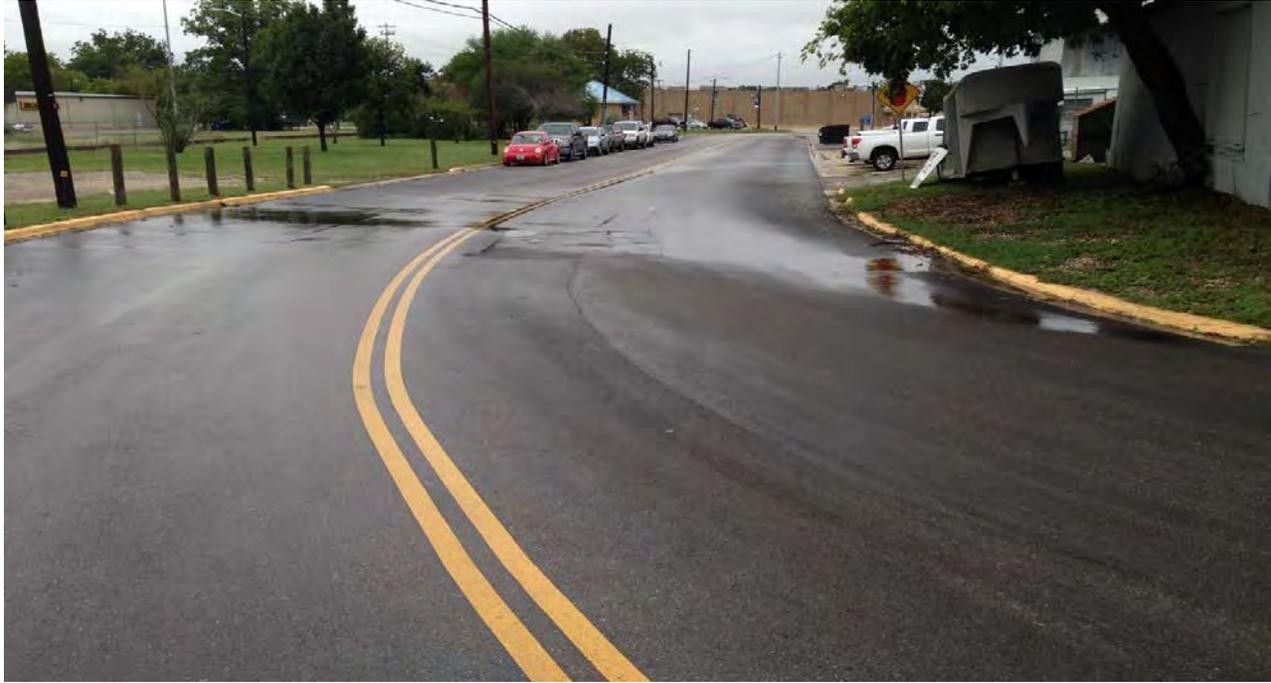
<i>P3</i>	<i>Looking W towards intersection of Ed Gary / LBJ; sheet flow across road/standing water</i>
-----------	---

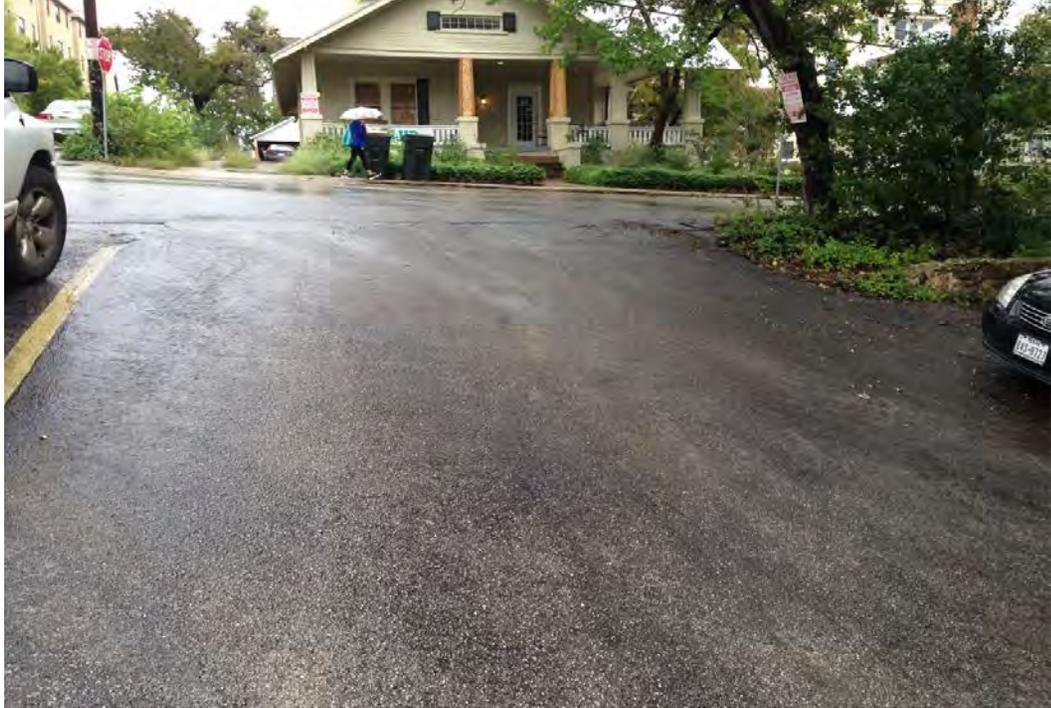
P3	<i>Looking E at driveway along Comanche St; no curb/speed bump to prevent runoff entry</i>
----	--

OPT B Recommend driveway adjustments (e.g., speed bump, valley gutter) to reduce frequency of flow into private property from Comanche St. 1

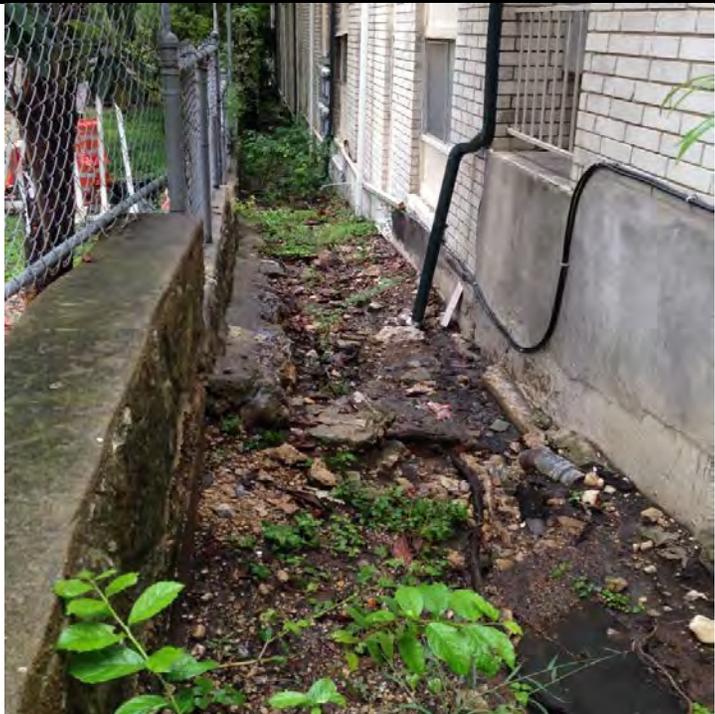
P4	<i>Looking W along S side of building; erosion in private drainage channel</i>
----	--

OPT C Recommend stabilization of channel behind apartment complex (S of bldg) to reduce erosion potential. 1

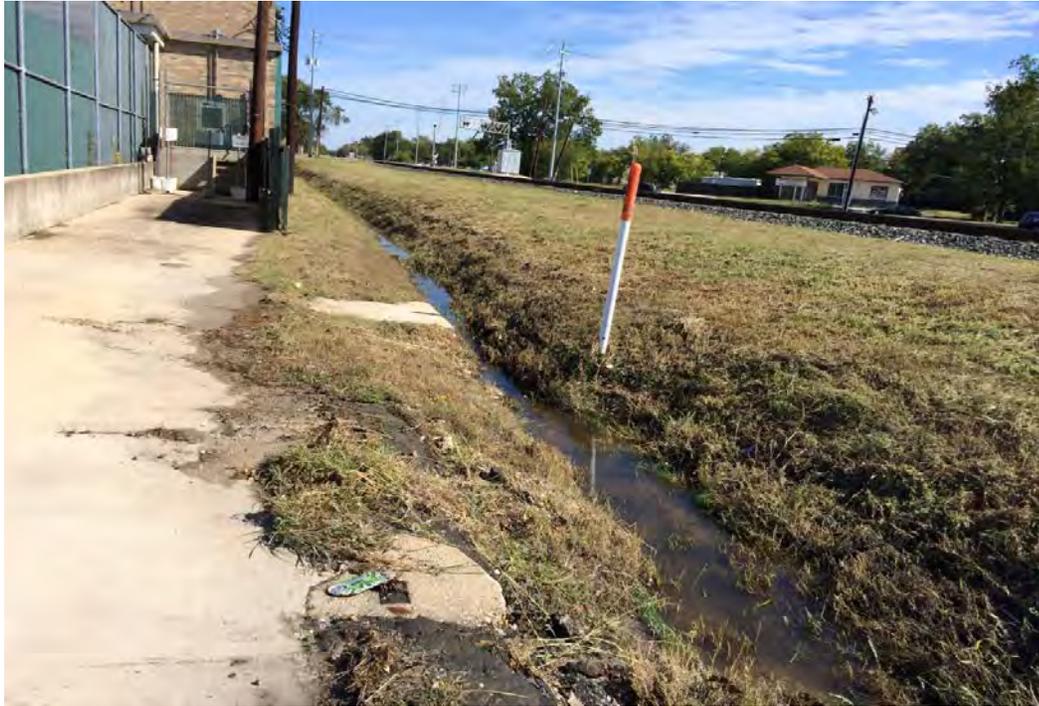
P3	<i>Looking E near S Guadalupe Street; private utility conflict/encroachment in channel</i>
----	--

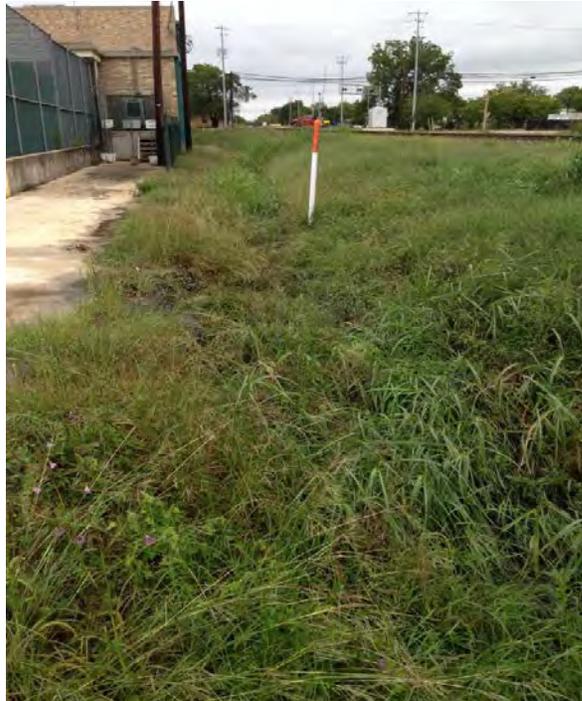
P4	<i>Looking NE from near S Guadalupe Street; vegetation in channel</i>
----	---

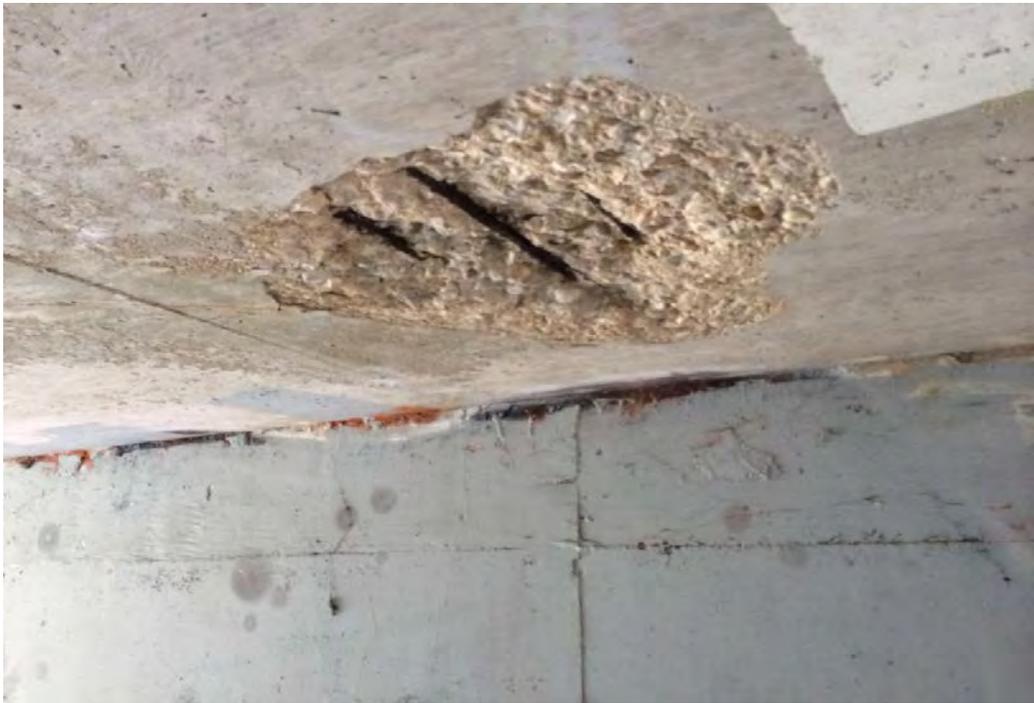
P2	<i>Looking SE at concrete spauling and exposed rebar at midspan top of center culvert</i>
----	---

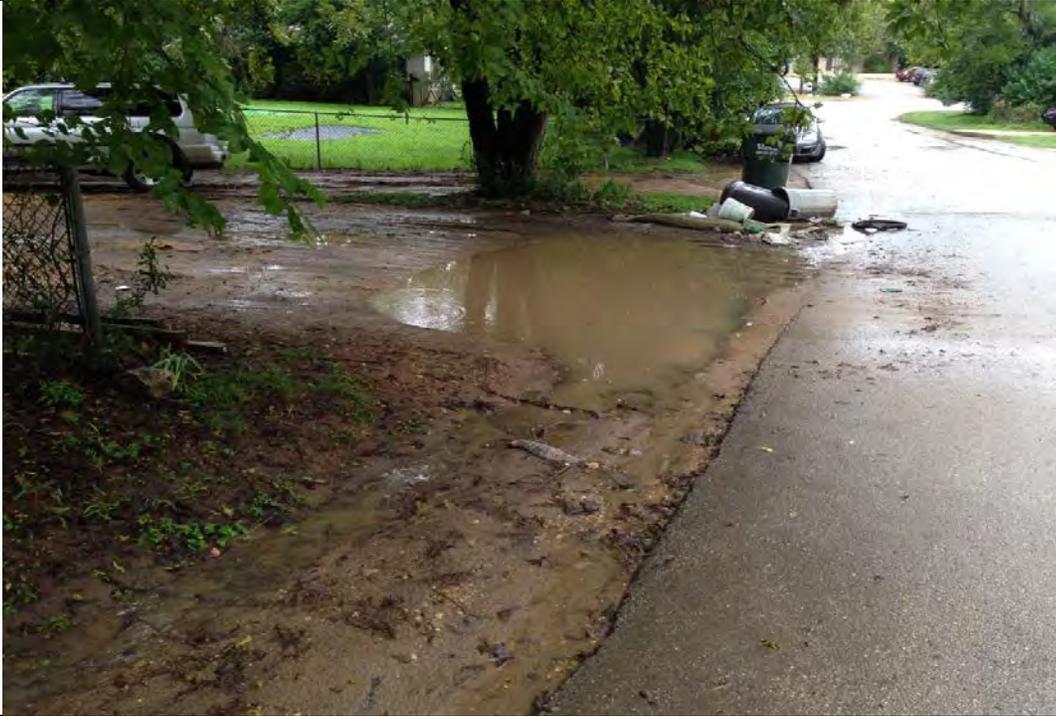
P3	<i>Looking W along Coers Circle; ponding in driveway (10/16/13)</i>
----	---

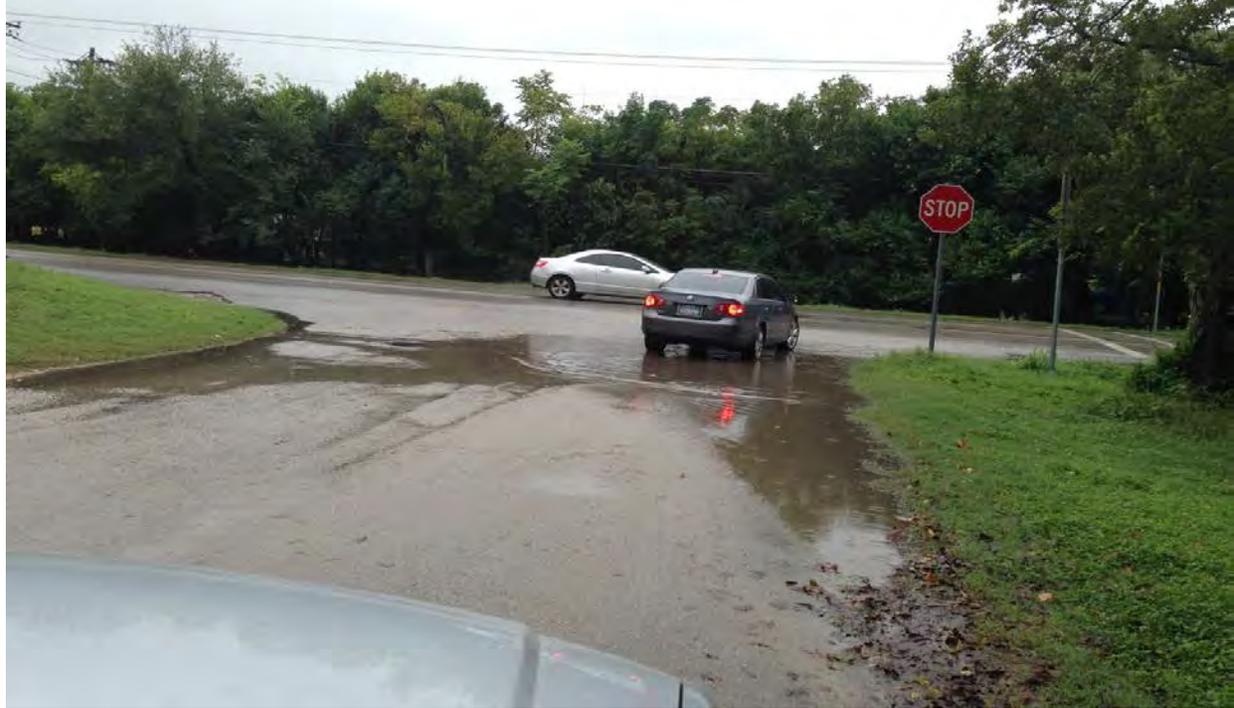
P4	<i>Looking SW along Coers Circle; ponding in roadway near RR-12 (10/16/13)</i>
----	--

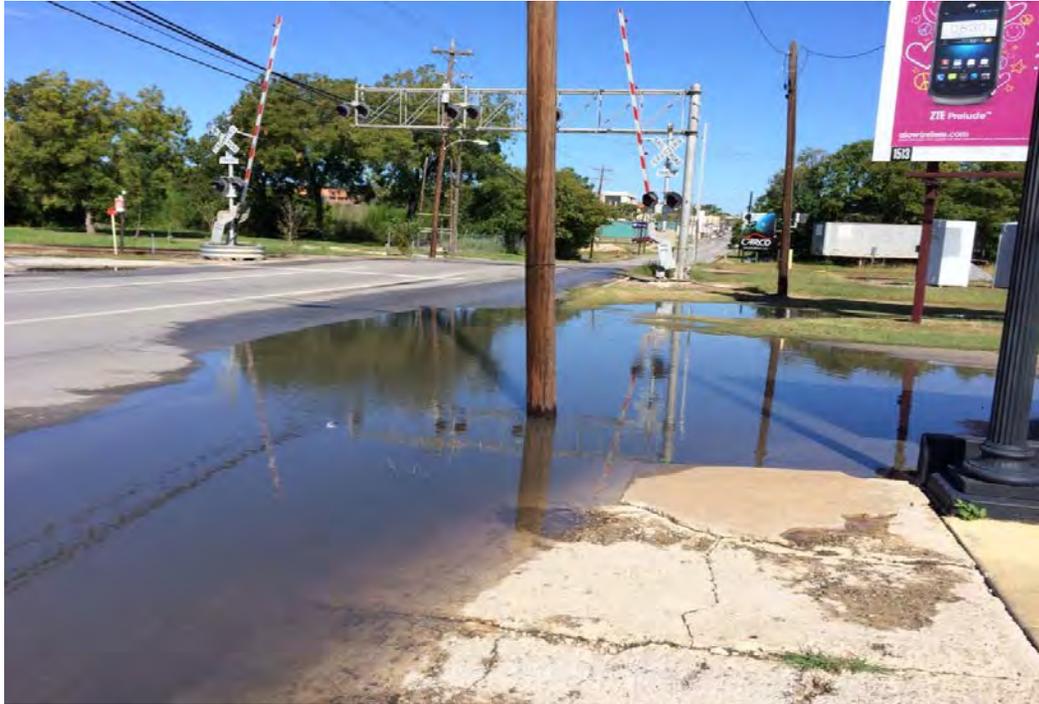
Photo #	Caption
P1	<i>Looking N along E side of LBJ; flooding in roadway, private property & RR ROW (10/31/13)</i>

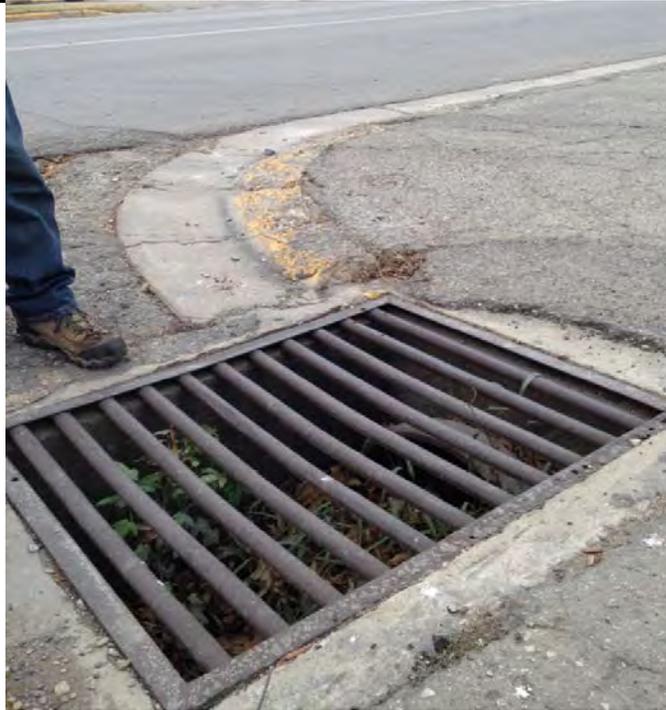
<i>P3</i>	<i>Looking NW on E side of LBJ; grate inlet with no outfall, sediment & vegetation w/in inlet</i>
-----------	---

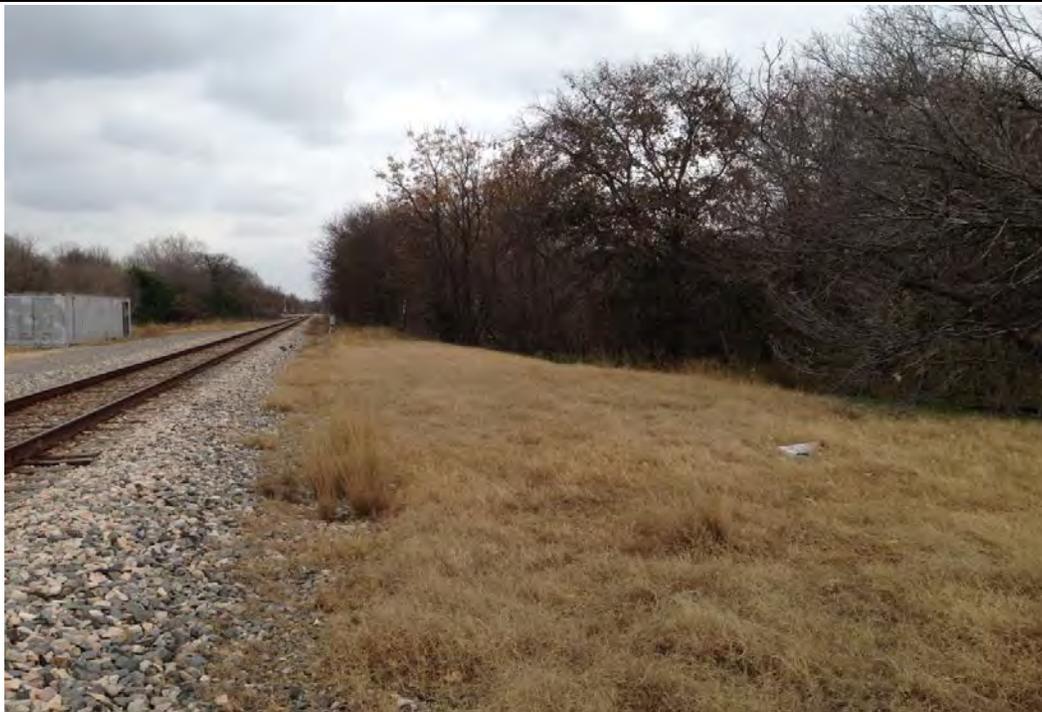
<i>P4</i>	<i>Looking E along S side of RR; low-lying open area ahead</i>
-----------	--

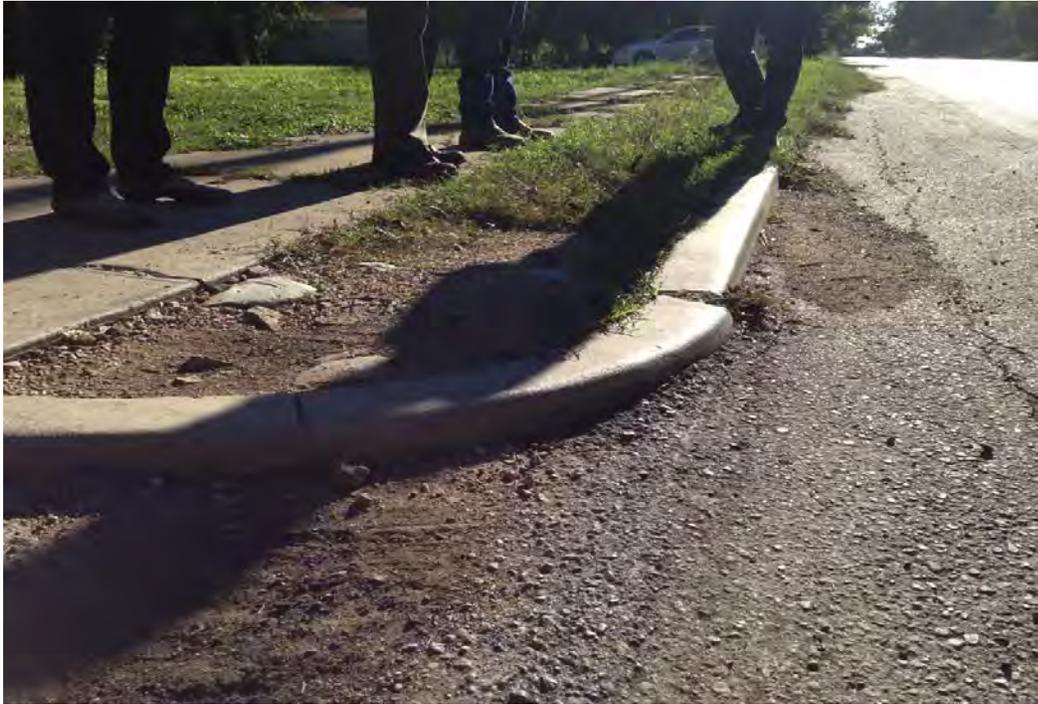
P1	<i>Looking SW along Hopkins at 1117 Hopkins; extremely low curb profile at driveway</i>
----	---

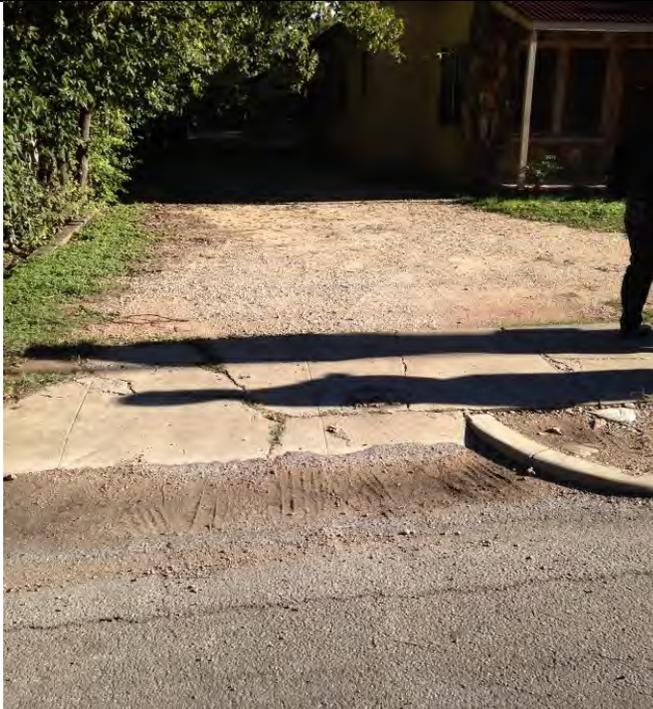
P2	<i>Looking SE at D1117 Hopkins driveway; local sag, sediment accumulation, erosion</i>
----	--

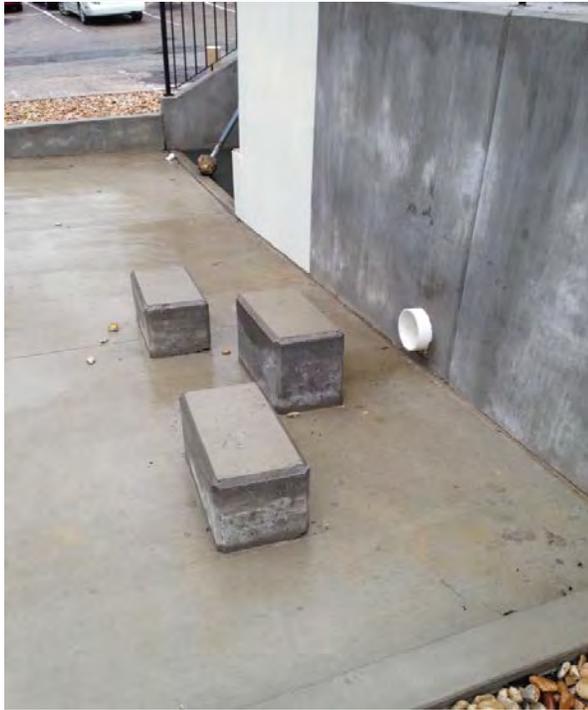
<i>P1</i>	<i>Outlet for detention basin looking northwest</i>
-----------	---

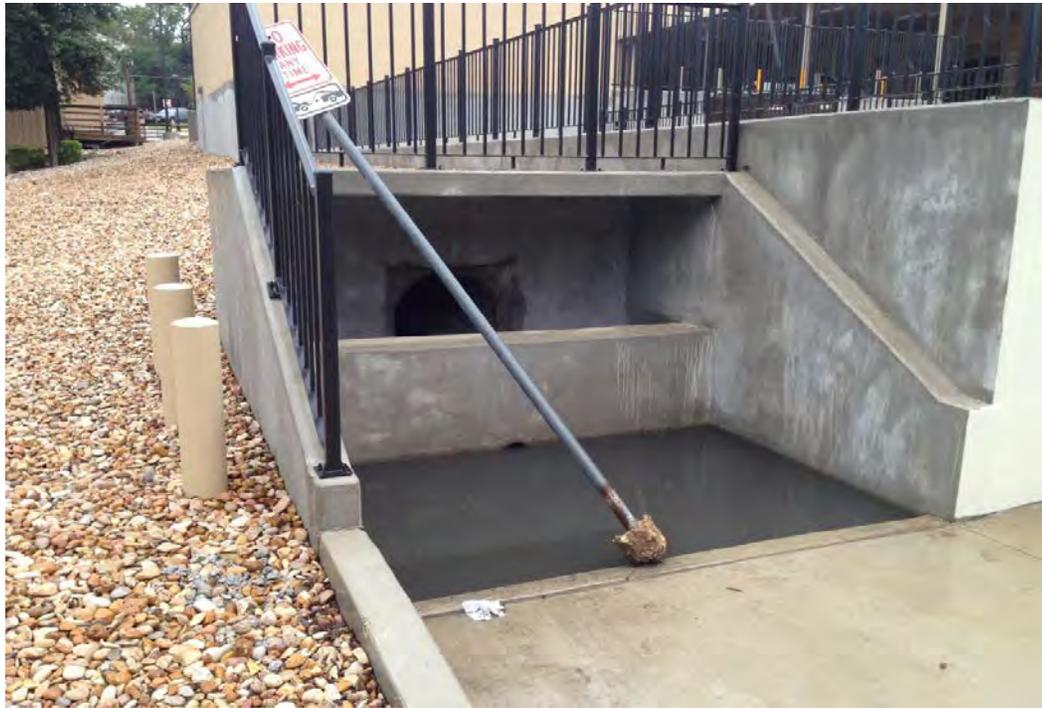
<i>P2</i>	<i>Stormwater Pipe outlet and structure looking north towards TxSt</i>
-----------	--

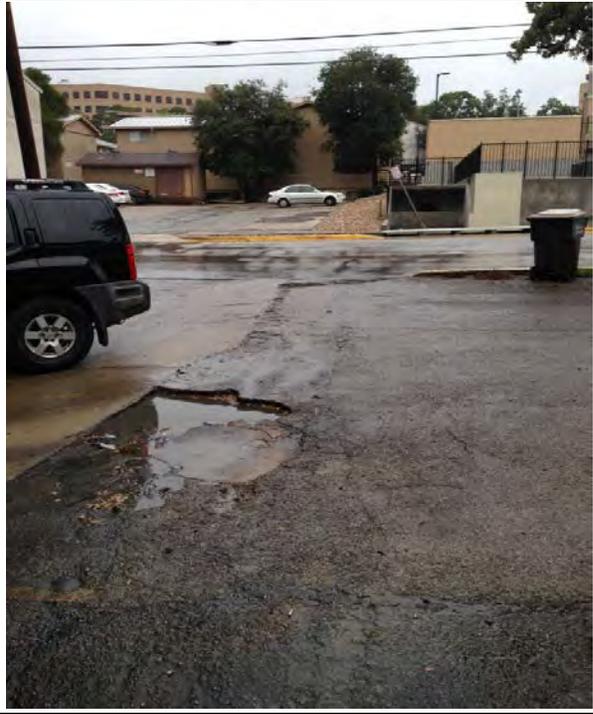
P3	<i>Apartment parking lot looking north towards TxSt</i>
----	---

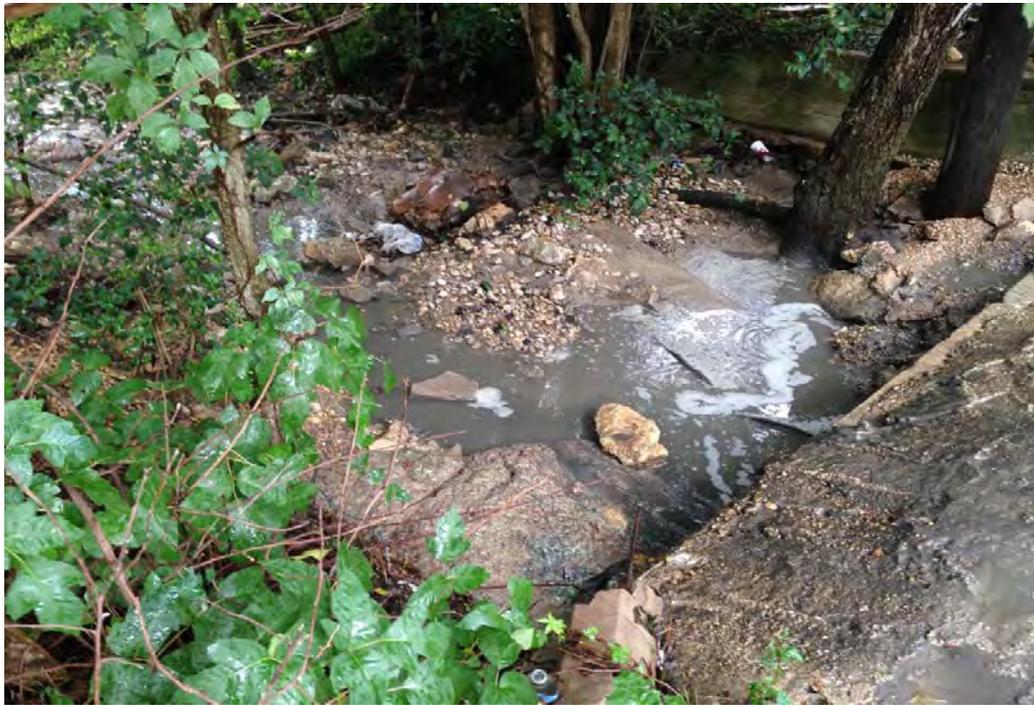
P4	<i>Downstream channel immediately downstream of Apt parking lot</i>
----	---

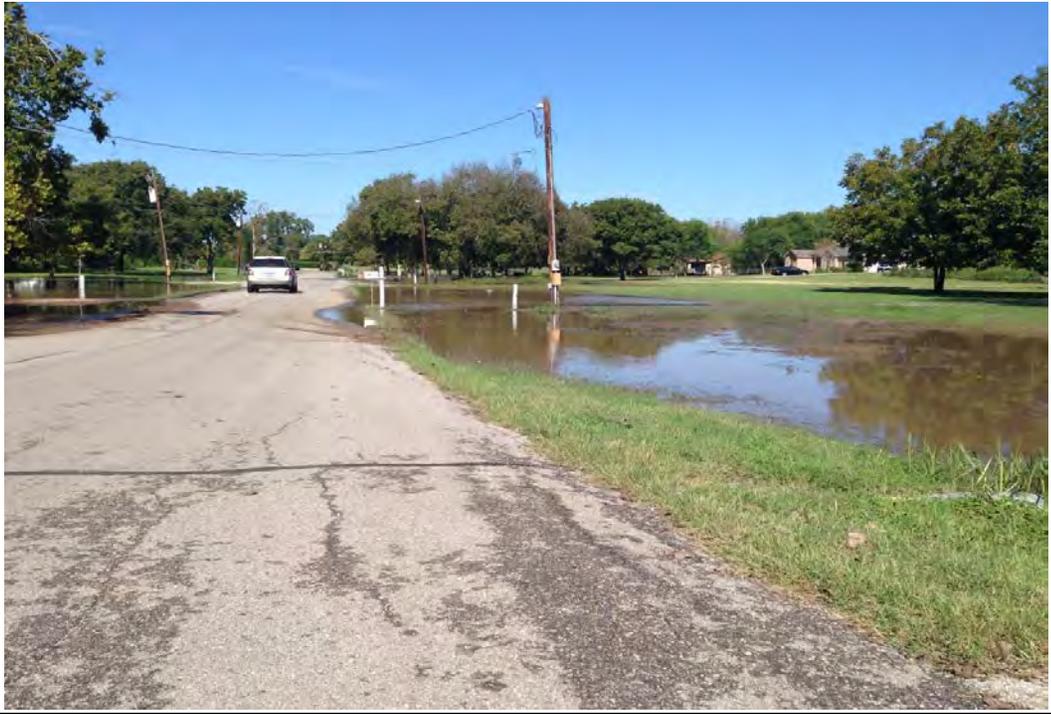
P1	<i>Bogie Drive looking north after the Oct 31, 2013 storm event</i>
----	---

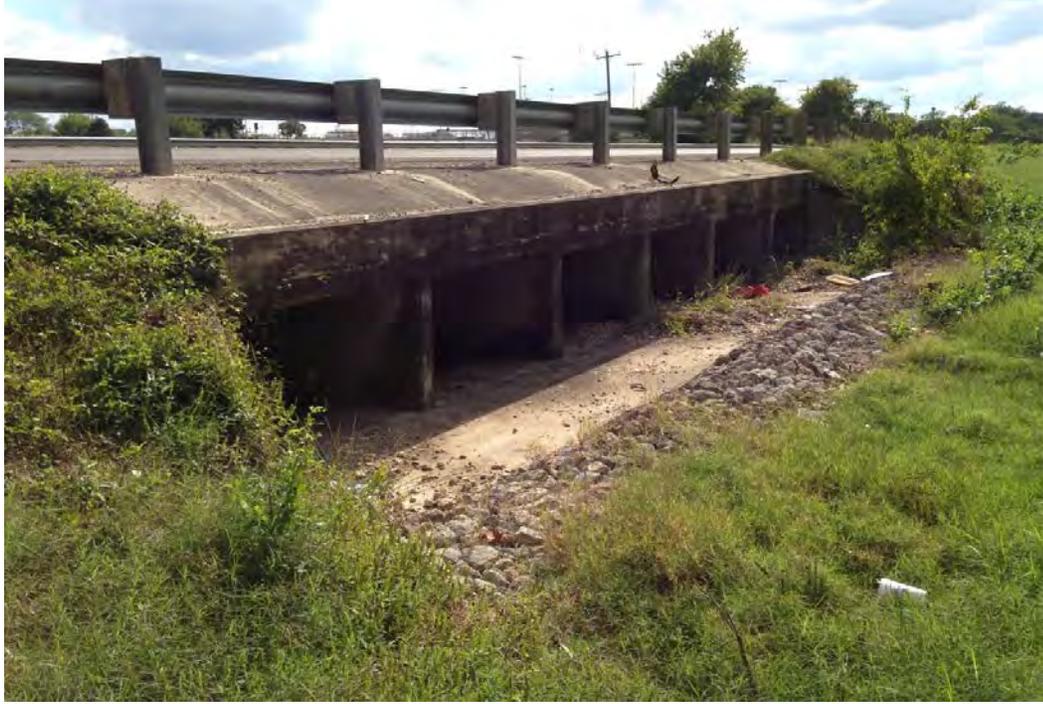
P2	<i>Inlet of culverts under Hwy 21 looking south</i>
----	---

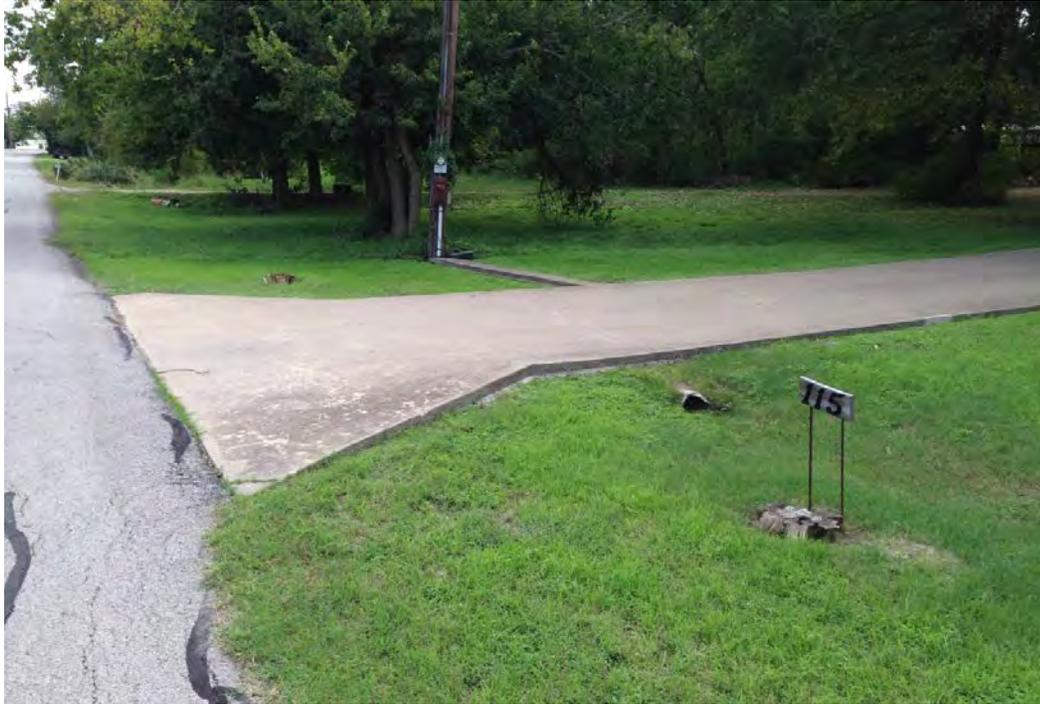
P3	<i>Driveway culvert at 115 Bogie Drive, looking south towards Hwy 21</i>
----	--

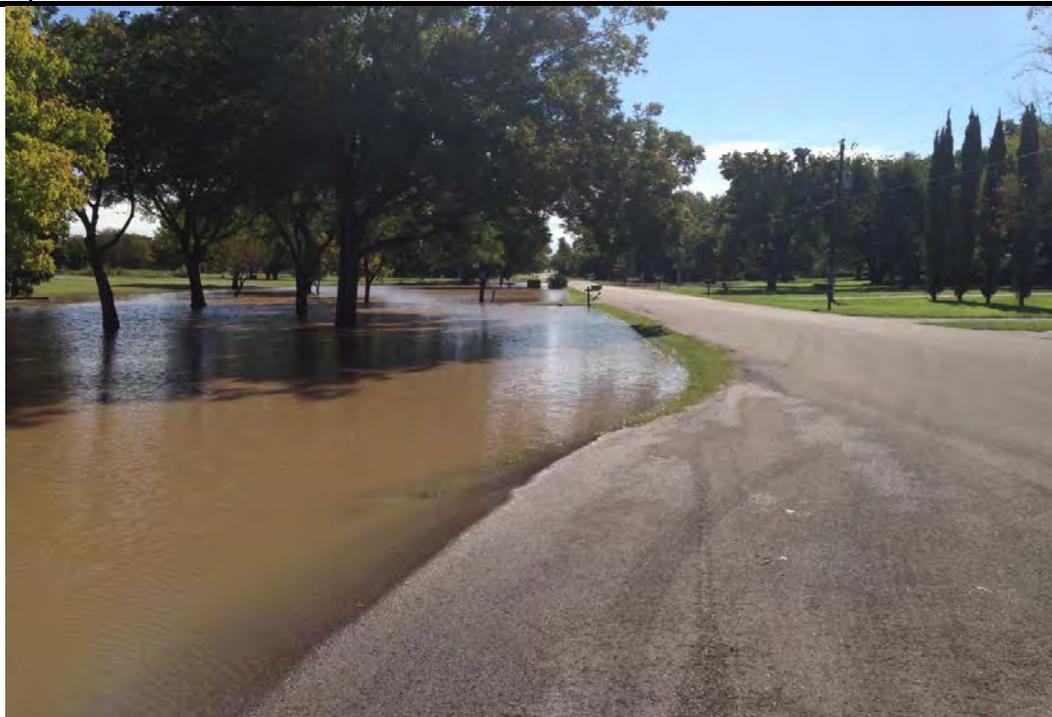
P4	<i>Channel along Bogie Drive after the Oct 31, 2013 storm event looking north</i>
----	---
