Field Assessment Report (Hot Spots)

Site No.: 1 Location: 700 Blk McKie St (Willow Springs Creek)

San Marcos Comprehensive Watershed Master Plan
Field Assessment Form - Local Flood Complaints

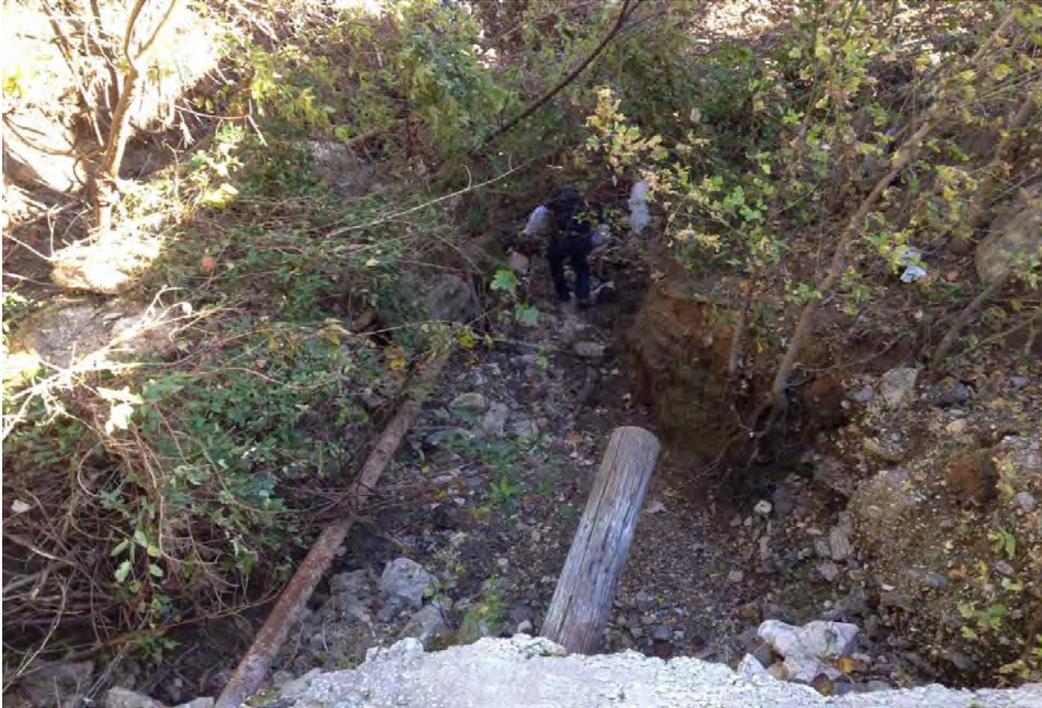
<i>P1</i>	<i>Eastern scour hole looking east towards Blanco River</i>
-----------	---

Notes: *Start w/ the eastern scour hole. Use large rock boulders to stabilize the area and stabilize or replace concrete apron. Then, install culvert under the road or reinforce road to convey flow by installing dip in culvert. Last, improve channel upstream.*

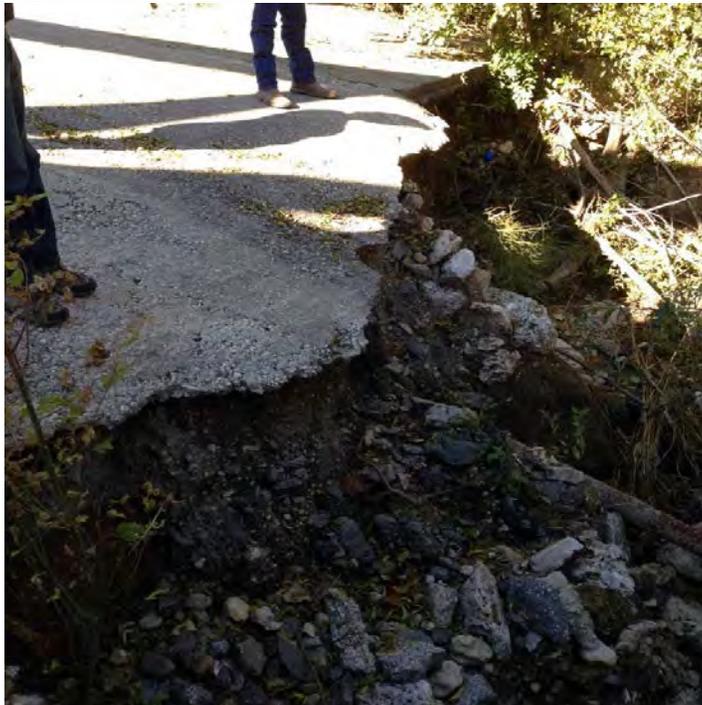
<i>P2</i>	<i>Concrete apron with roadway debris at eastern scour hole looking northwest</i>
-----------	---

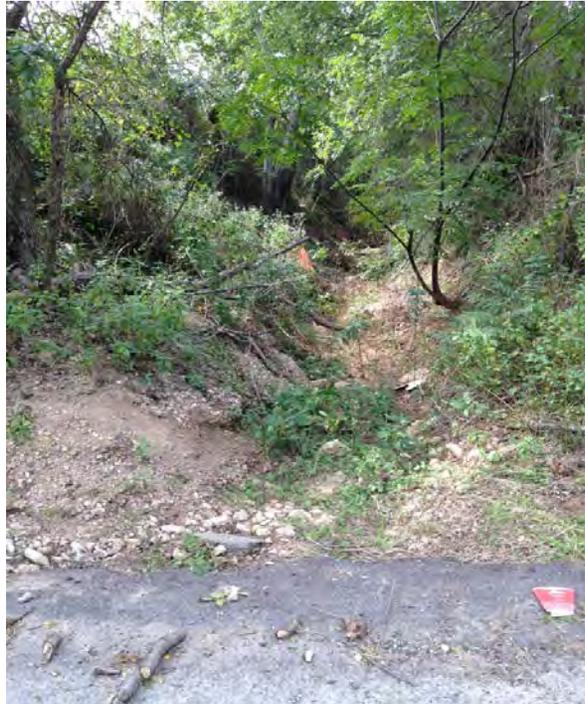
P3 *Creek upstream of River Road looking west*

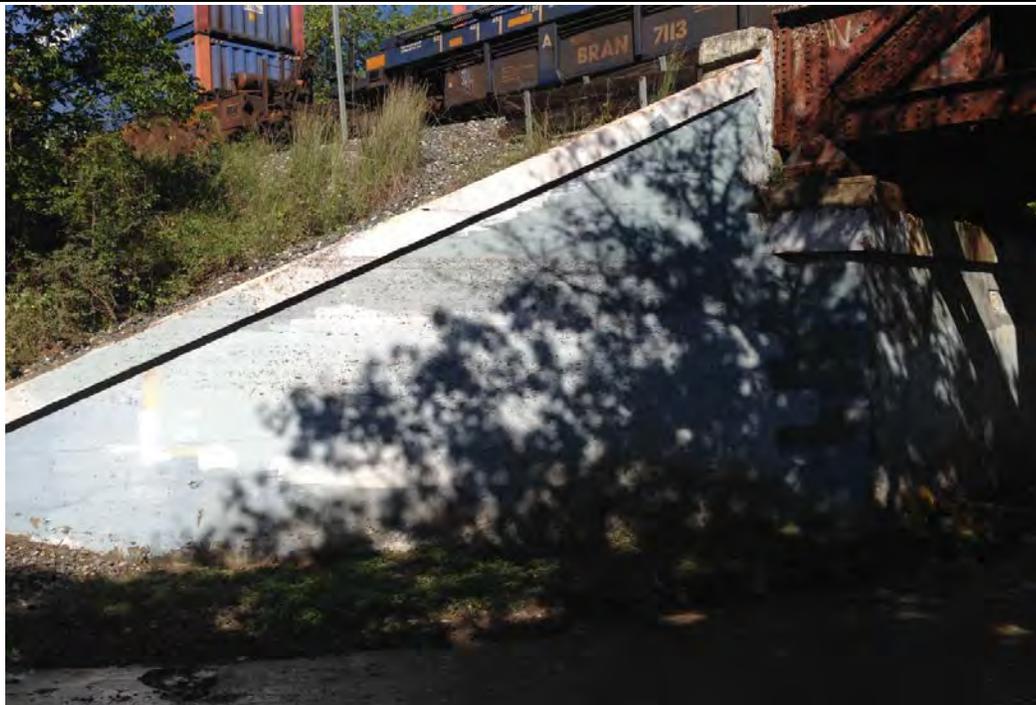
P4 *Water level shown on bridge from Oct 31, 2013 storm event*

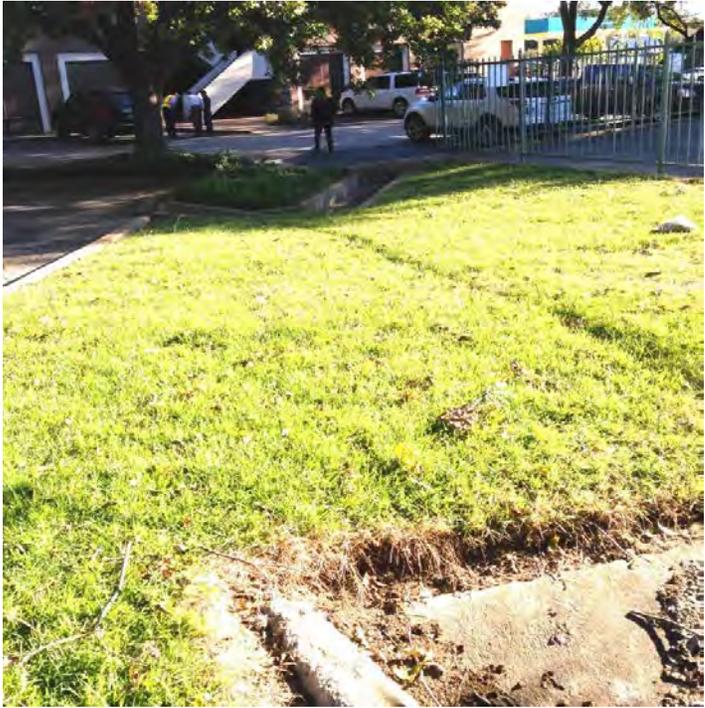
P1	<i>Looking SE from U/S end of channel towards inlet and 400 W Hopkins St</i>
----	--

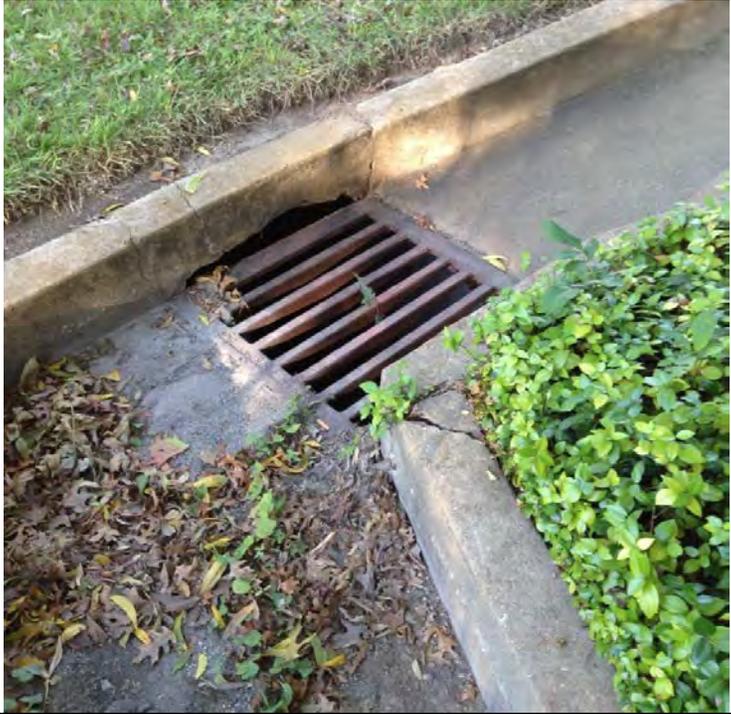
<i>P3</i>	<i>Looking at inlet before 400 W Hopkins St</i>
-----------	---

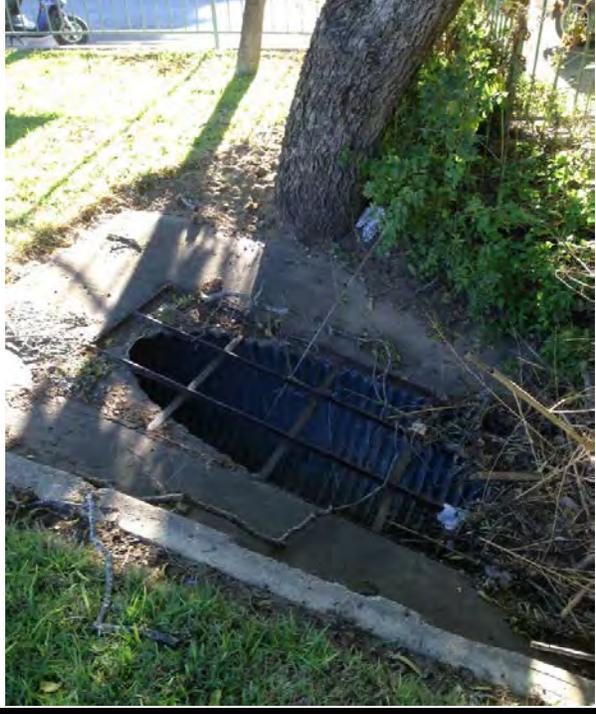
<i>P4</i>	<i>Looking SE at the storm sewer inlet U/S of inlet in P3</i>
-----------	---

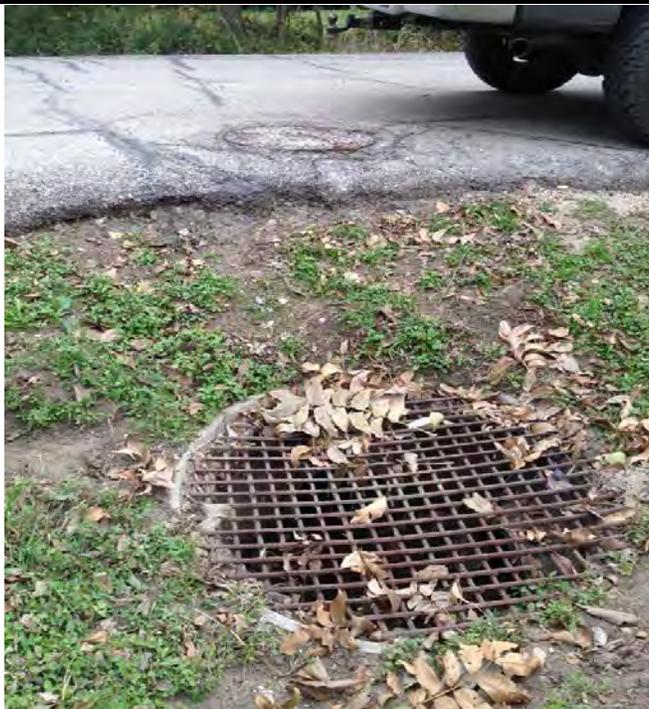
P2	<i>Looking SE at grate inlet on N side of Orchard; leaves and debris from previous event</i>
----	--

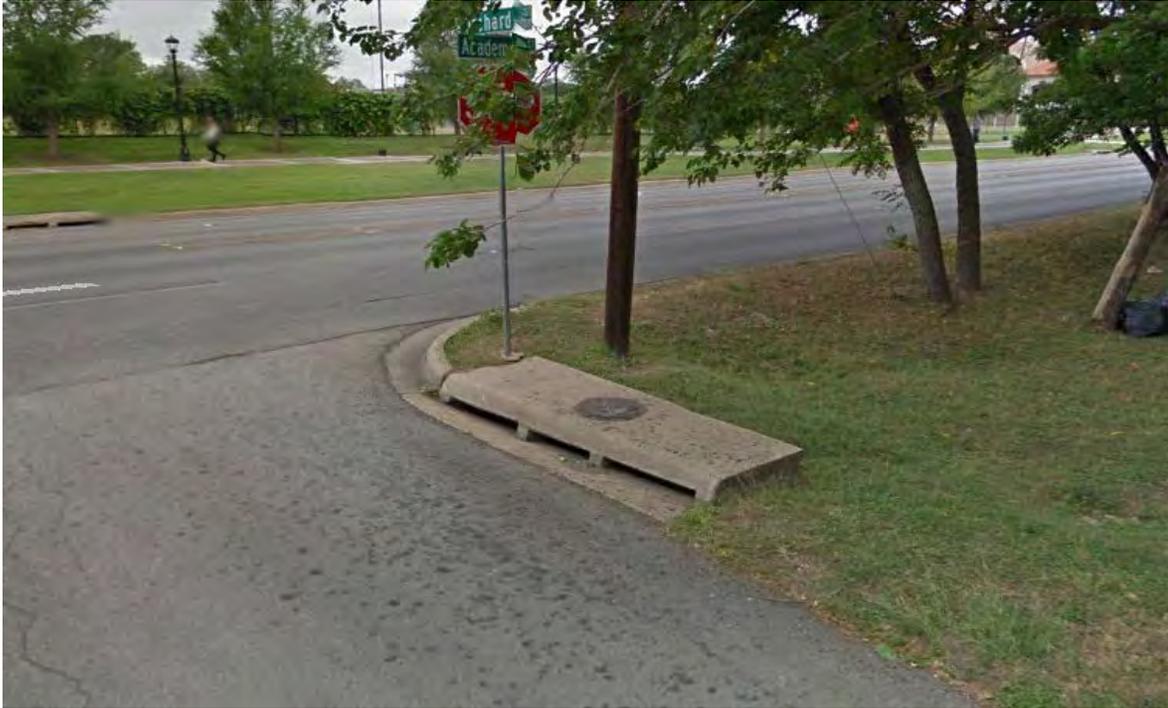
P3	<i>Looking W at curb inlet on N corner of Academy/Orchard</i>
----	---

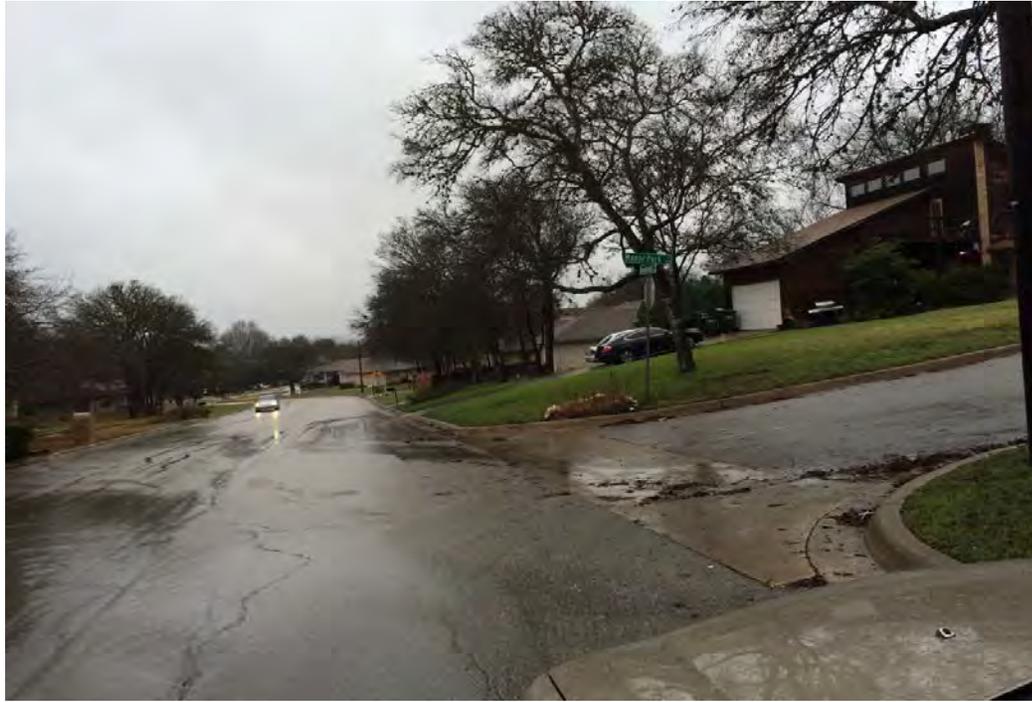
P1	<i>Looking N at water flowing at intersection of Hughson Drive and Manor Park Road</i>
----	--

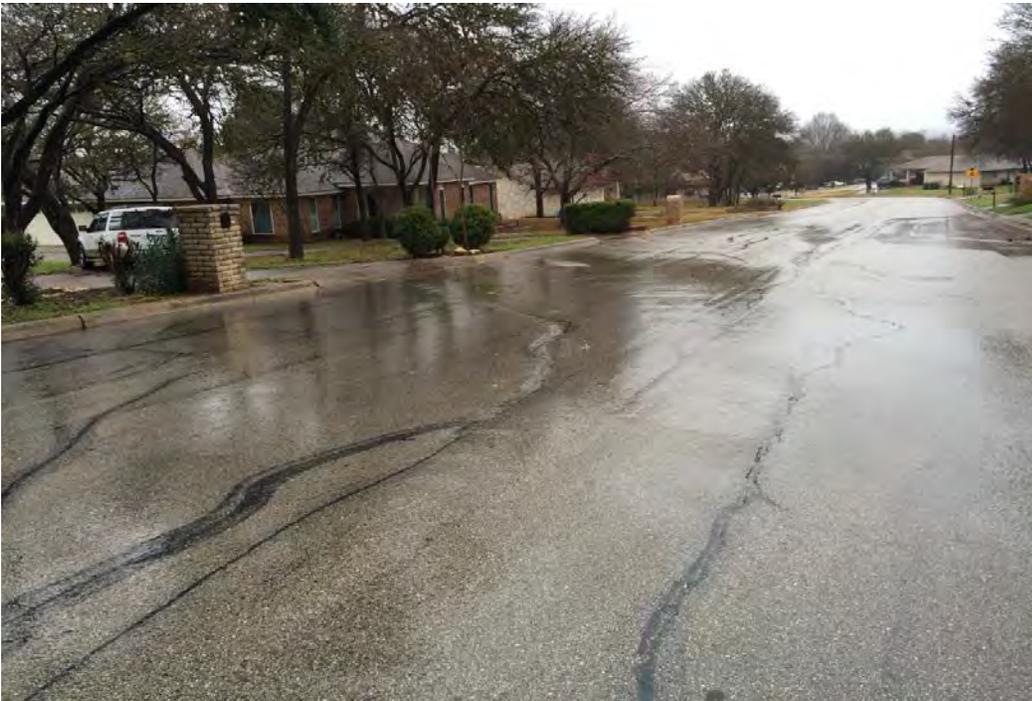
P2	<i>Looking NW towards 402 Hughson Drive and the flow coming from Manor Park Road</i>
----	--

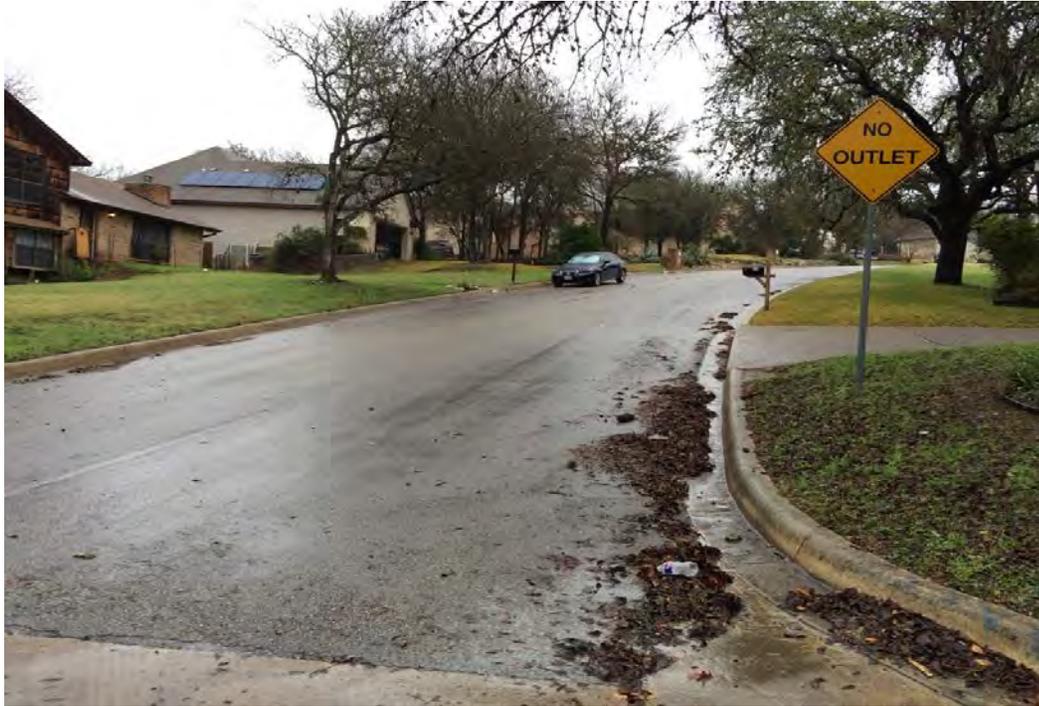
P3	Looking E up Manor Park Road
----	------------------------------

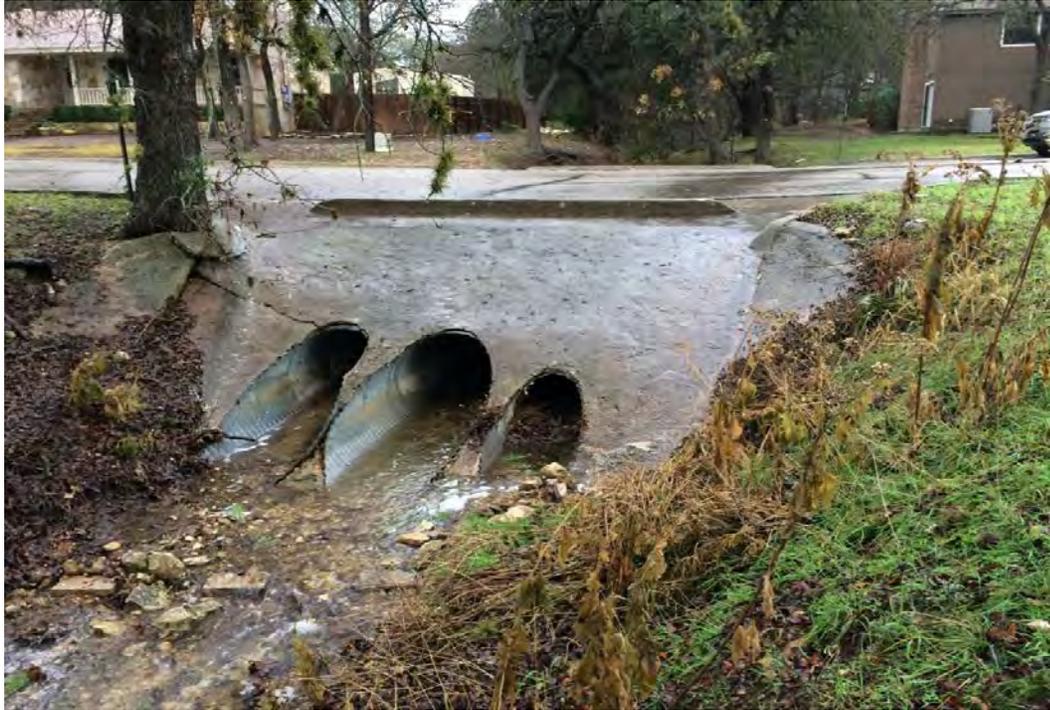
P3	<i>Looking at D/S side of culvert on NE loop of Oakridge St</i>
----	---

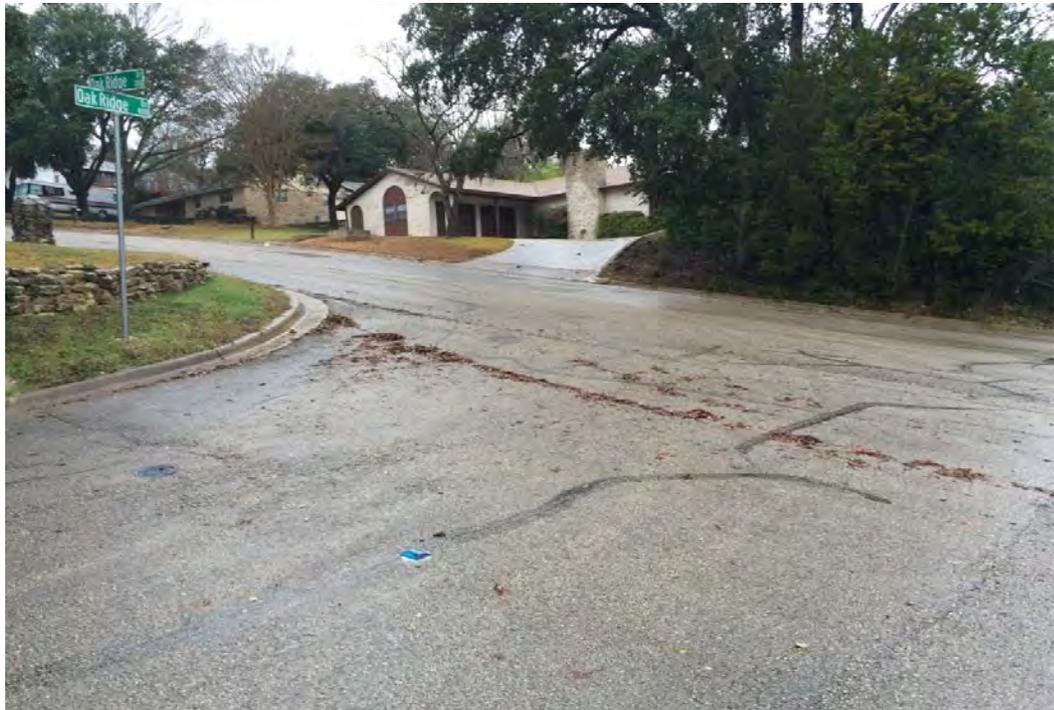
P4	<i>Looking W at debris line on Oakridge St loop intersection</i>
----	--

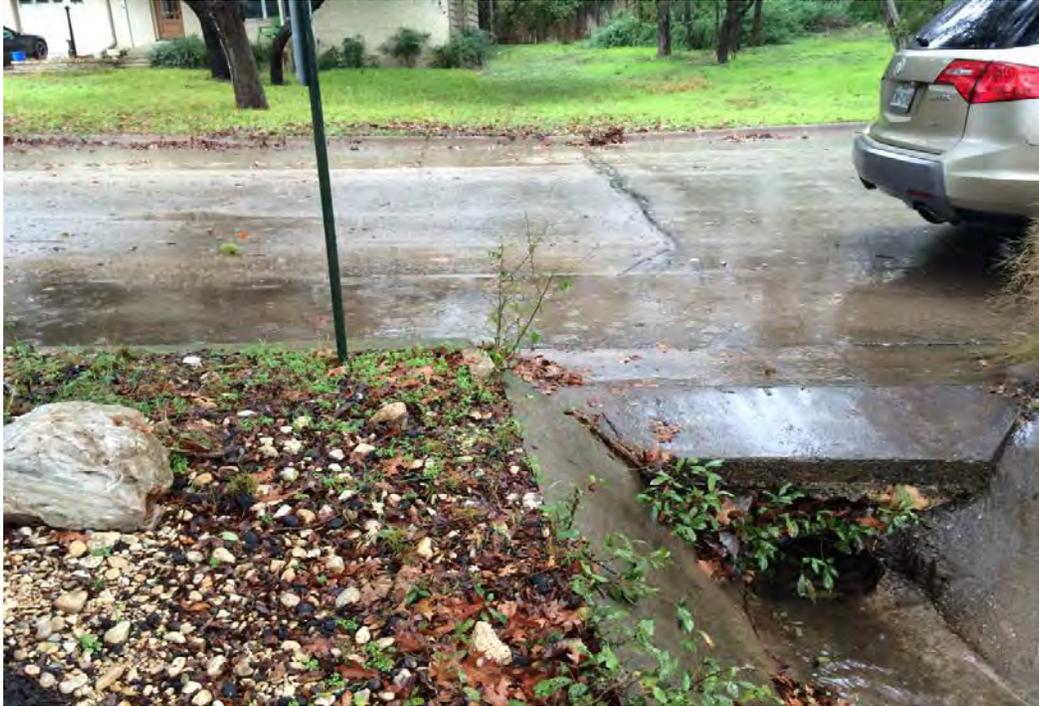
P1	Looking N at the D/S side of the culvert on Ridgeway Dr closest to Chestnut St
----	--

Replace the culverts in Hillcrest Drive and Ridgeway Drive with larger culverts

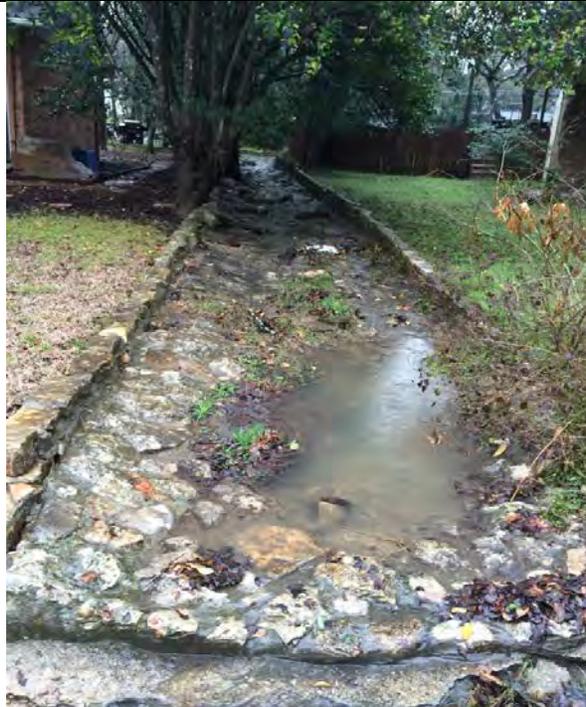
P2	Looking NW at the U/S channel of the culvert on Ridgeway Dr closest to Canyon Dr
----	--

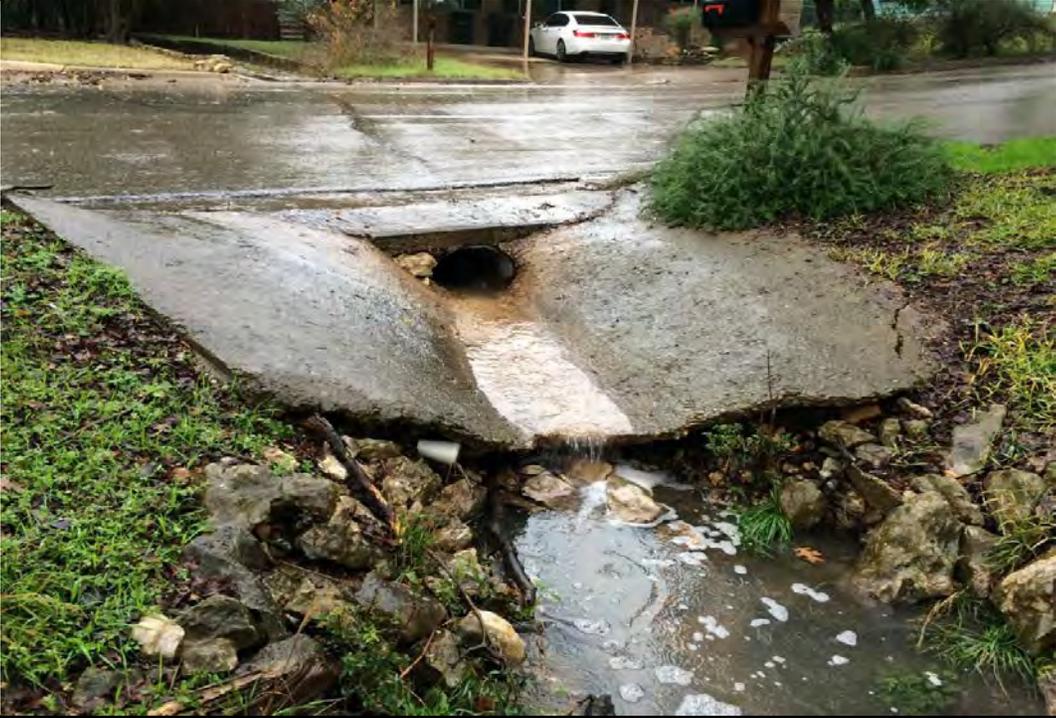
<i>P3</i>	<i>Looking NW at the D/S culvert on Ridgeway Dr closest to Canyon Dr</i>
-----------	--

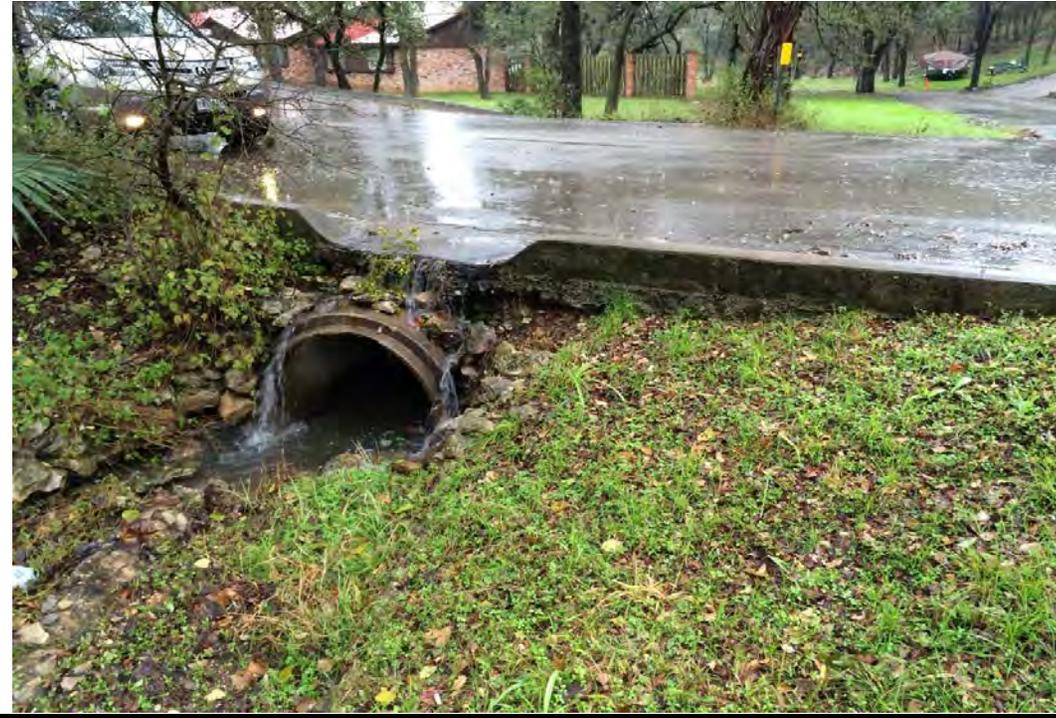
<i>P4</i>	<i>Looking SW at the U/S culvert on E. Hillcrest Dr</i>
-----------	---

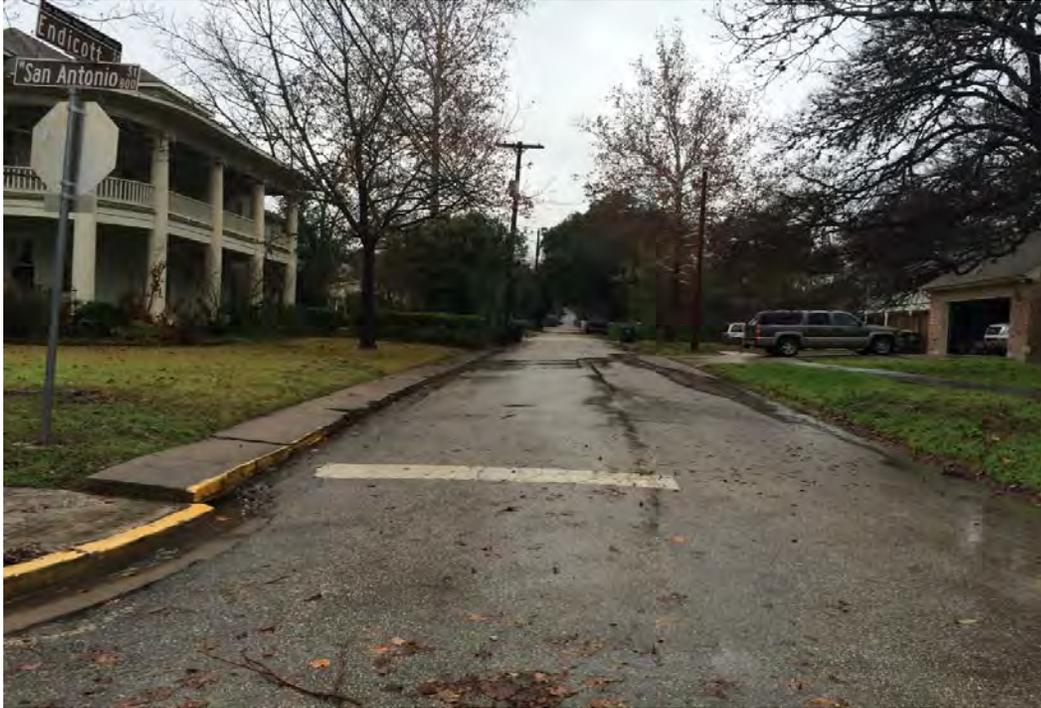
P1	Looking SW up Endicott St from San Antonio St
----	---

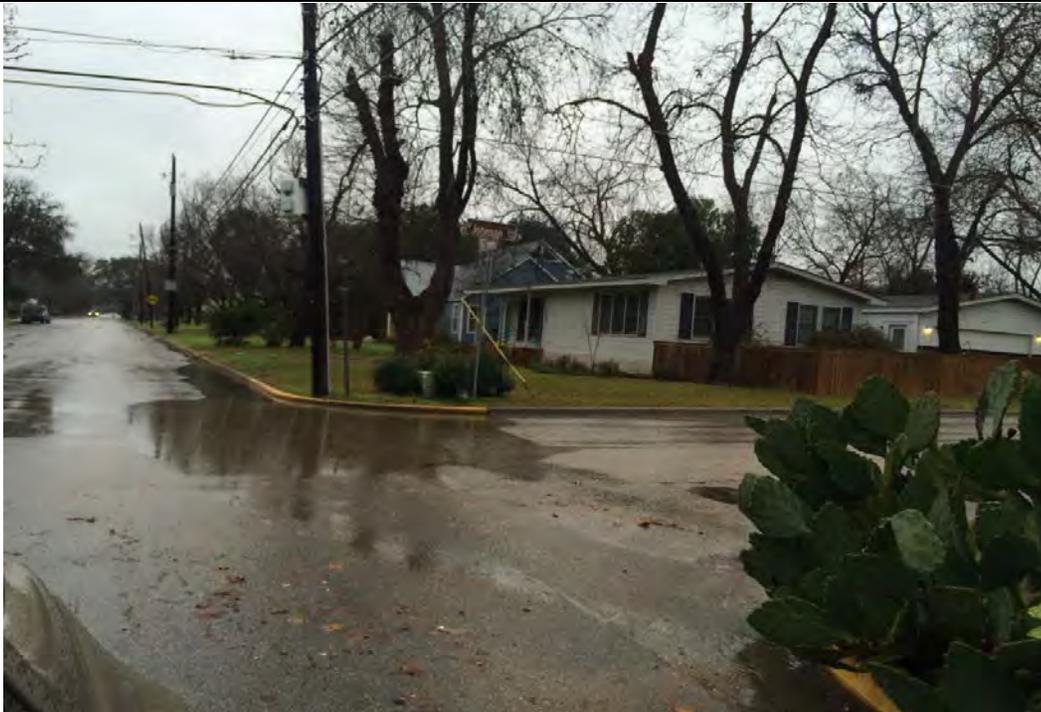
P2	Looking SW at standing water in intersection of Johnson St and San Antonio St
----	---

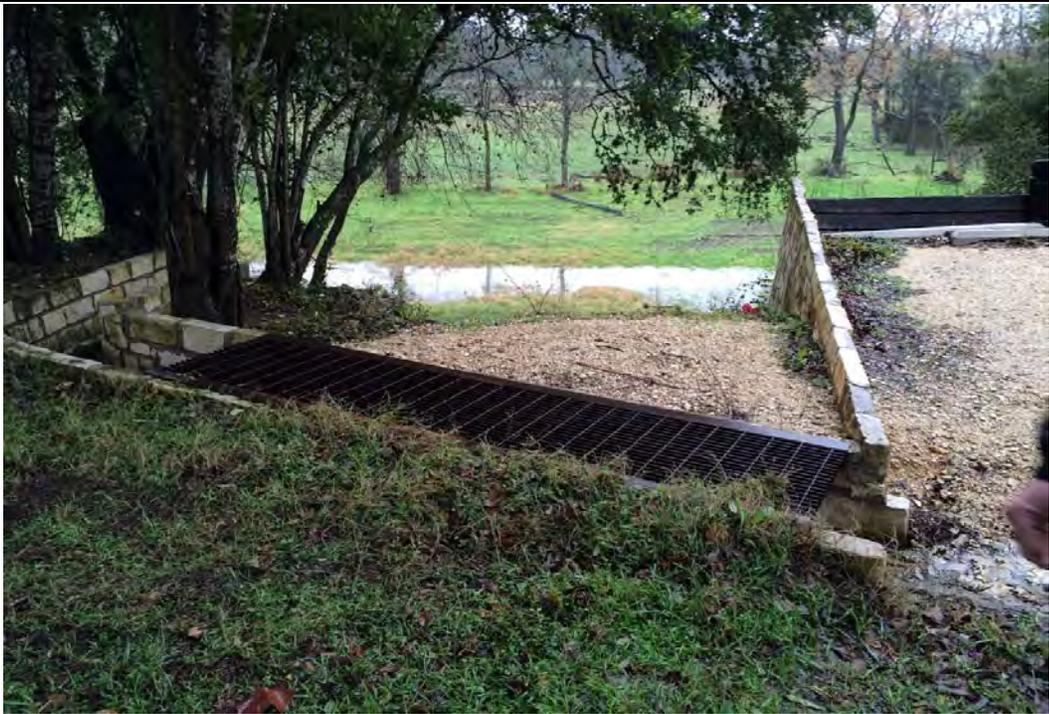
P4	<i>Outlet channel for neighborhood runoff into Purgatory Creek from Bishop St</i>
----	---

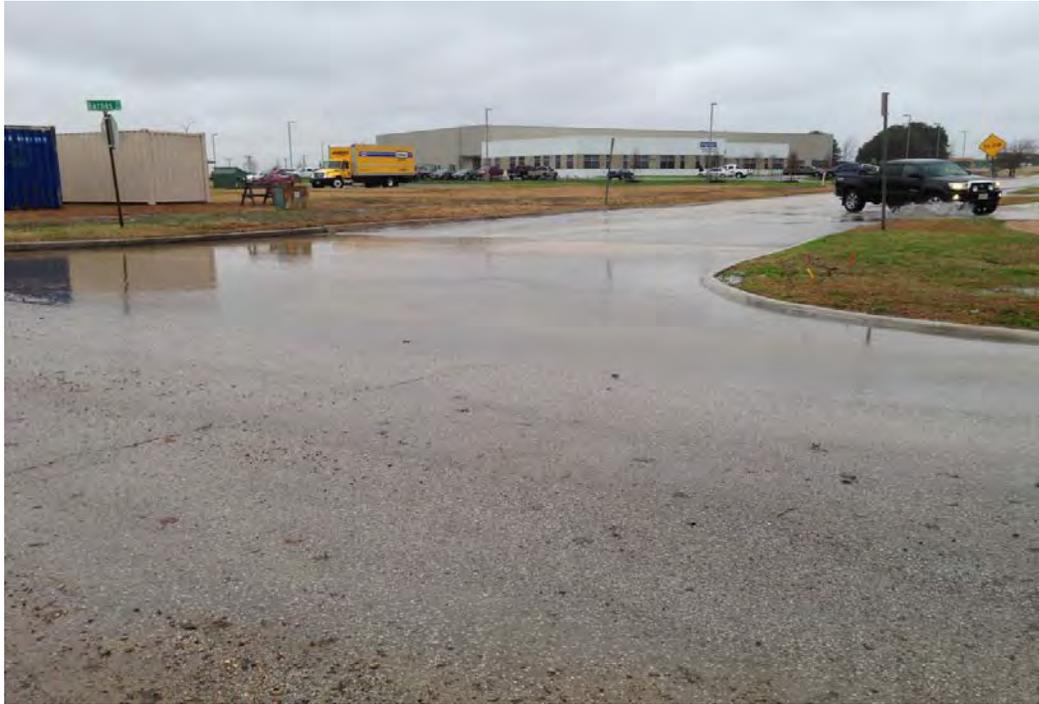
P1	<i>Looking W towards the intersection of Barnes Dr from Thermon Dr</i>
----	--

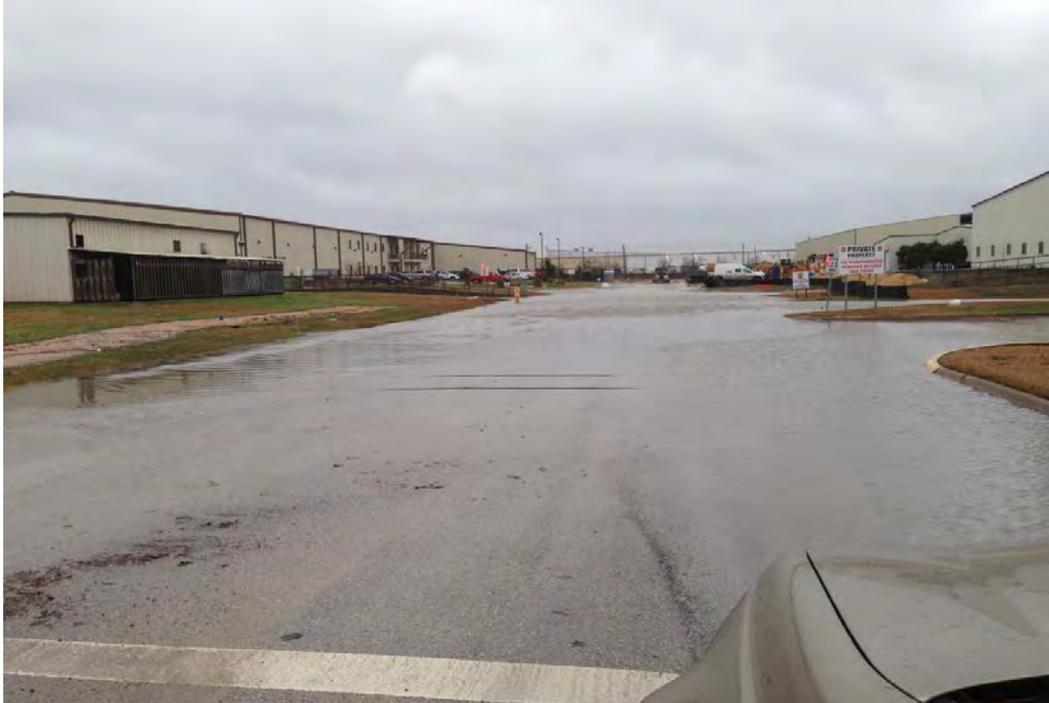
P2	<i>Looking NW on Thermon Dr from intersection of Thermon Dr and Barnes Dr</i>
----	---

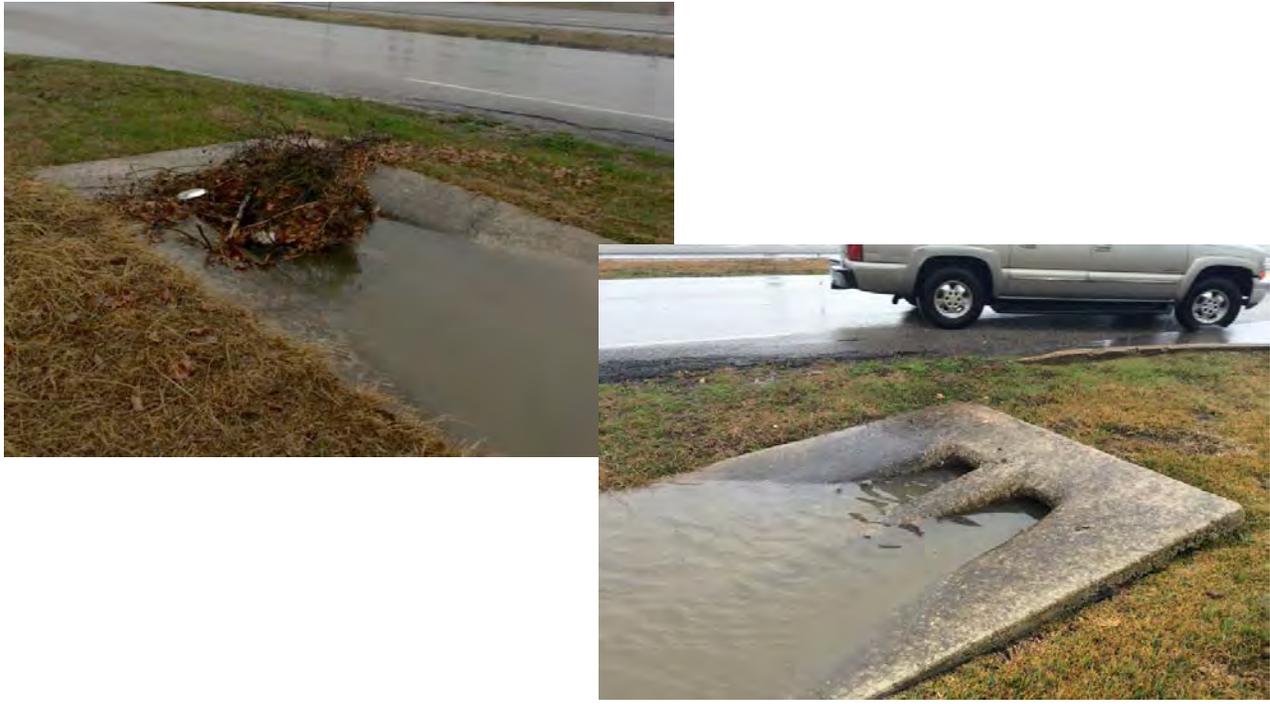
<i>P3</i>	<i>U/S and D/S side of culvert at Thermon Dr and IH 35 frontage road</i>
-----------	--

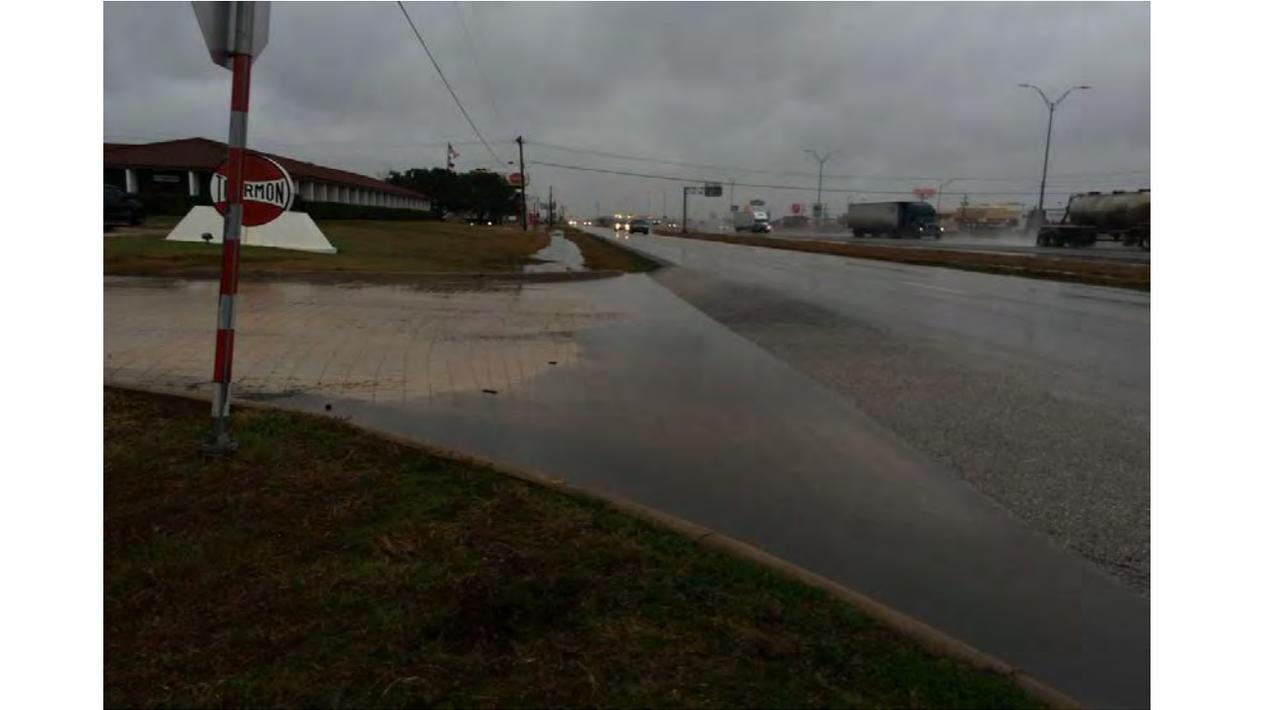
<i>P4</i>	<i>Looking NE from Thermon Dr up the IH 35 frontage road</i>
-----------	--

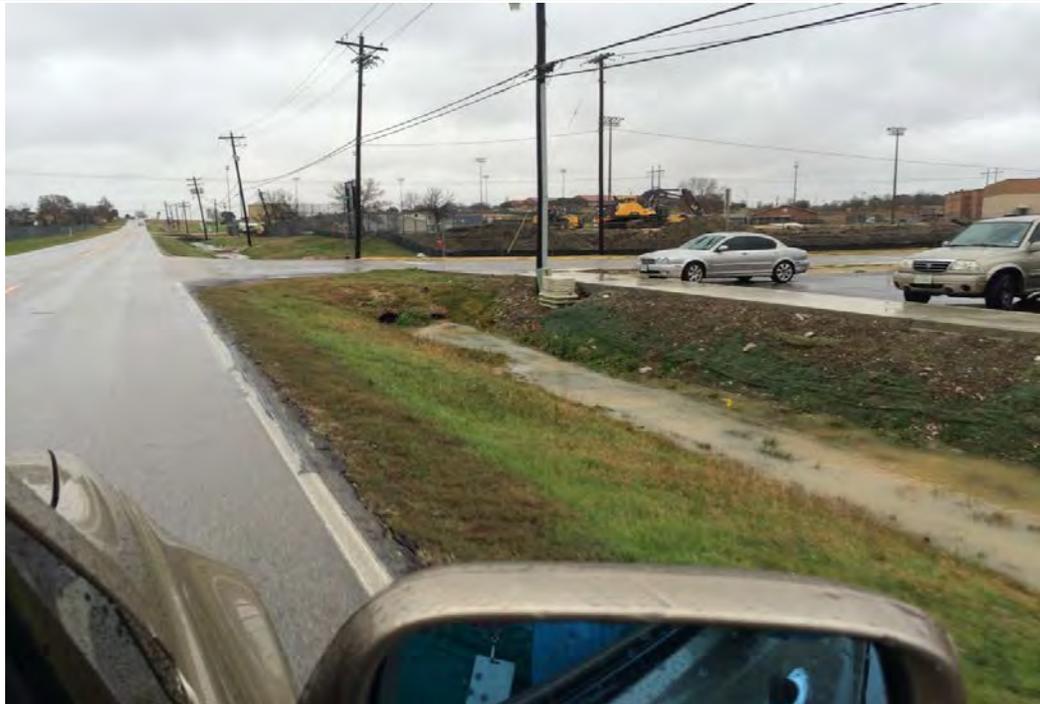
P1	<i>Looking S at the culverts on the W side of Staples Rd</i>
----	--

Replace eight (8) undersized culverts, upgrade existing storm sewer system,

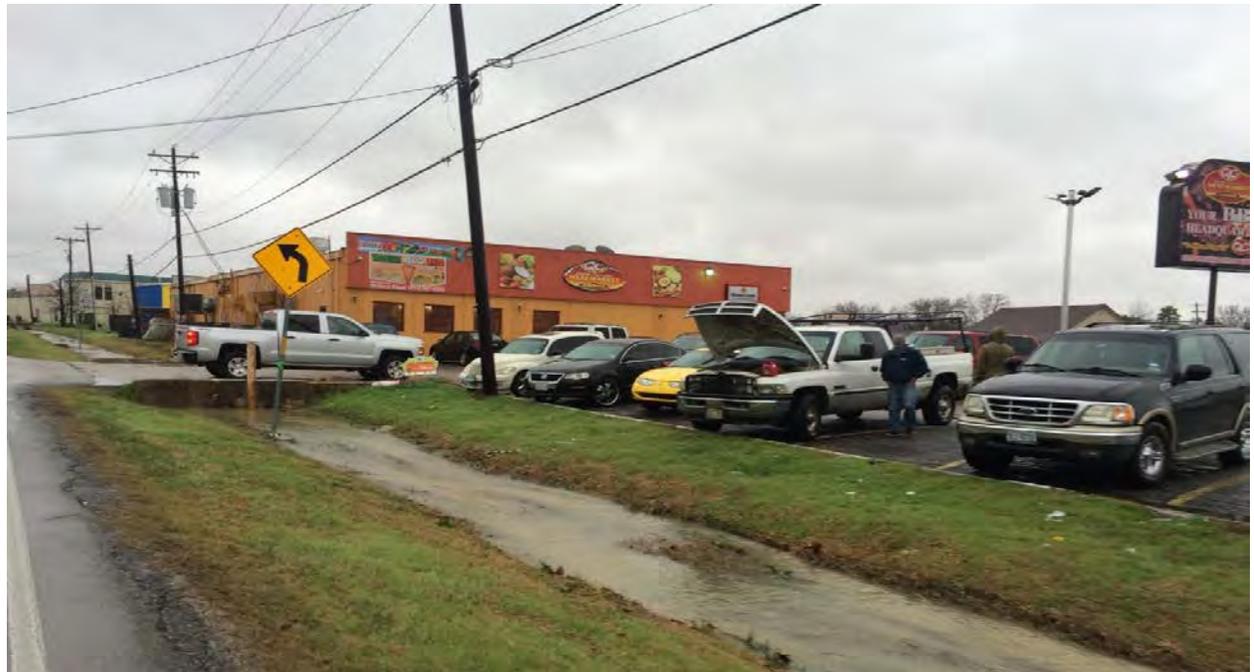
P2	<i>Looking S at the culverts on the W side of Staples Rd</i>
----	--

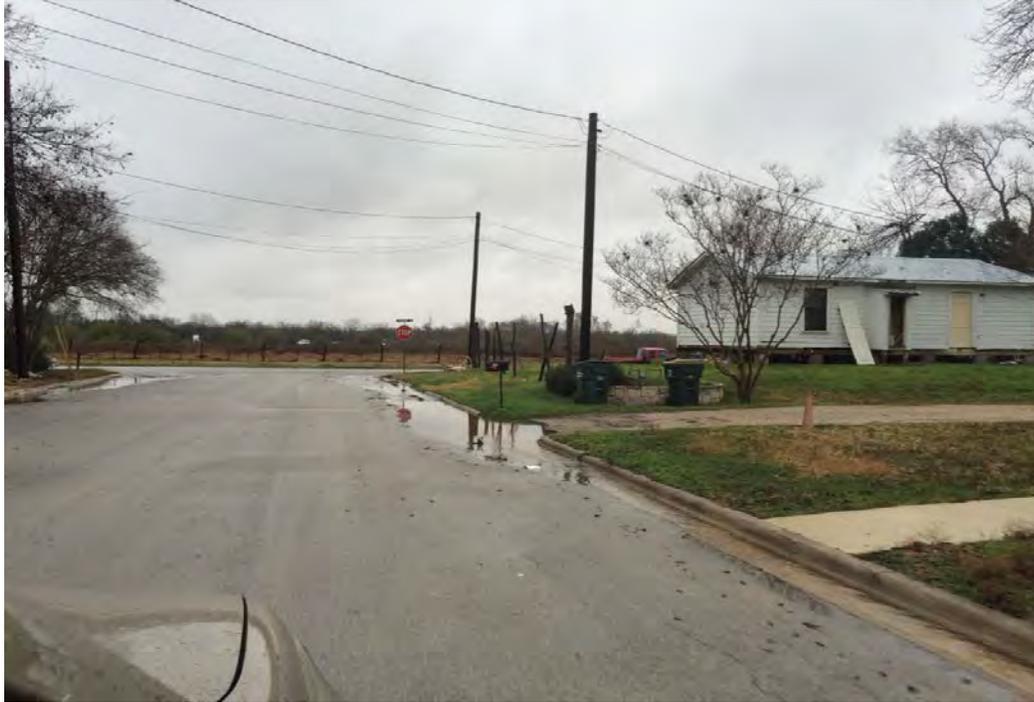
<i>P3</i>	<i>Water on Tampico Street looking NW towards Flores Blvd</i>
-----------	---

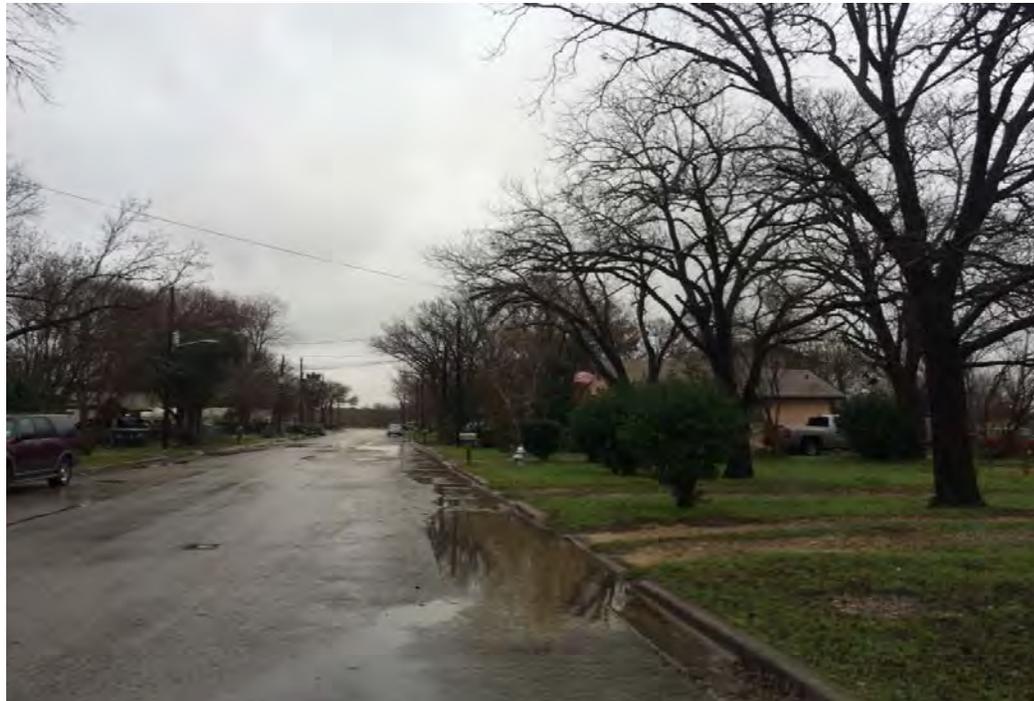
<i>P4</i>	<i>Looking NE on Laredo Street towards Flores Blvd</i>
-----------	--

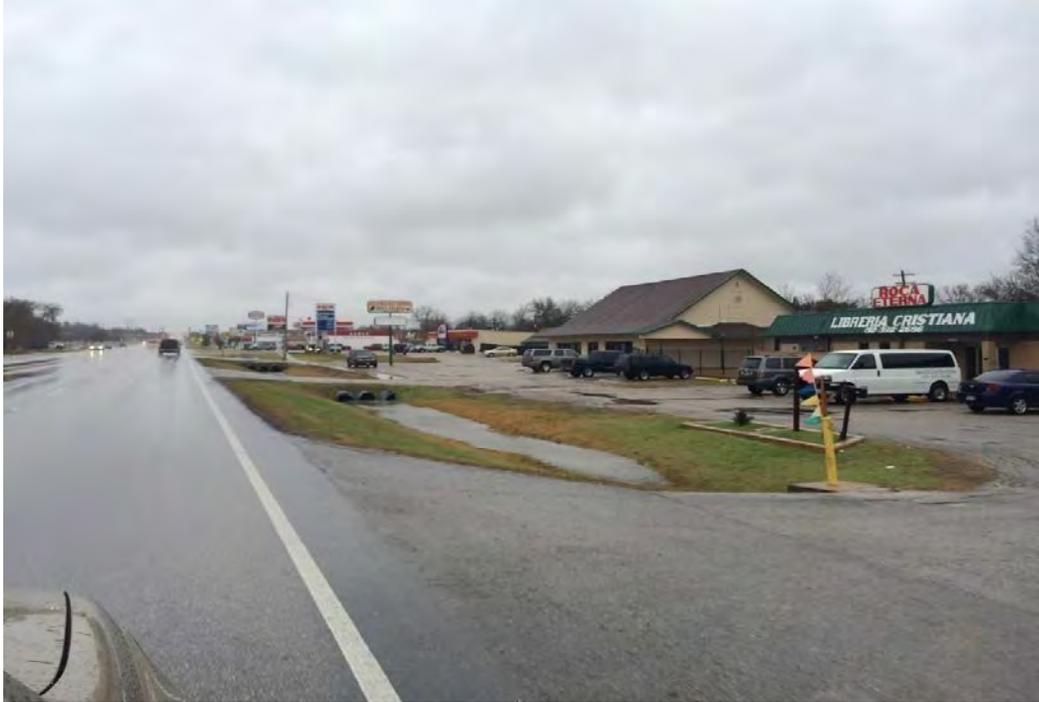
Cause of Flooding: Culverts fail to convey a 10-year storm event and one fails to convey a 2-year storm event.

P1	<i>Culverts on the W side of SH-123 looking S from Ebony St</i>
----	---

Increase and replace culverts along the East and West side of SH 123

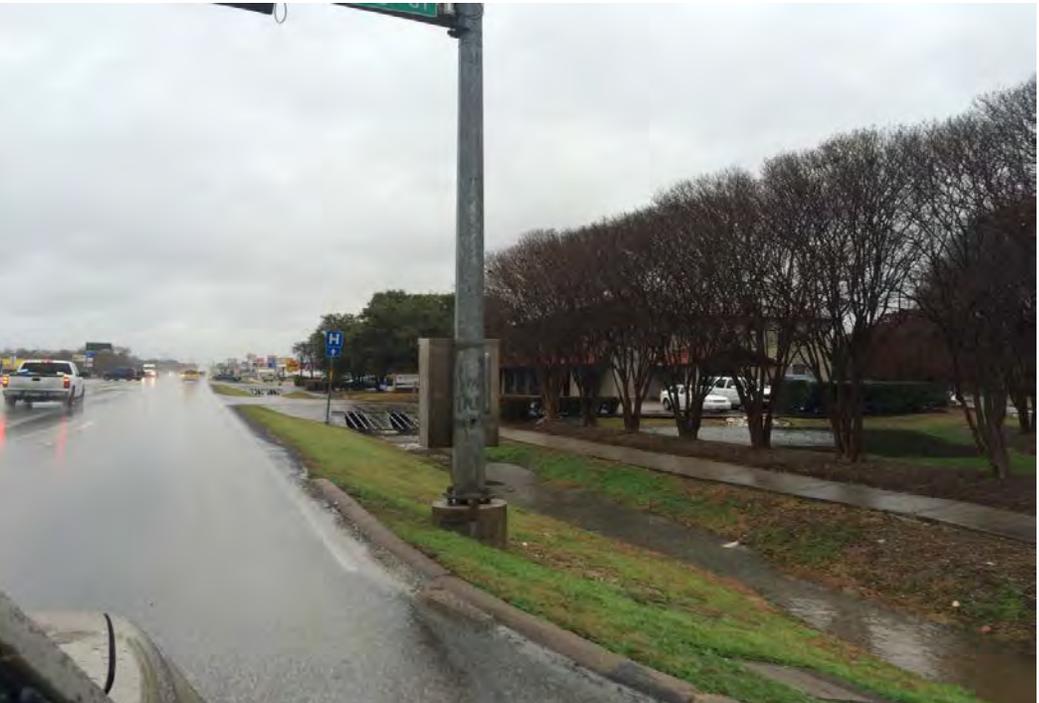
P2	<i>Culverts on the W side of SH-123 looking S from Staples Rd</i>
----	---

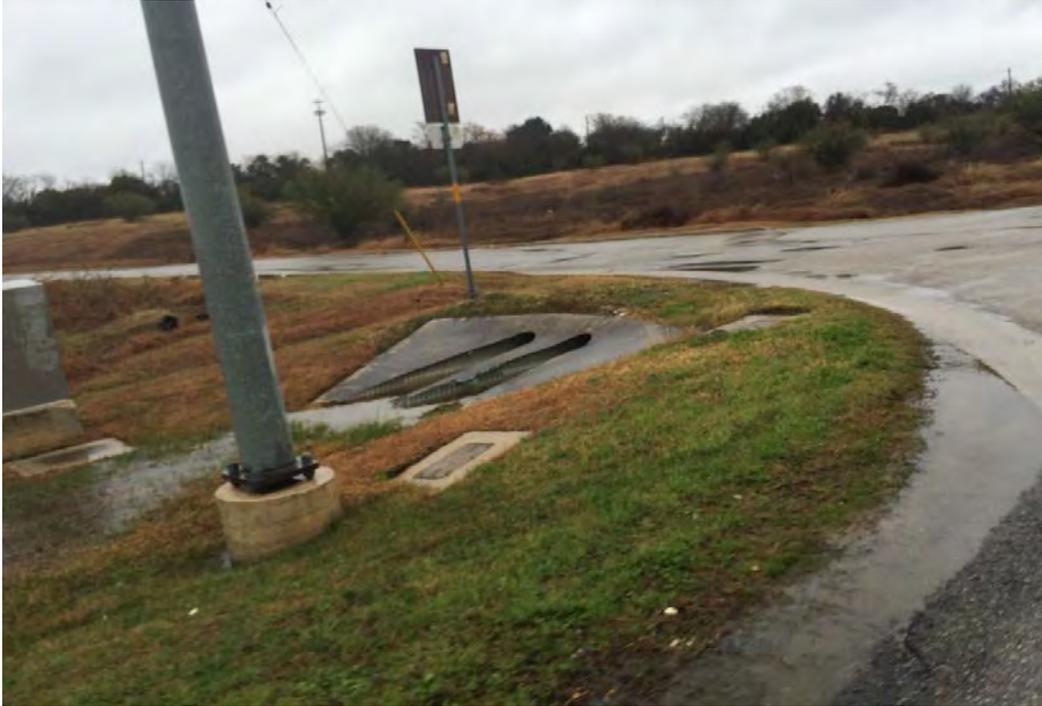
P3	<i>Culvert on E side of SH-123 at De Zavala Dr looking SW</i>
----	---
