Field Assessment Report (Hot Spots)

Site No.: 1 Location: 700 Blk McKie St (Willow Springs Creek)

San Marcos Comprehensive Watershed Master Plan
Field Assessment Form - Local Flood Complaints

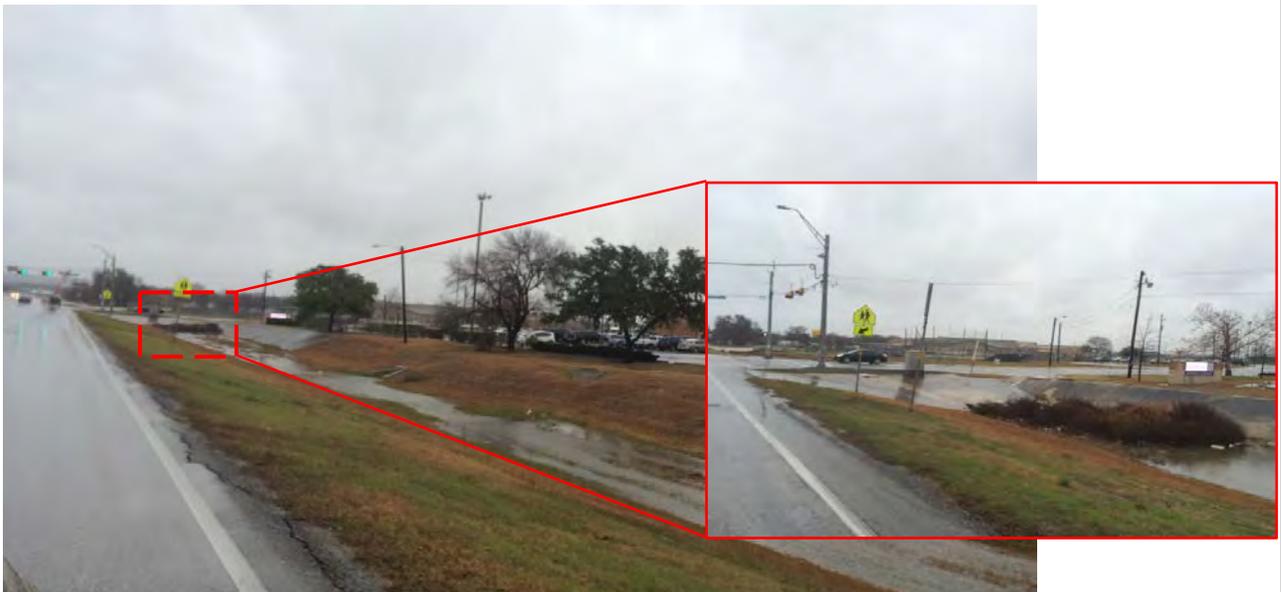
Cause of Flooding: Culverts fail to convey a 10-year storm event and one fails to convey a 2-year storm event.

P4	<i>Vegetation in culvert on E side of SH-123 looking N towards IH-35</i>
----	--

Increase and replace culverts along the East and West side of SH 123

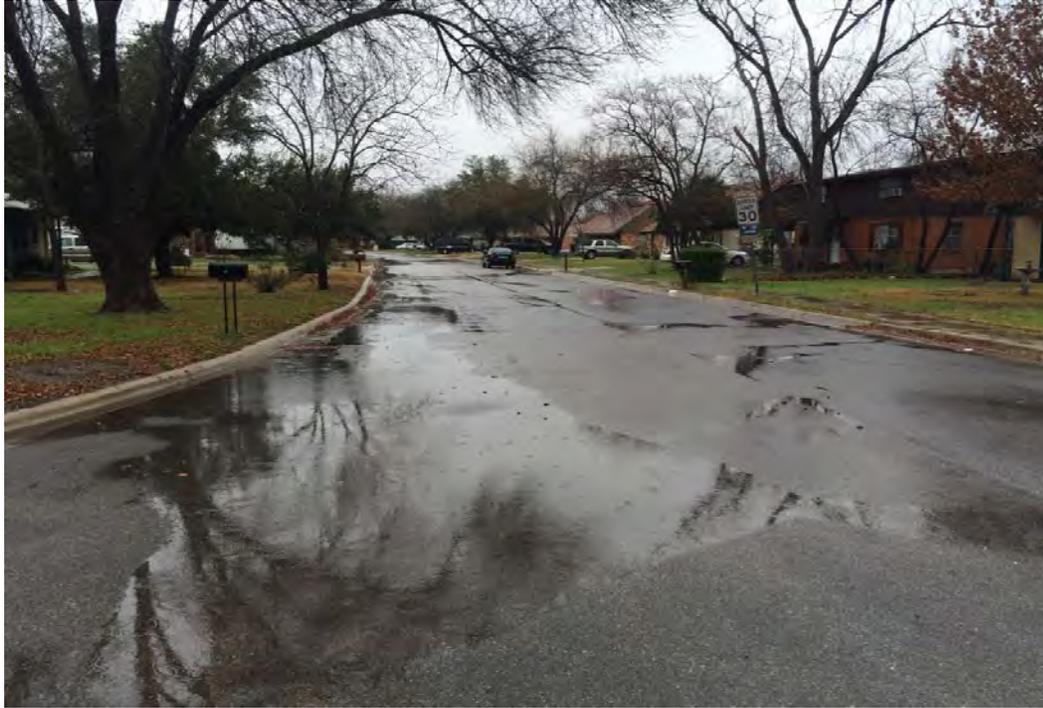
P1	<i>Looking NE towards Candlelight Ln from Broadway Dr at standing water in street</i>
----	---

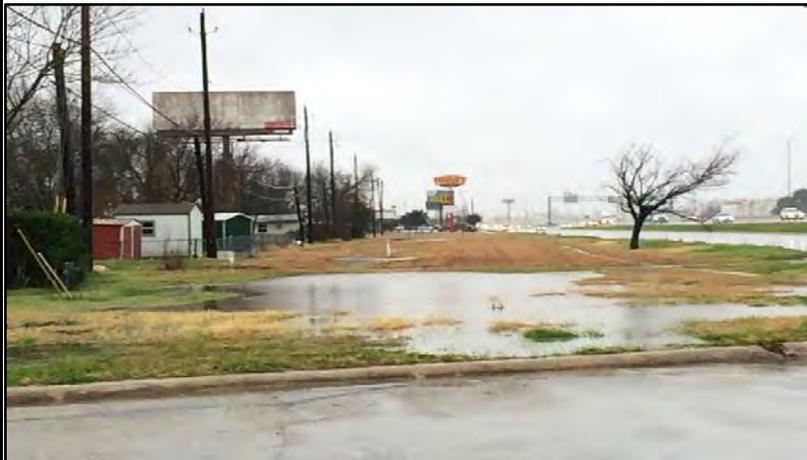
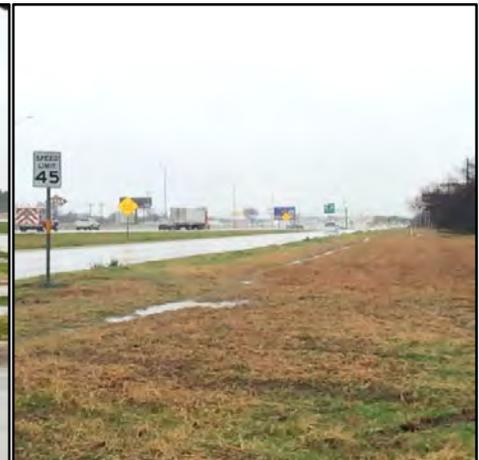
P2	<i>Drainage ditch along IH-35 Frontage Road looking NE and SW form Broadway Dr</i>
----	--

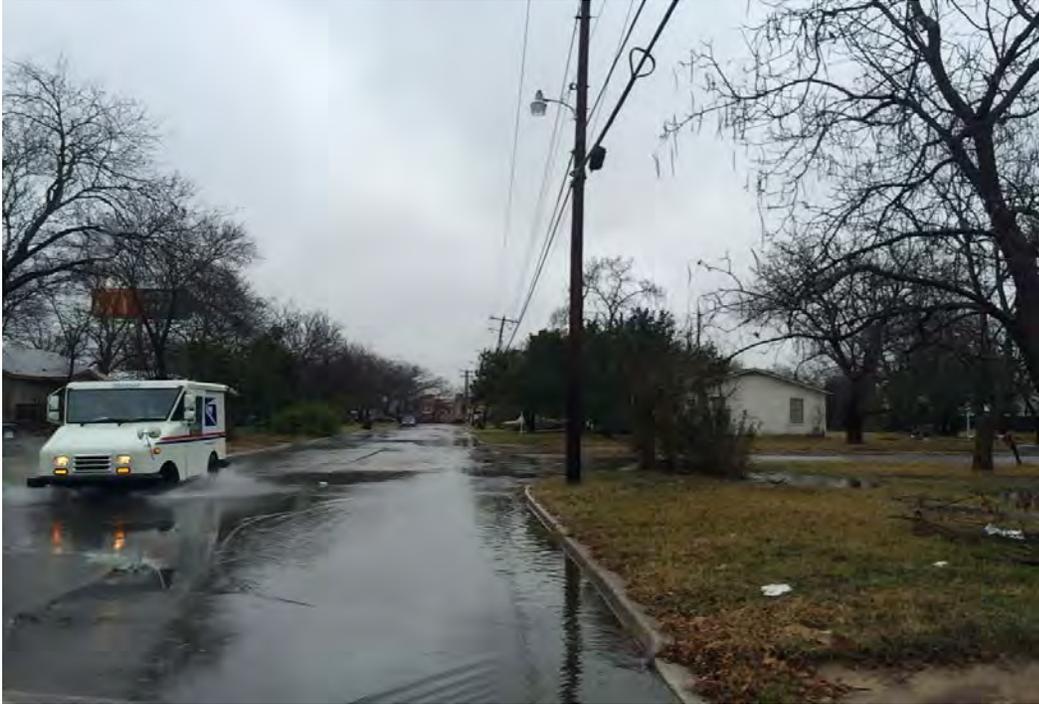
<i>P3</i>	<i>Looking NE on Patricia Dr towards Ebony St</i>
-----------	---

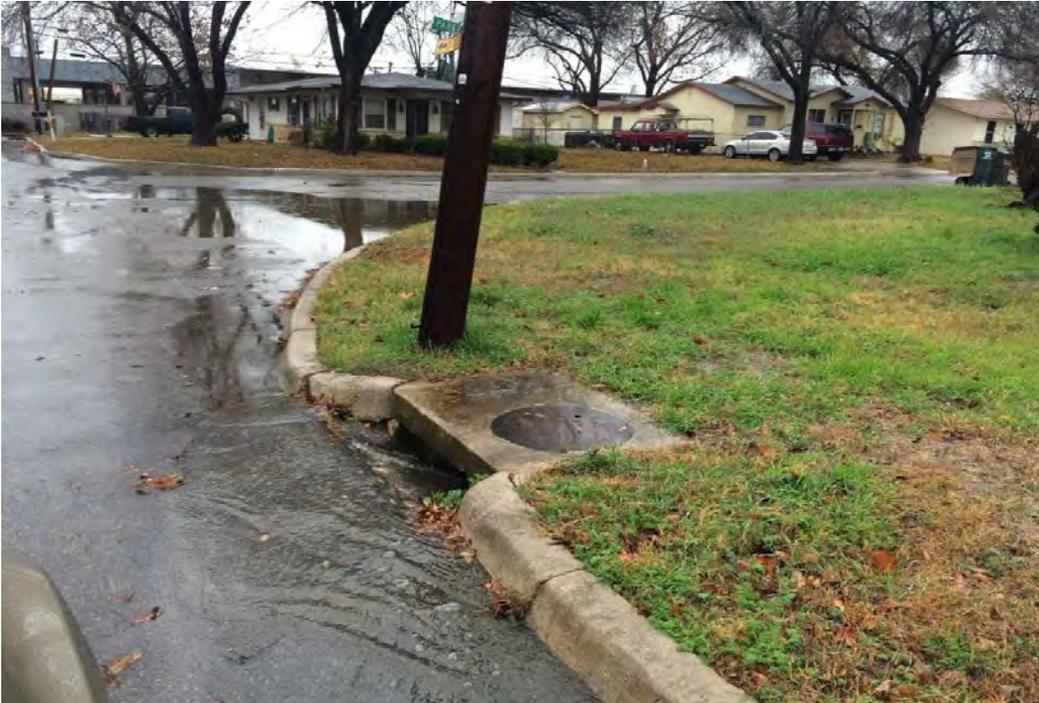
<i>P4</i>	<i>Existing inlet on Patricia Dr near intersection of Parker Dr</i>
-----------	---

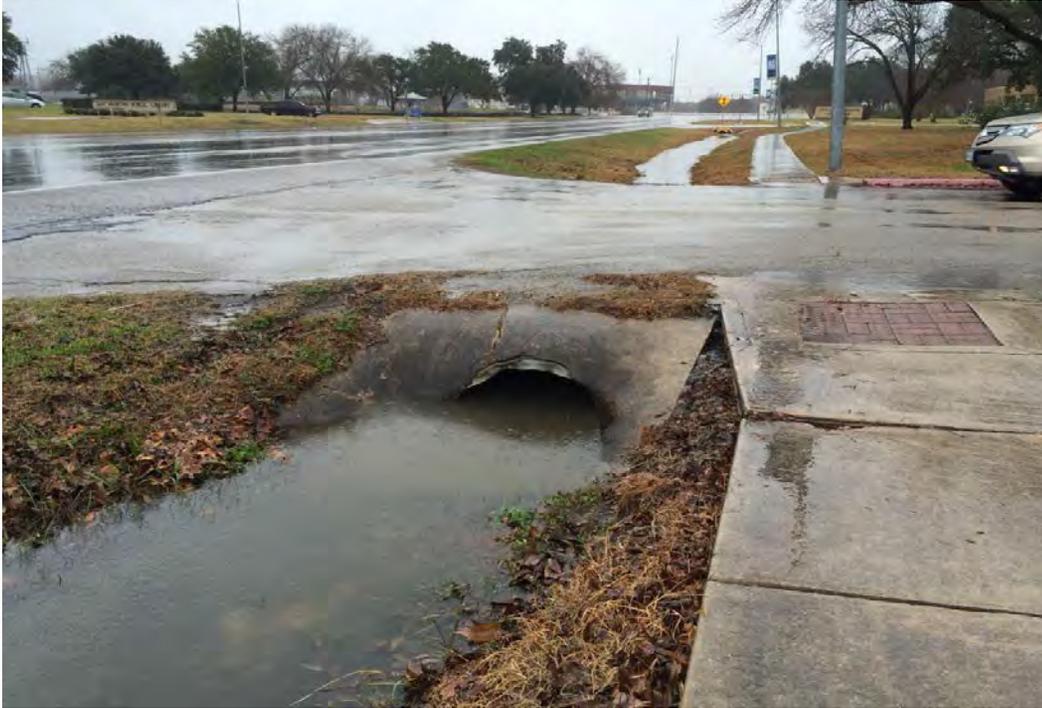
<i>P1</i>	<i>Looking NE towards D/S side of culvert at the entrance to St. Johns Catholic Church</i>
-----------	--

Replace and increase culvert sizes in this area.

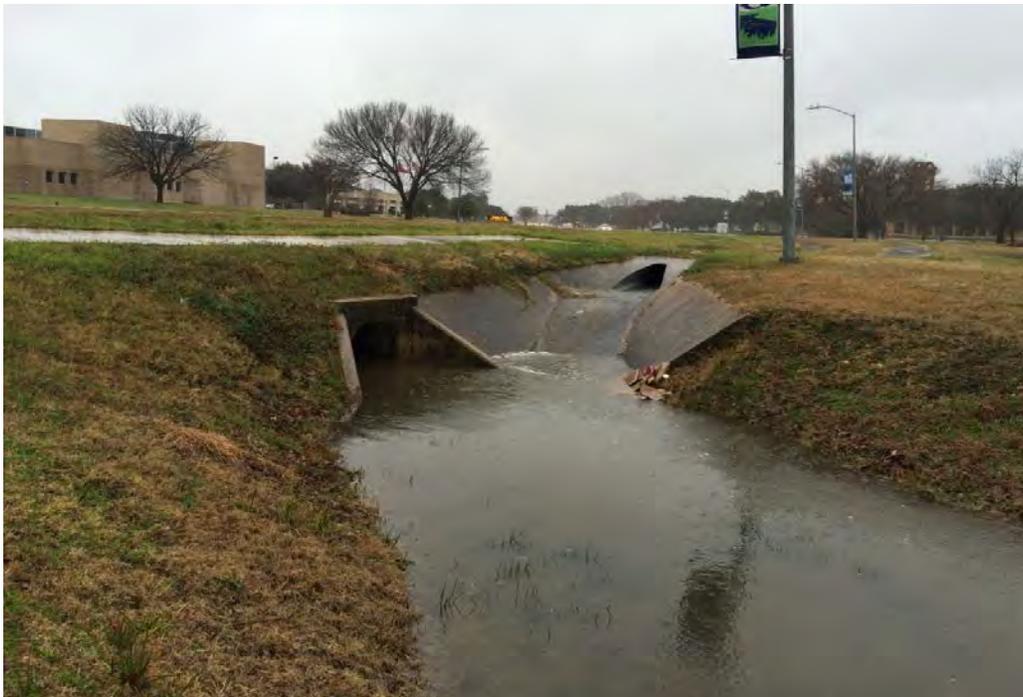
<i>P2</i>	<i>Looking N towards the D/S side of the culvert going under RR 12</i>
-----------	--

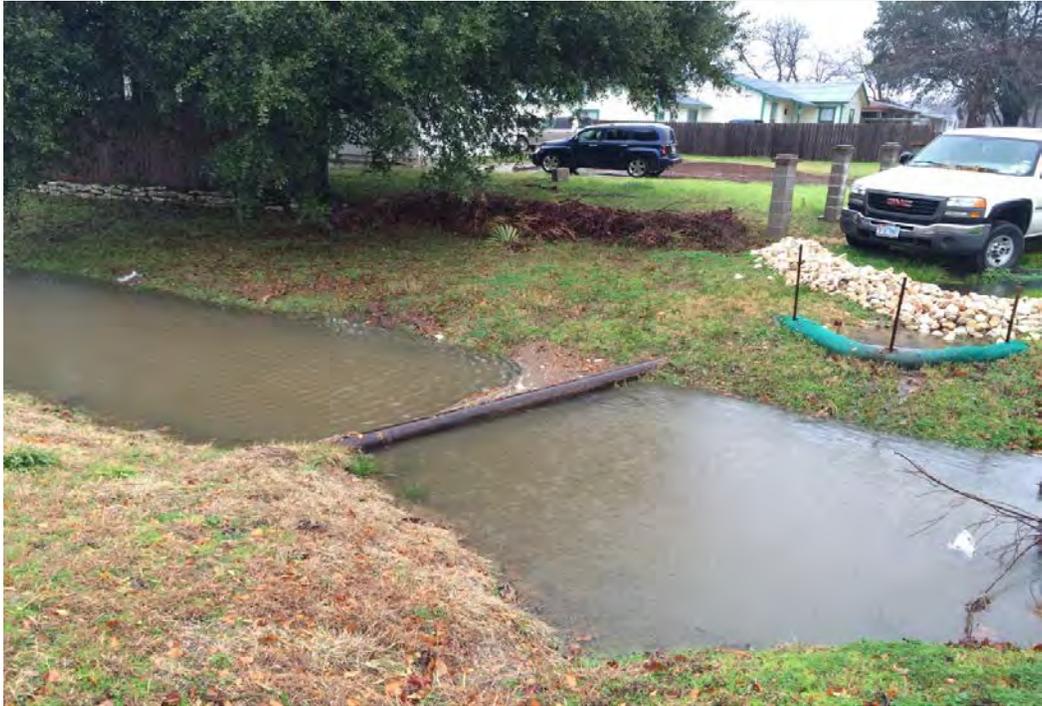
<i>P3</i>	<i>Looking N towards the U/S side of the culvert at pipe that crosses the channel</i>
-----------	---

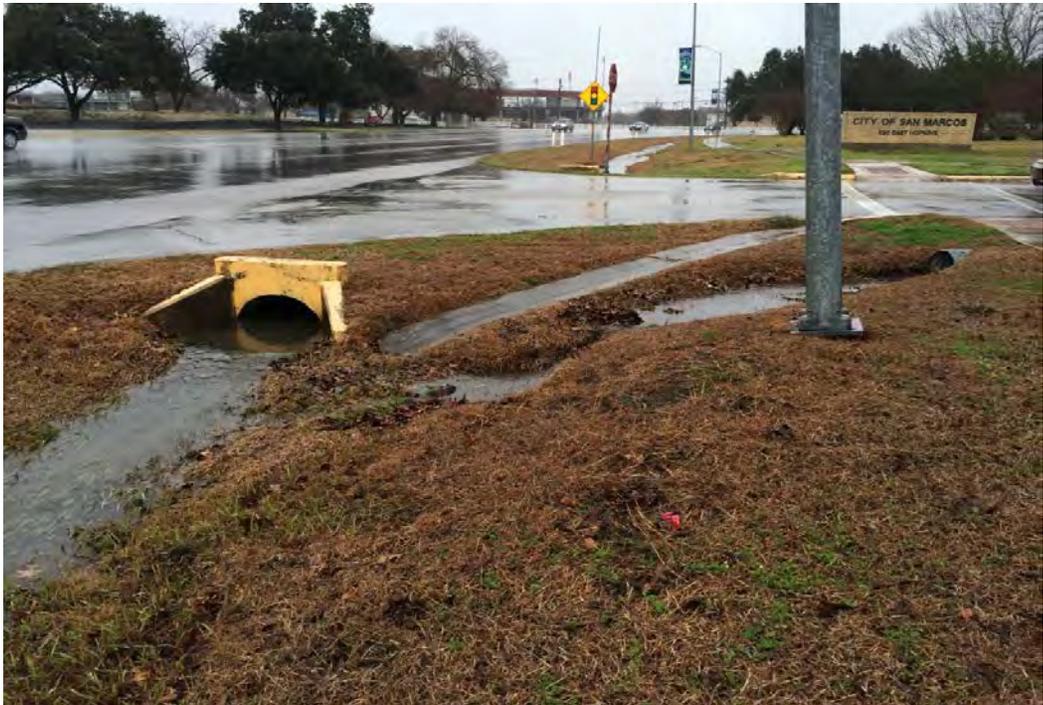
<i>P4</i>	<i>Looking NE towards the D/S side of the culvert at the W entrance to City Hall</i>
-----------	--

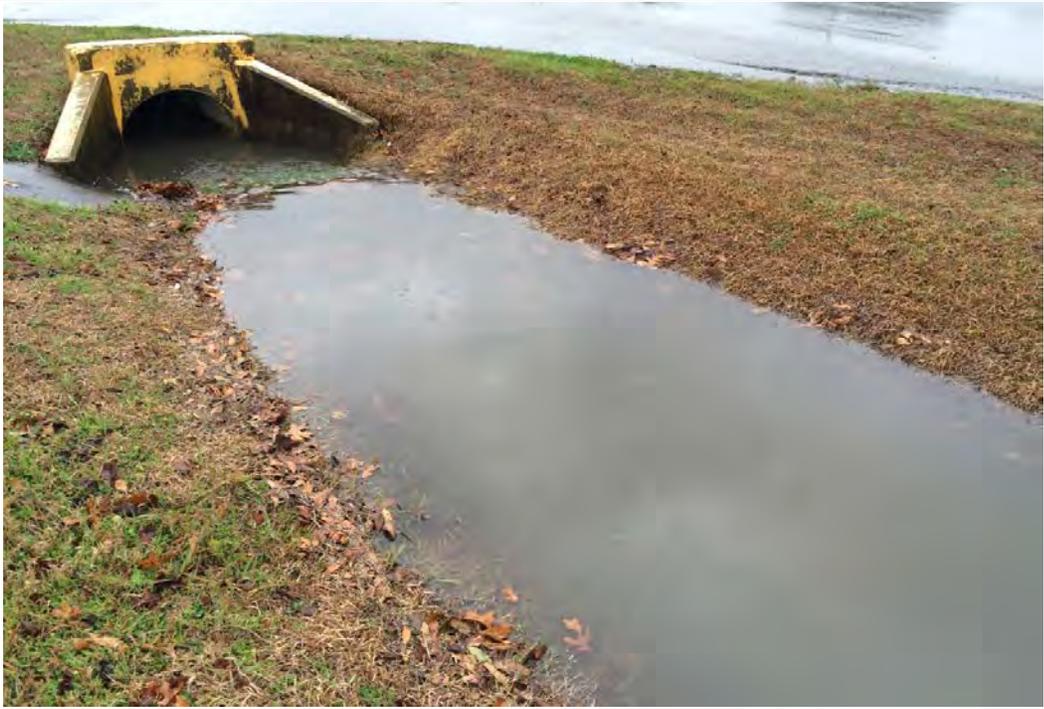
<i>P5</i>	<i>Looking W at U/S side of culvert at the W entrance to City Hall and the scour hole here</i>
-----------	--

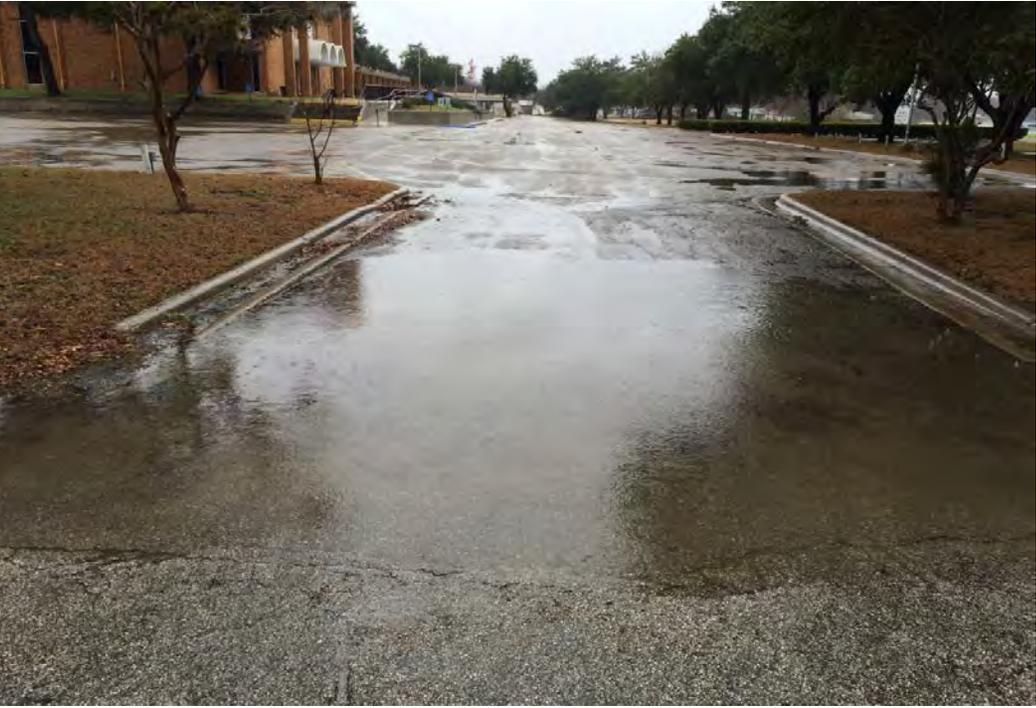
<i>P6</i>	<i>Looking W at the standing water in the side entrance to St. Johns Catholic Church</i>
-----------	--

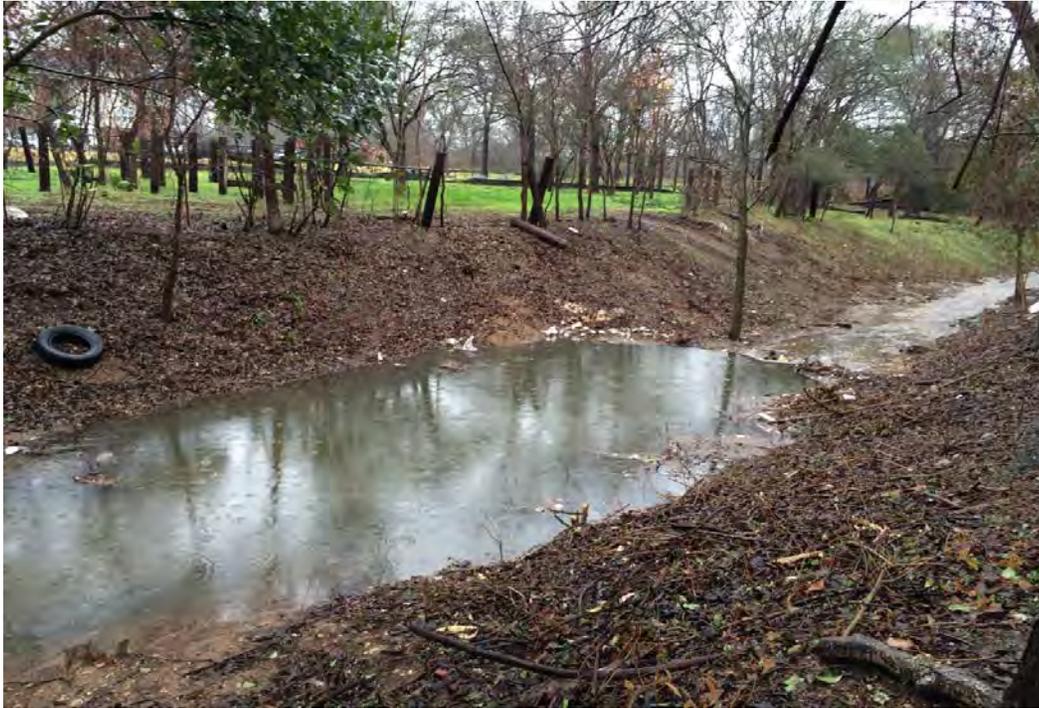
<i>P1</i>	<i>Drainage channel on N and E side of property, facing SE</i>
-----------	--

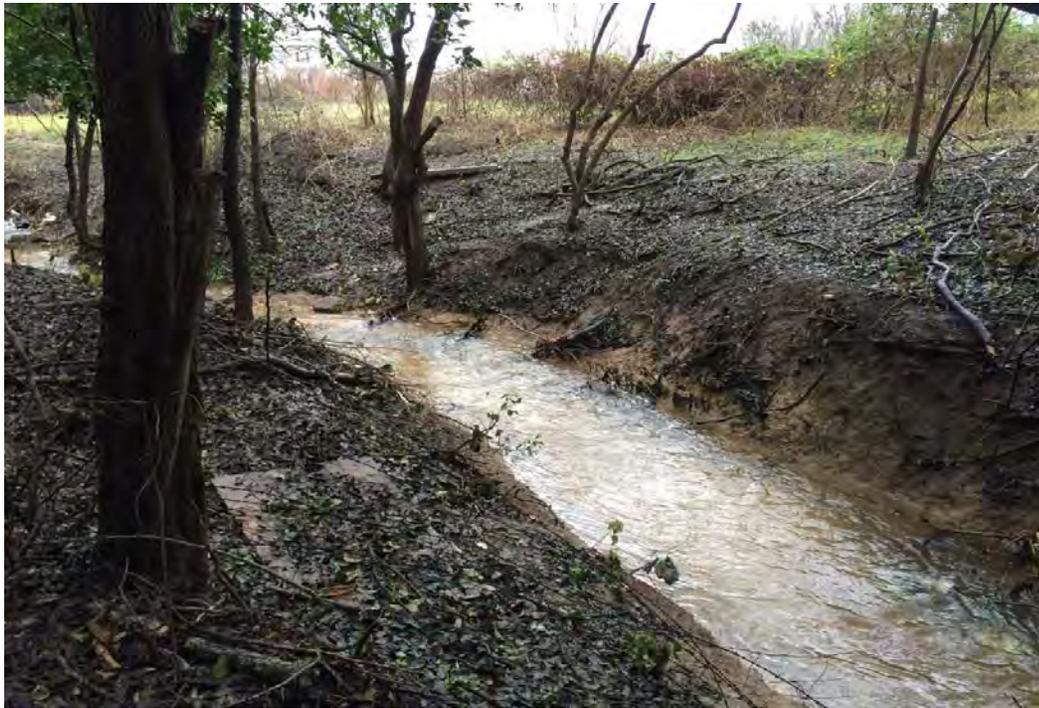
<i>P2</i>	<i>Drainage channel on N and E side of property, facing NW</i>
-----------	--

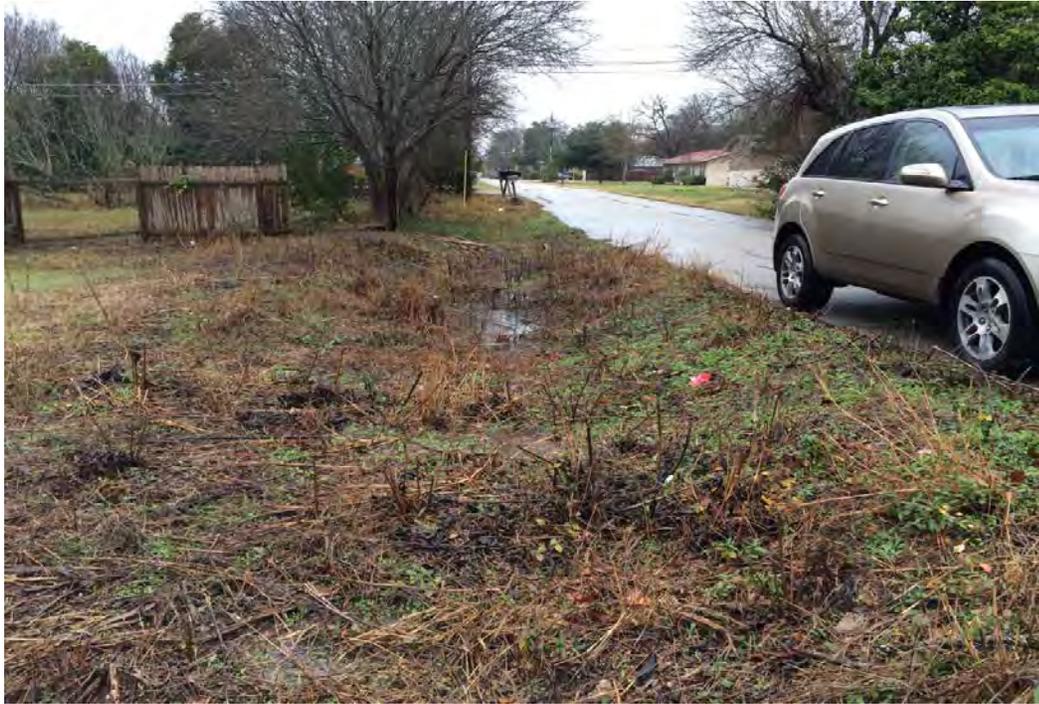
<i>P3</i>	<i>Drainage ditch along Pecan Street, facing S</i>
-----------	--

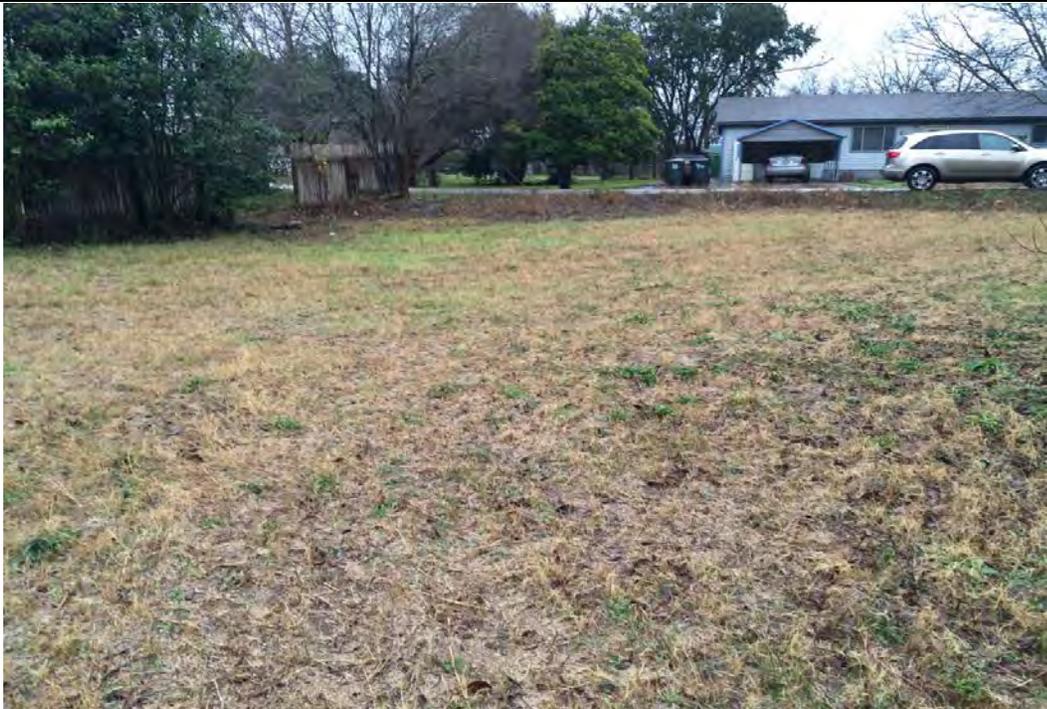
<i>P4</i>	<i>Grading on property, facing W towards Pecan St</i>
-----------	---

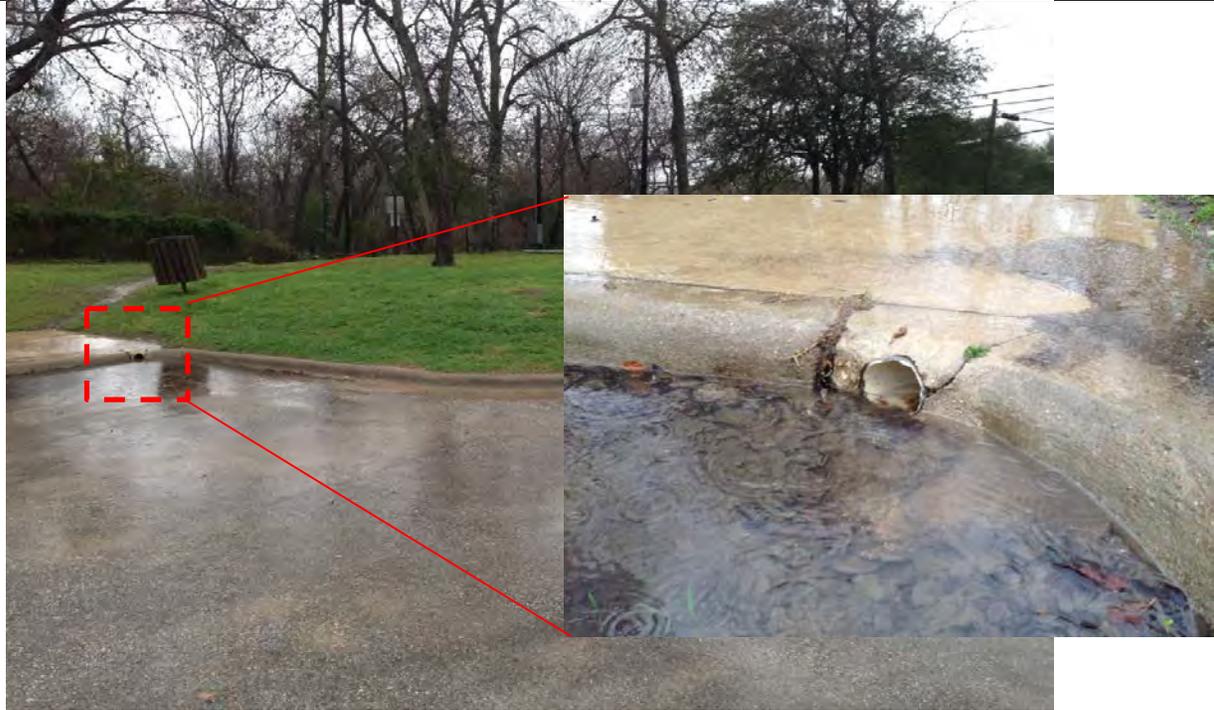
Cause of Flooding: *Parking lot floods during most storm events. 4" drainage pipe responsible for draining entire parking lot.*

P1	Looking NW at drainage pipe for parking lot and zoomed in view of pipe
----	--

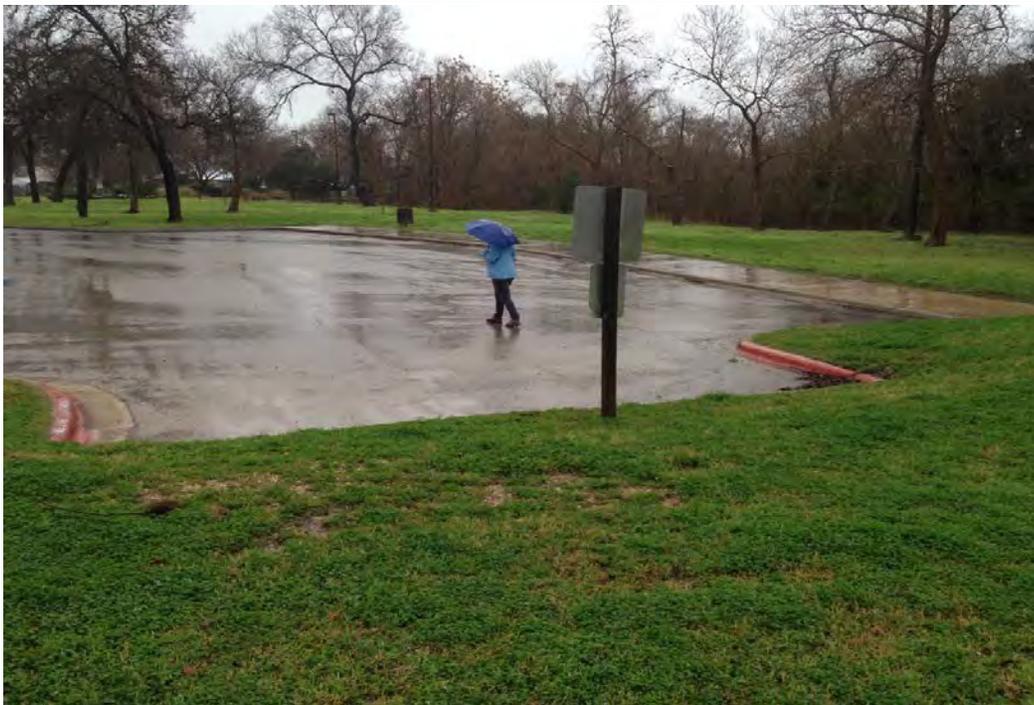
P2	Looking S at the parking lot from grassy area between lot and Cheatam Street
----	--

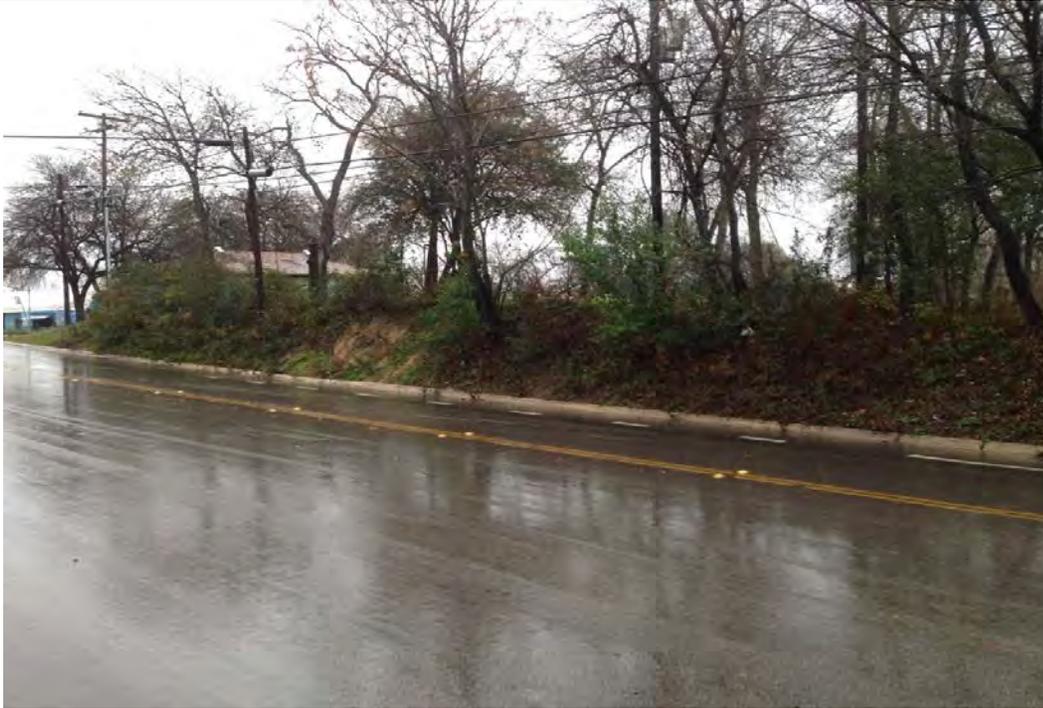
<i>P3</i>	<i>Looking S at grassy area and possible outlet locations from Cheatam Street</i>
-----------	---

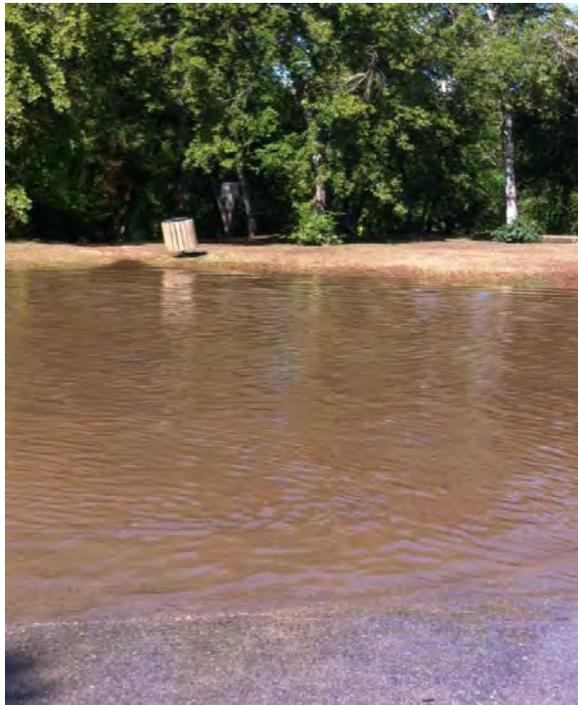
<i>P4</i>	<i>Looking W at parking lot while flooded</i>
-----------	---

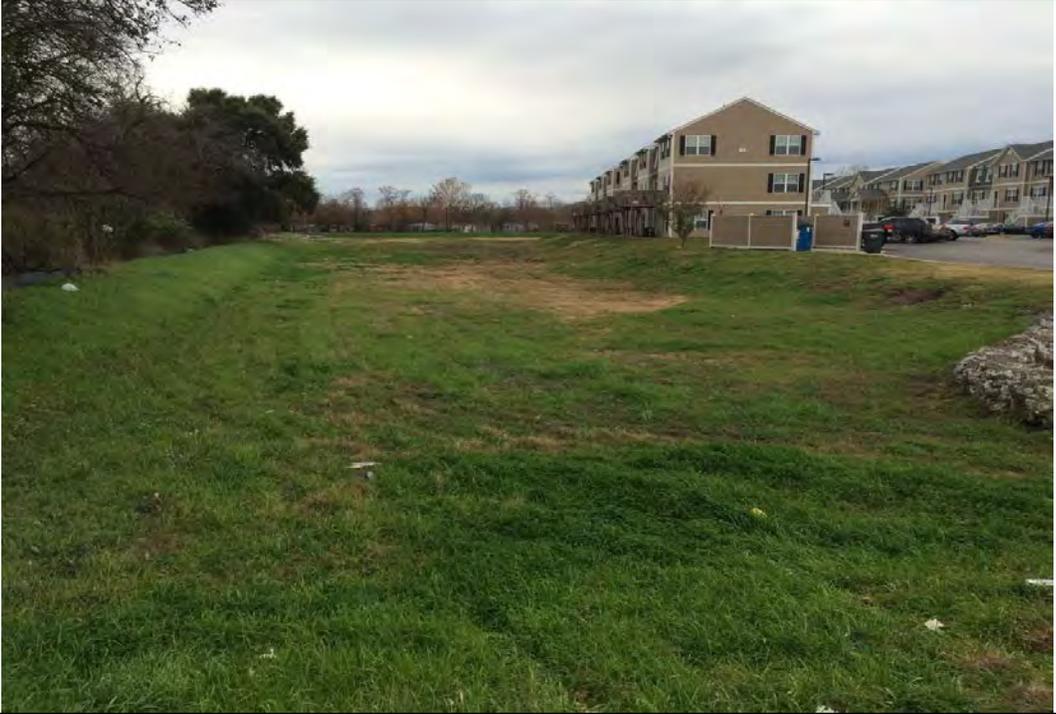
P1	<i>New apartment complex detention pond from Mill St looking east</i>
----	---

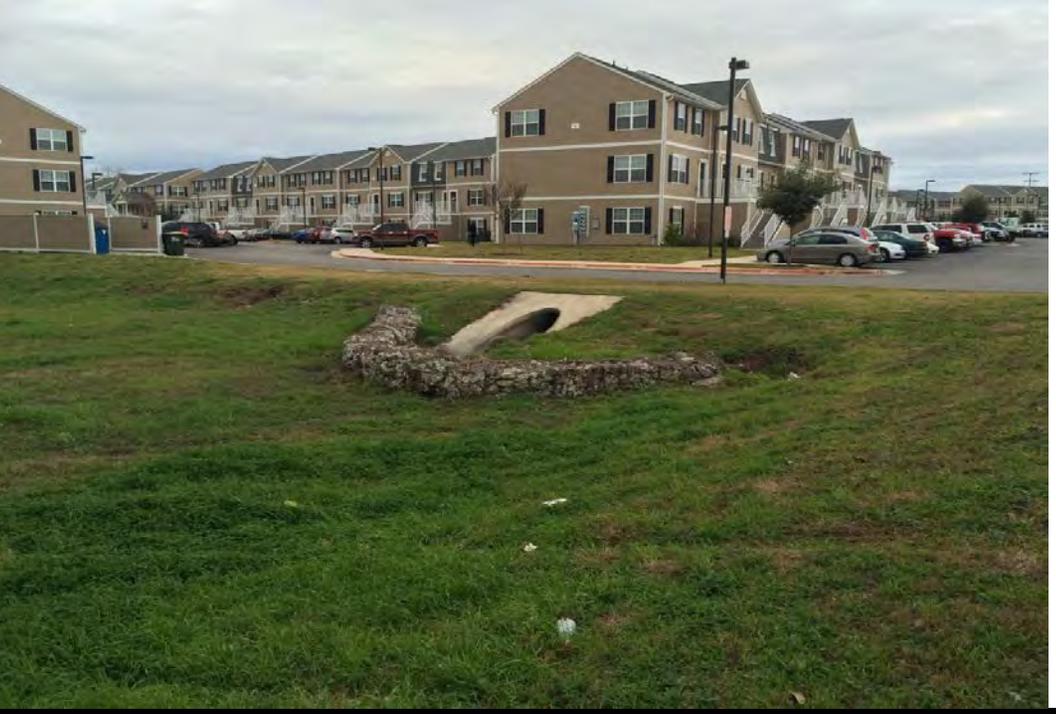
Cause of Flooding: Detention pond outfall is discharging directly onto adjacent property.

P2	<i>Outlet on the northeast side of the detention pond</i>
----	---

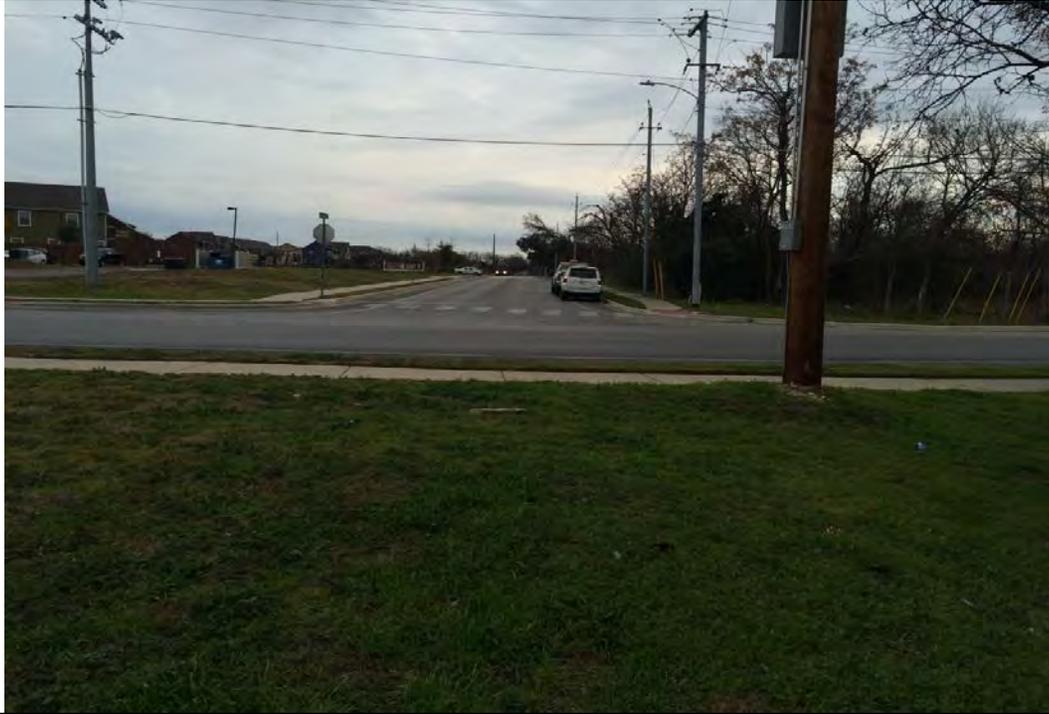
<i>P3</i>	<i>Photo from detention pond looking northeast towards Telluride Street and Mill Street</i>
-----------	---

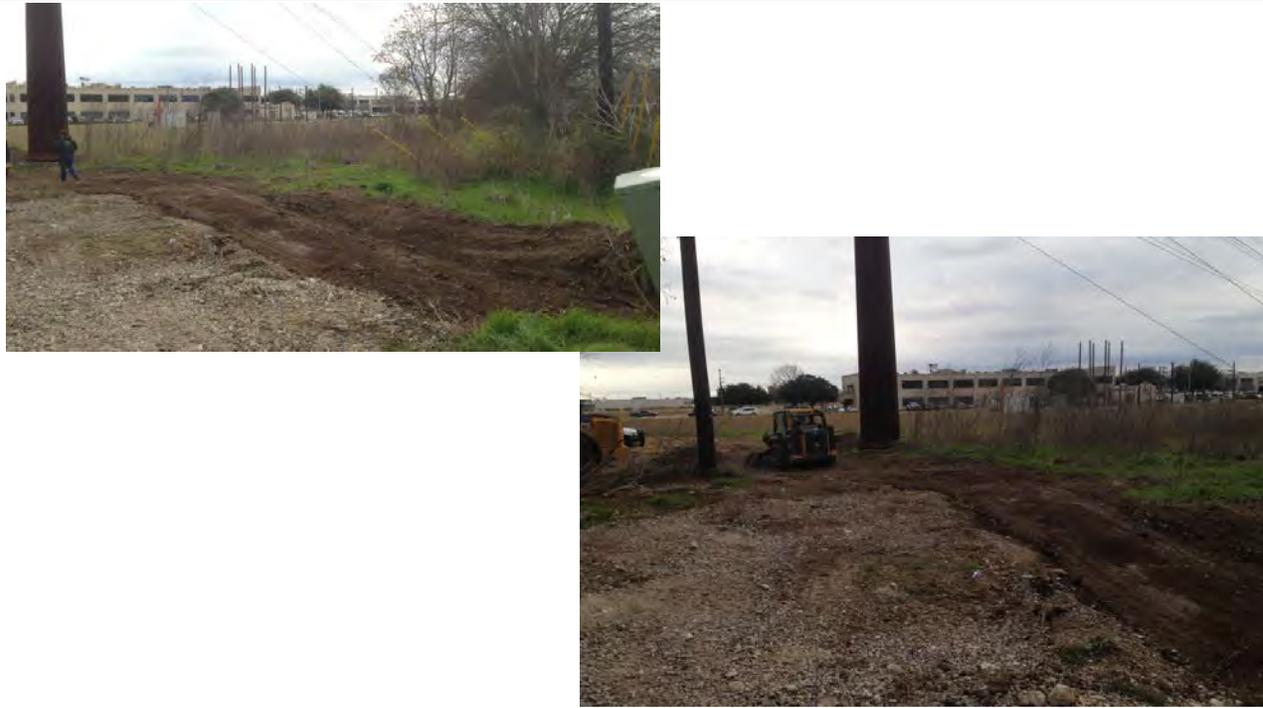
P1	<i>End of existing channel and adjacent property where channel extension would go</i>
----	---

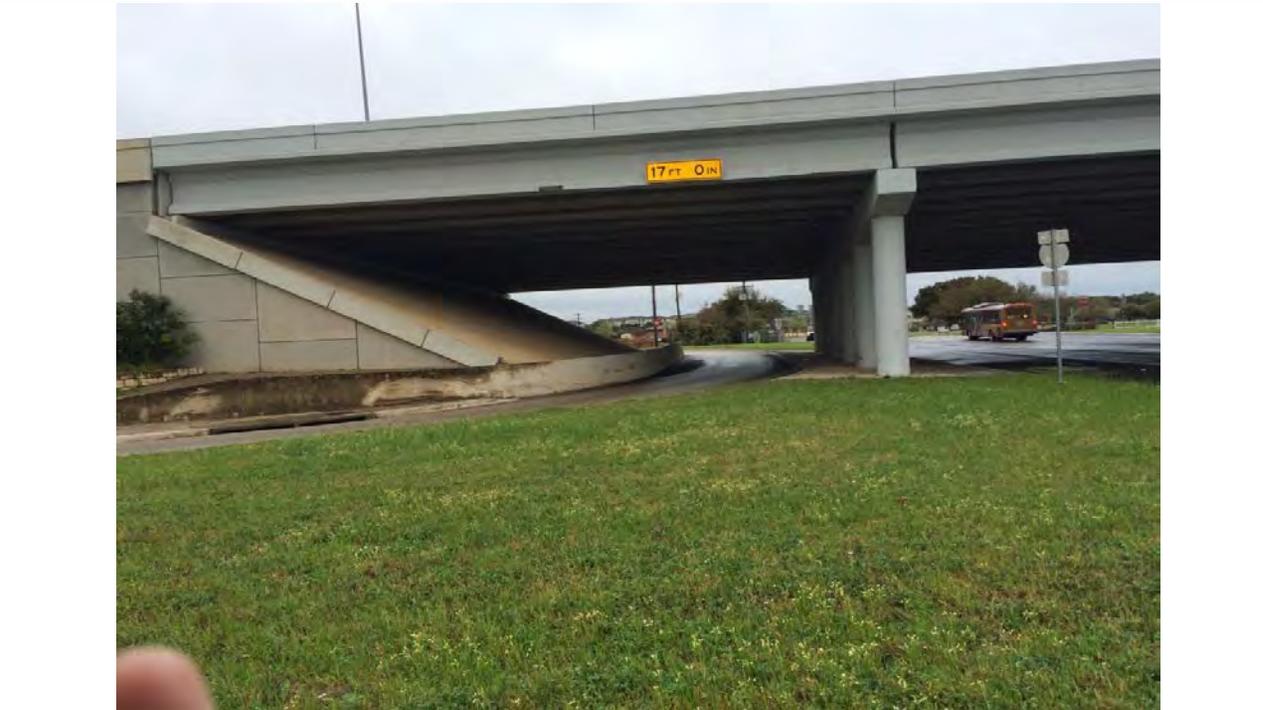
P2	<i>Looking NW up River Ridge Dr at IH-35 intersection</i>
----	---

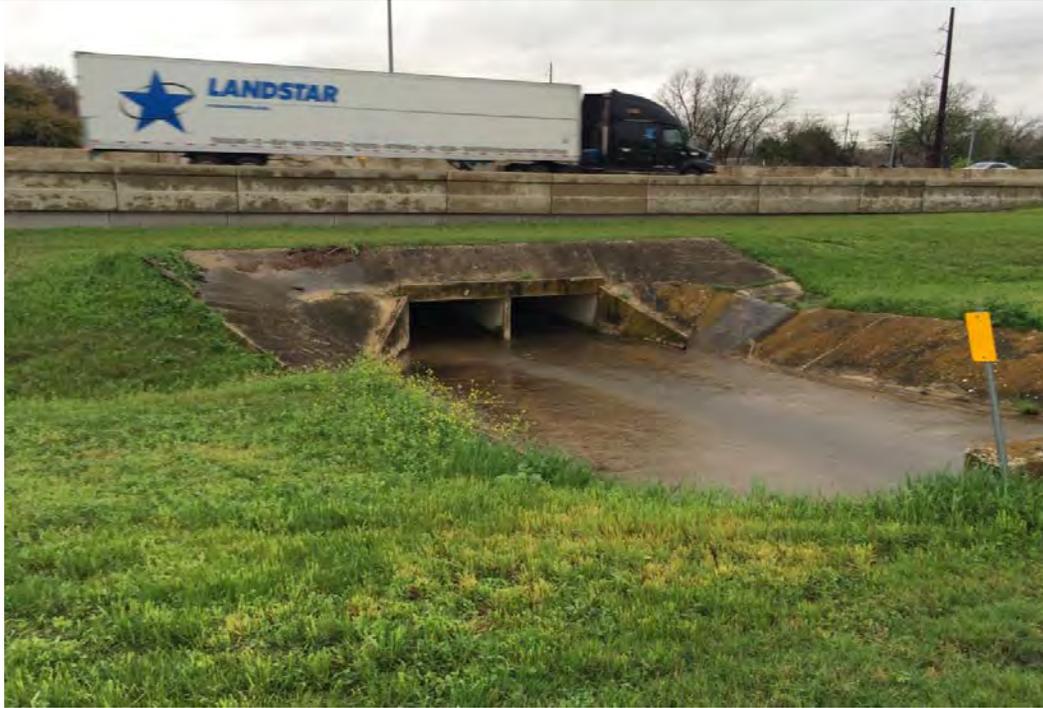
P3	<i>Looking SE at existing culvert under IH-35 intersection, S of River Ridge Pkwy</i>
----	---

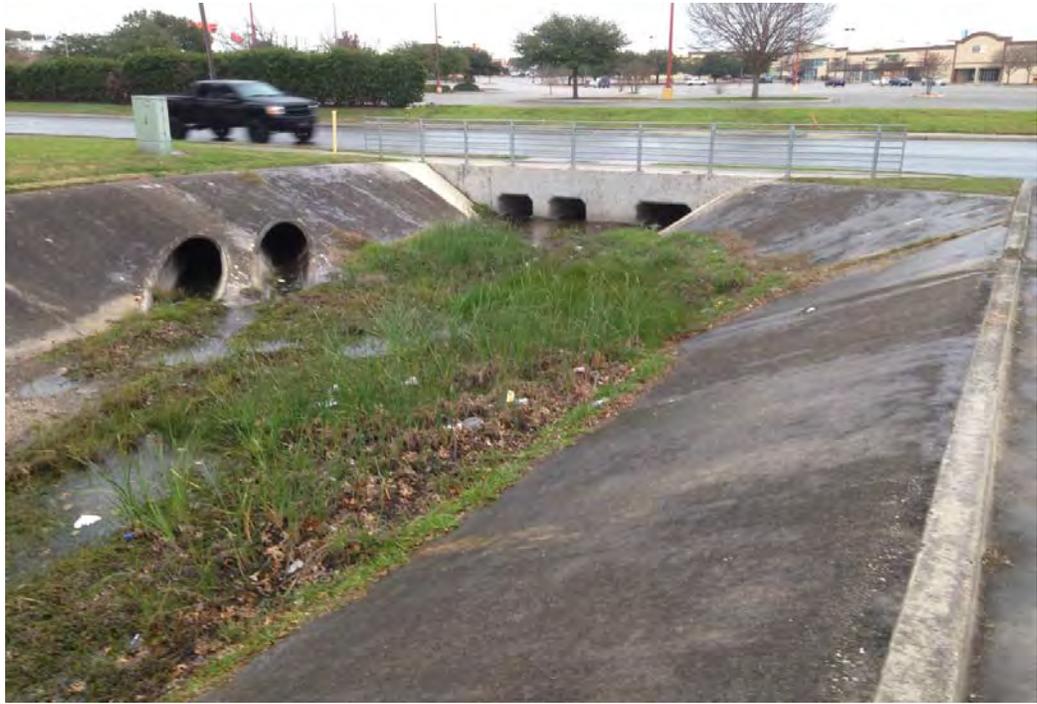
P1	<i>Looking N at water flowing at intersection of Hughson Drive and Manor Park Road</i>
----	--

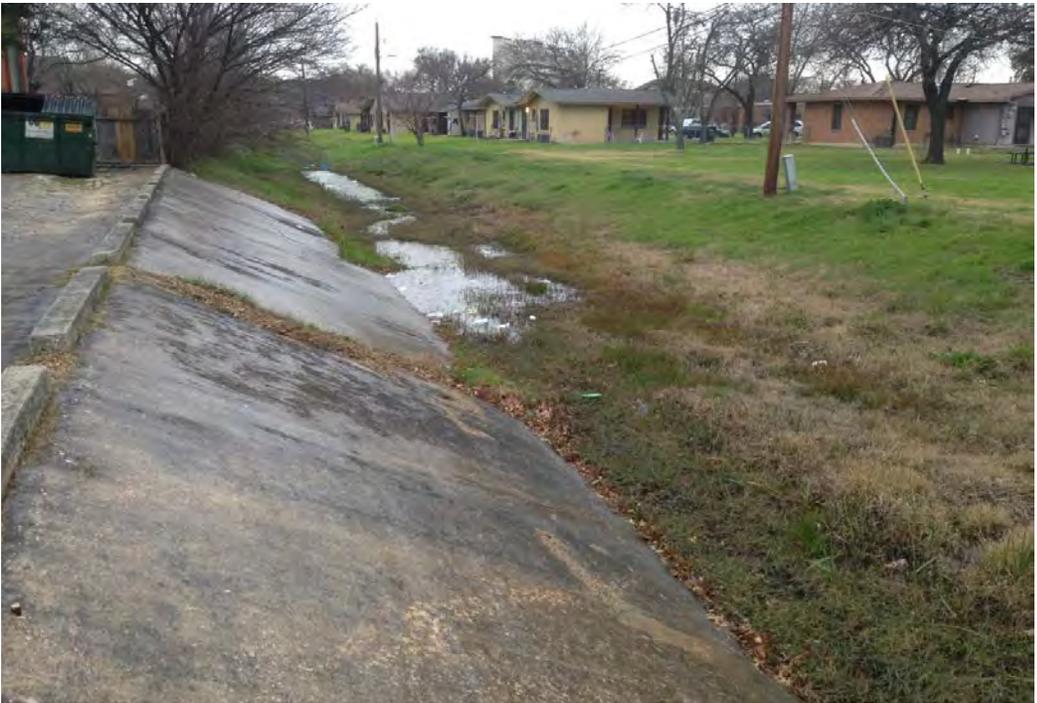
P2	<i>Looking NW towards 402 Hughson Drive and the flow coming from Manor Park Road</i>
----	--

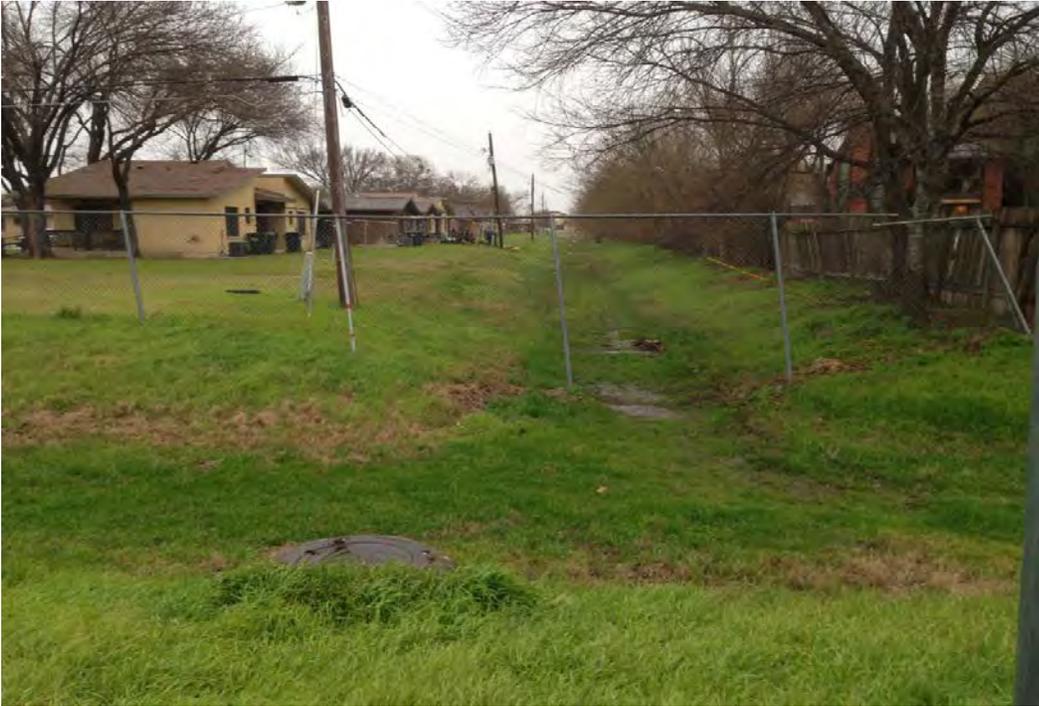
<i>P3</i>	<i>Looking E up Manor Park Road</i>
-----------	-------------------------------------

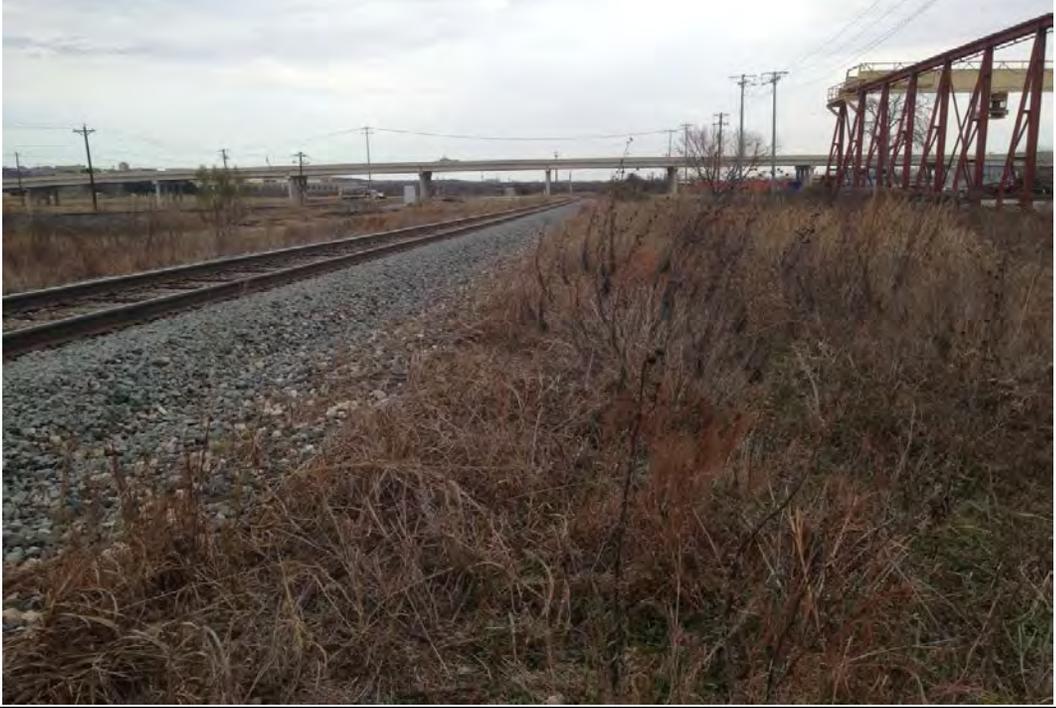
Cause of Flooding: *Ditches along railroad track are poorly maintained and impeded flow. Tracks act as a dam with limited culverts along the corridor.*

P1	<i>Overgrown ditches along RR tracks</i>
----	--

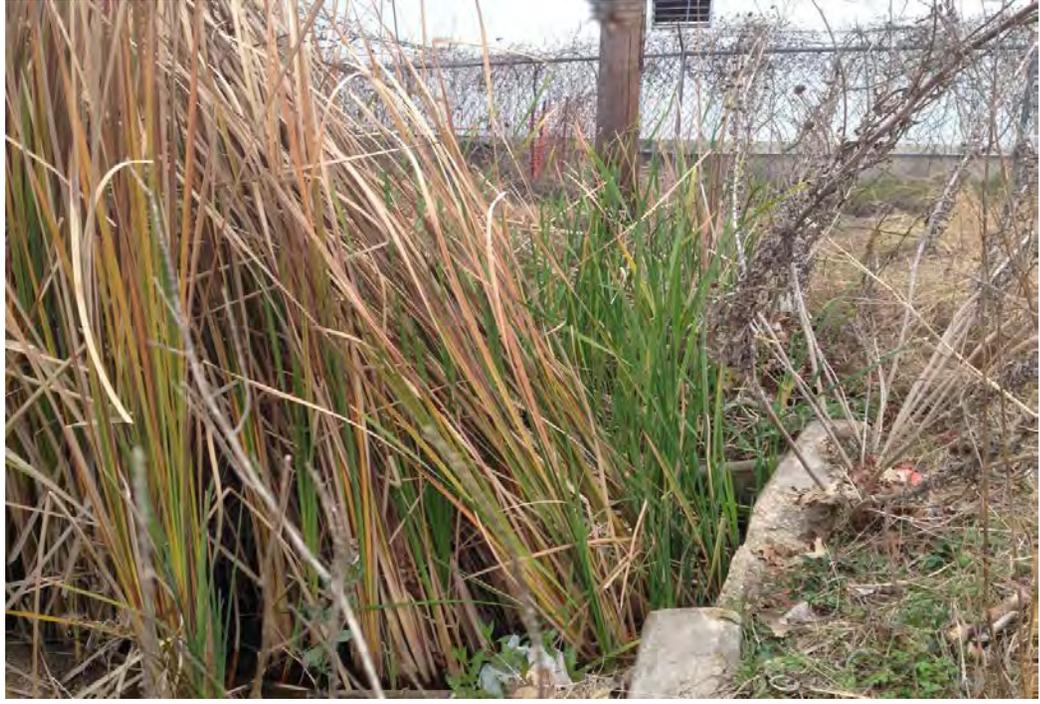
P2	<i>Culvert blocked with vegetation in ditch adjacent to RR tracks</i>
----	---
