Field Assessment Report (Hot Spots)

Site No.: 1 Location: 700 Blk McKie St (Willow Springs Creek)

San Marcos Comprehensive Watershed Master Plan
Field Assessment Form - Local Flood Complaints

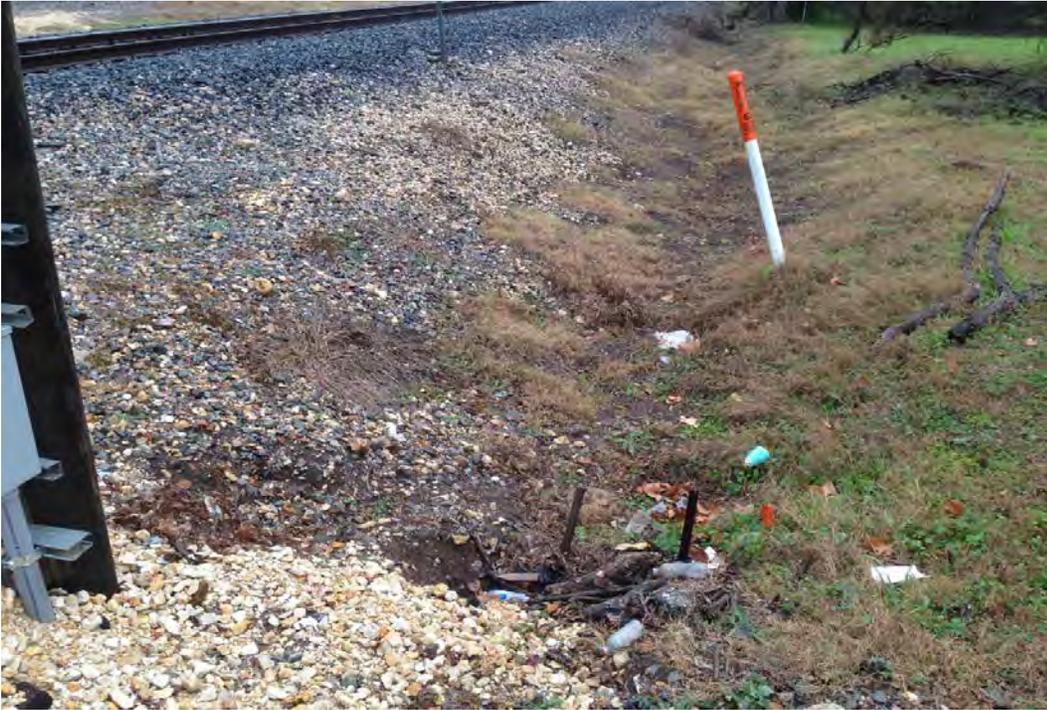
P3	<i>Ditch along RR tracks with blocked culvert inlet</i>
----	---

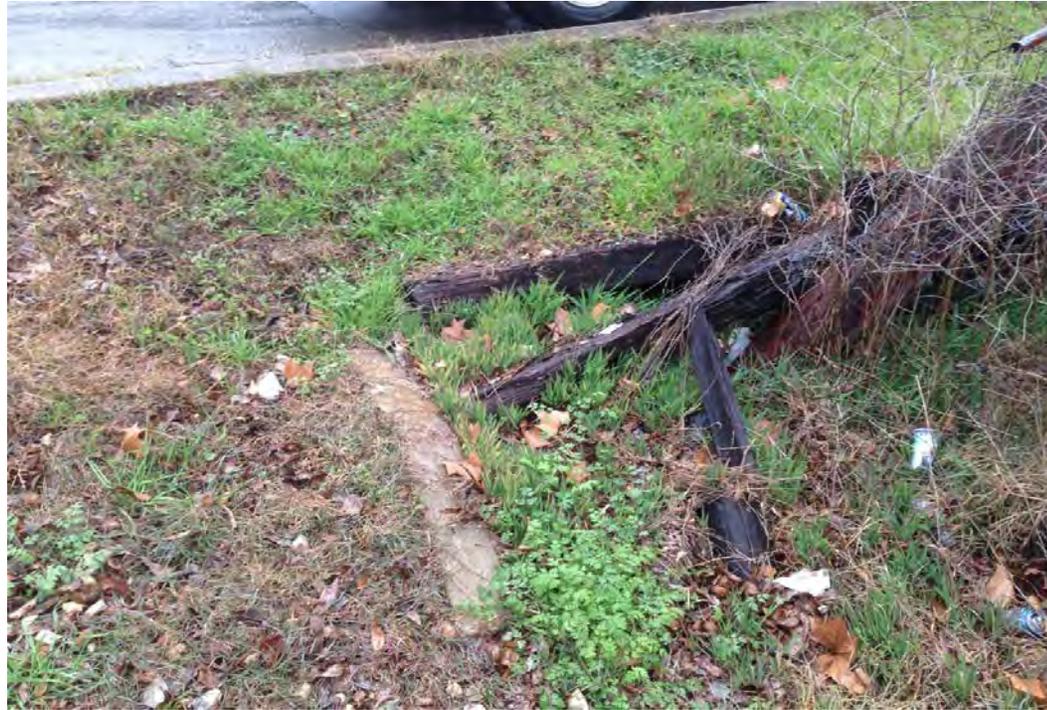
P4	<i>Blocked culvert outlet in ditch along RR tracks</i>
----	--

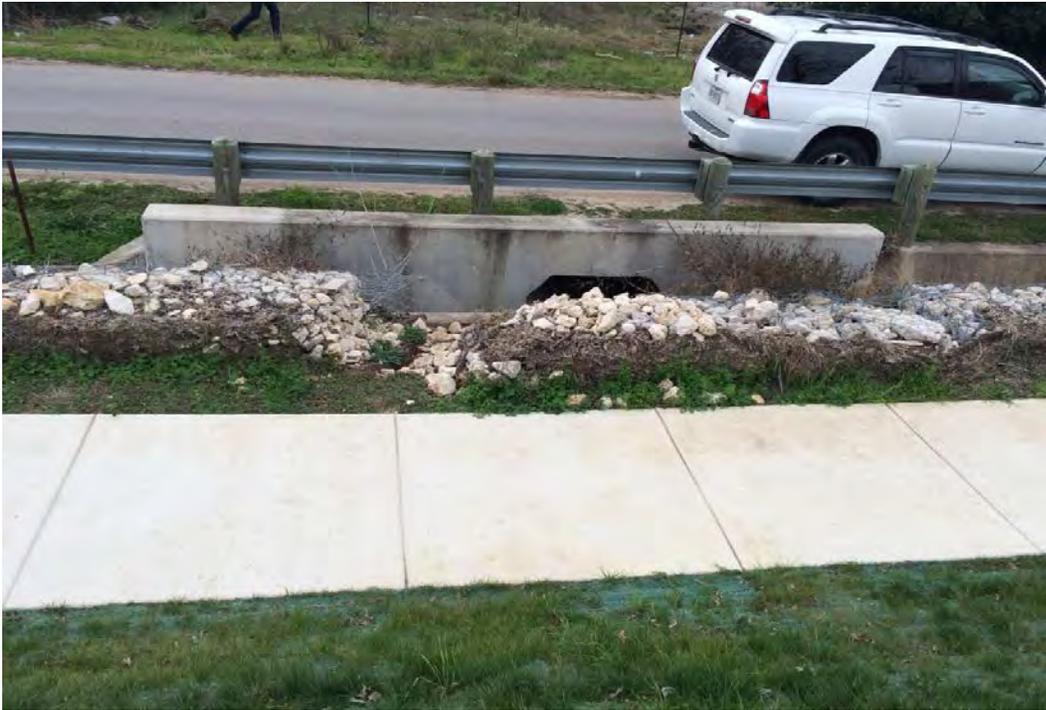
P1	<i>Looking SW towards culvert inlet with rock gabions surrounding it</i>
----	--

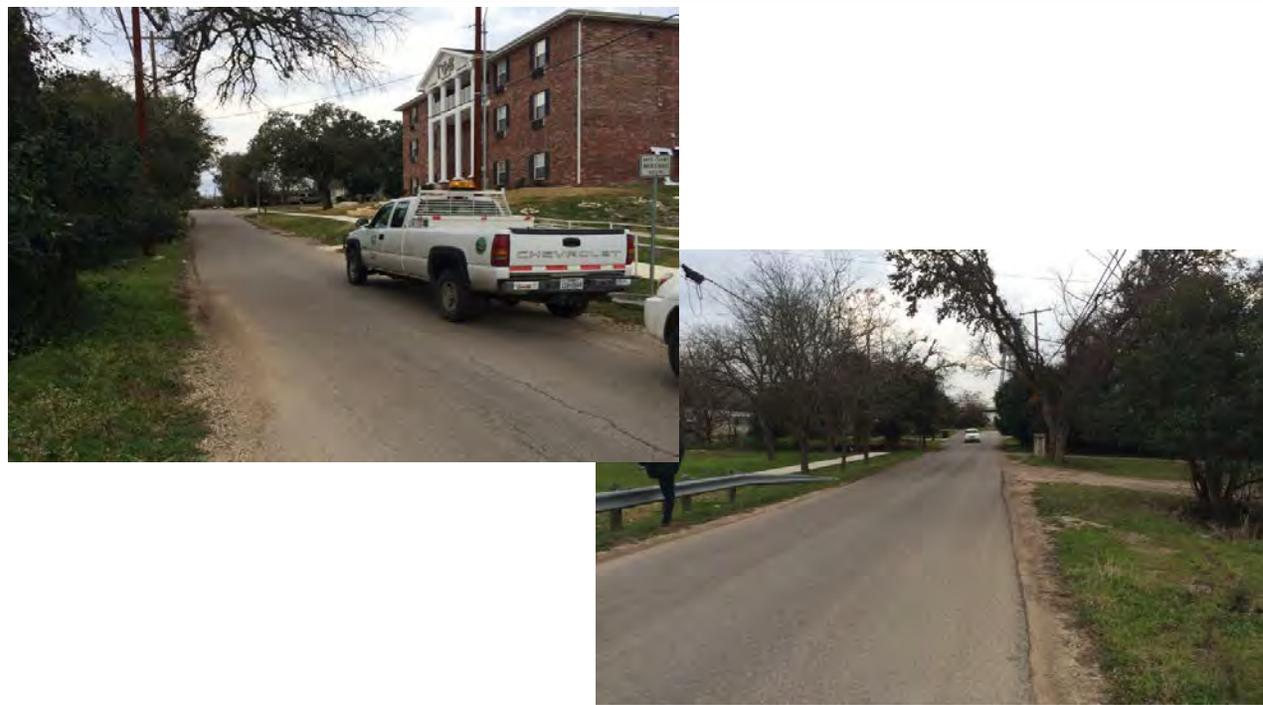
Cause of Flooding: Low water crossing and undersized culvert

P2	<i>Looking NW and SE from low point on Spring Road</i>
----	--

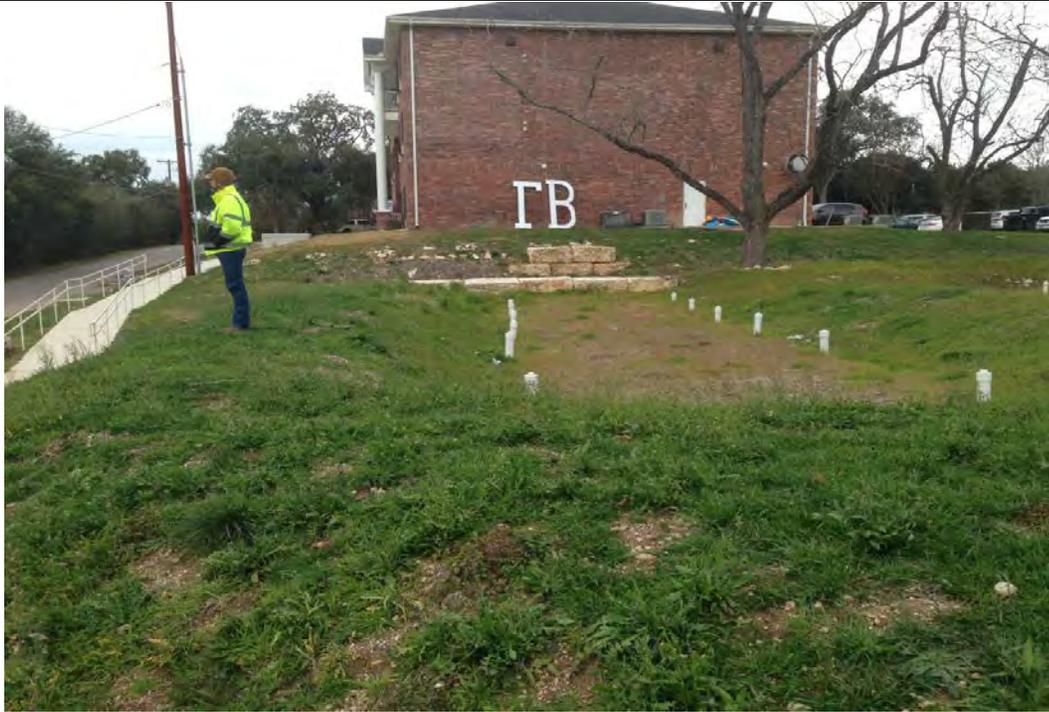
P3	Looking NW at the sorority house w/ bioremediation pond on right and Spring Rd on left
----	--

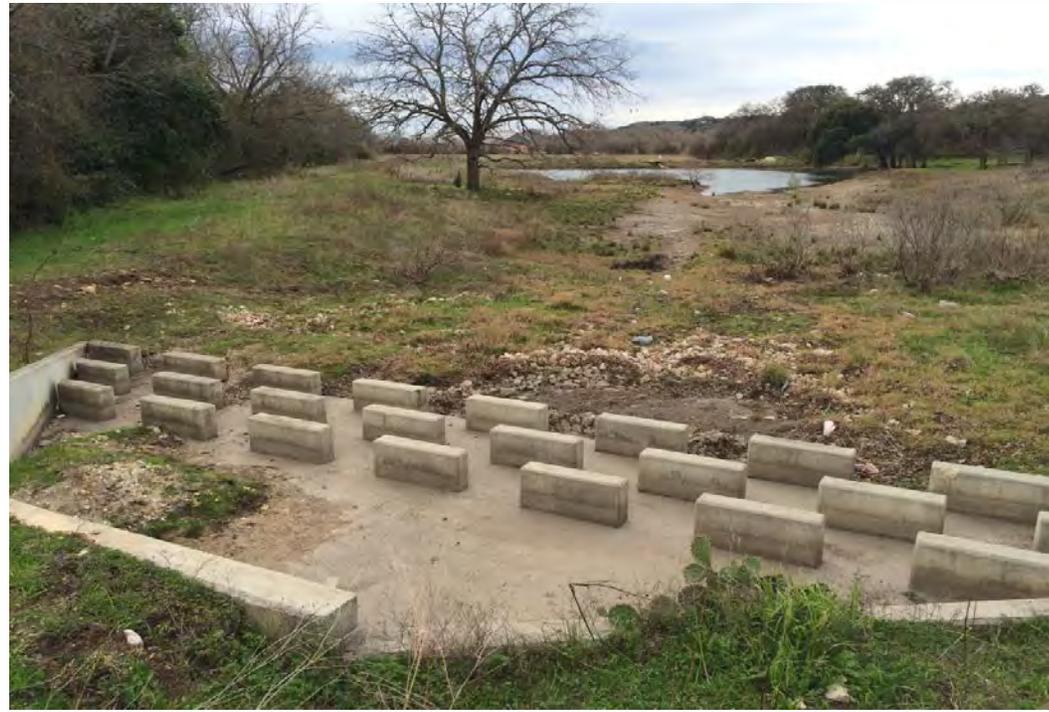
P4	Looking SW towards outfall structure and detention pond
----	---

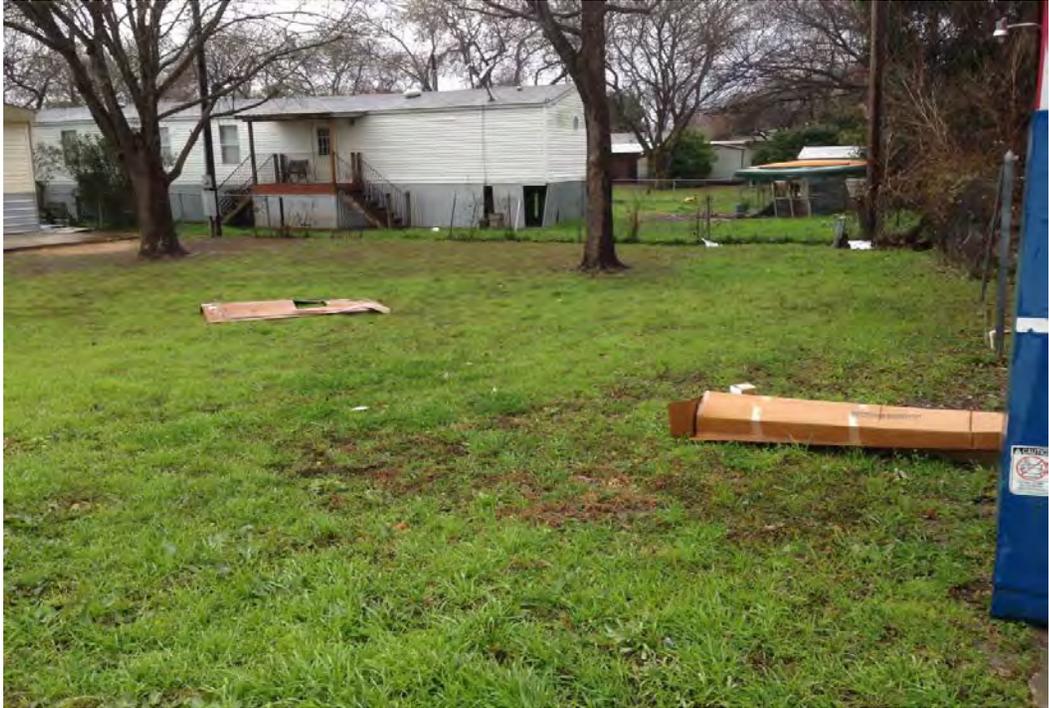
Cause of Flooding: Water ponding on propoerty; property is low point in neighborhood; driveways are level with the ground and do not have a 6" rise at the curb.

P1	Looking NW at lots from River Road
----	------------------------------------

Notes: Repair existing curb and raise driveways in ROW to curb height; owners should consider raising their homes and/or regrading their lots to encourage flow to drain off their lots.

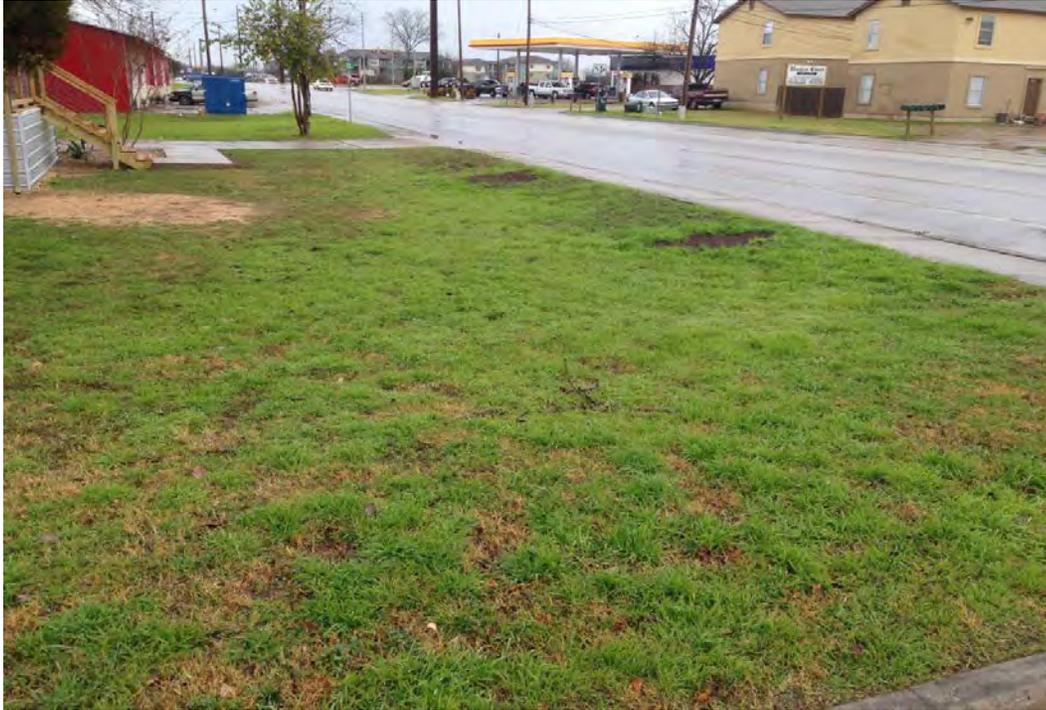
<i>P3</i>	<i>Looking NE at grading on lot from intersection of Harper Drive and River Road</i>
-----------	--

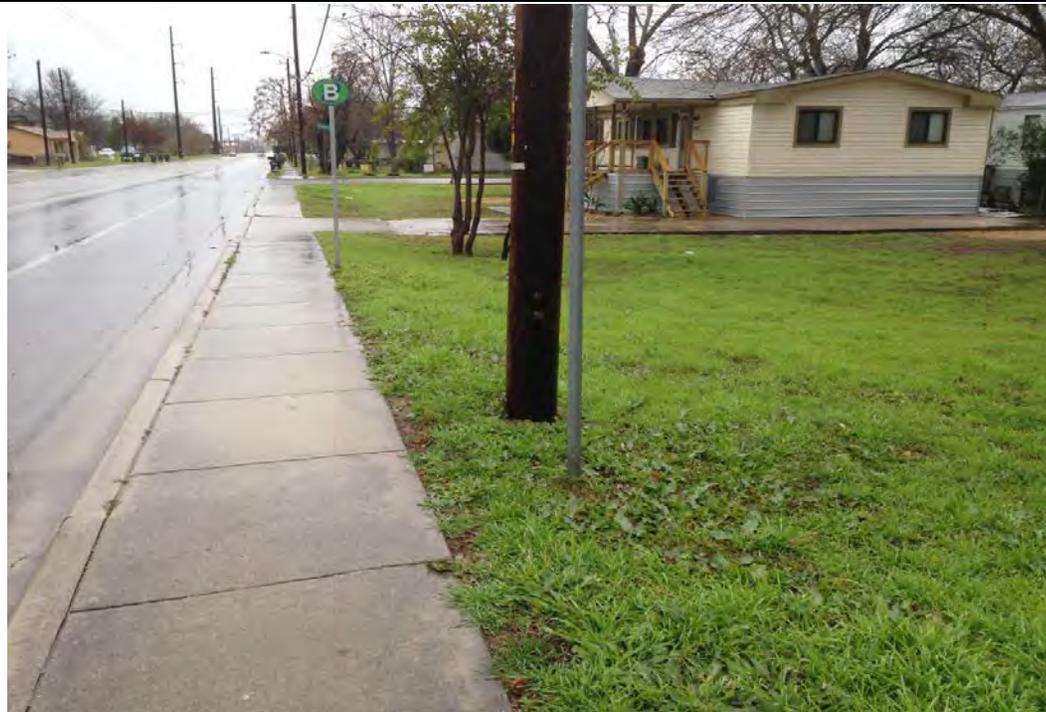
<i>P4</i>	<i>Looking SW at grading on lot at 1443 Harper Drive from River Road</i>
-----------	--

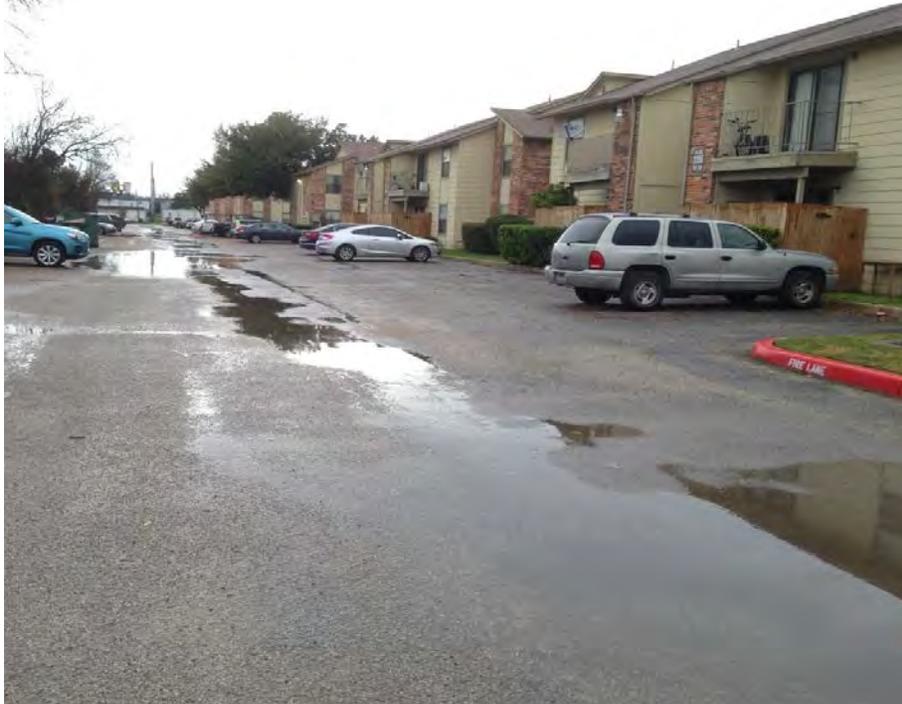
Cause of Flooding: Apartment complex has experienced flooding. Complex is located within the 100-yr floodplain of the Blanco River.

P1 *Looking NW from S corner of apartment complex towards Linda Drive*

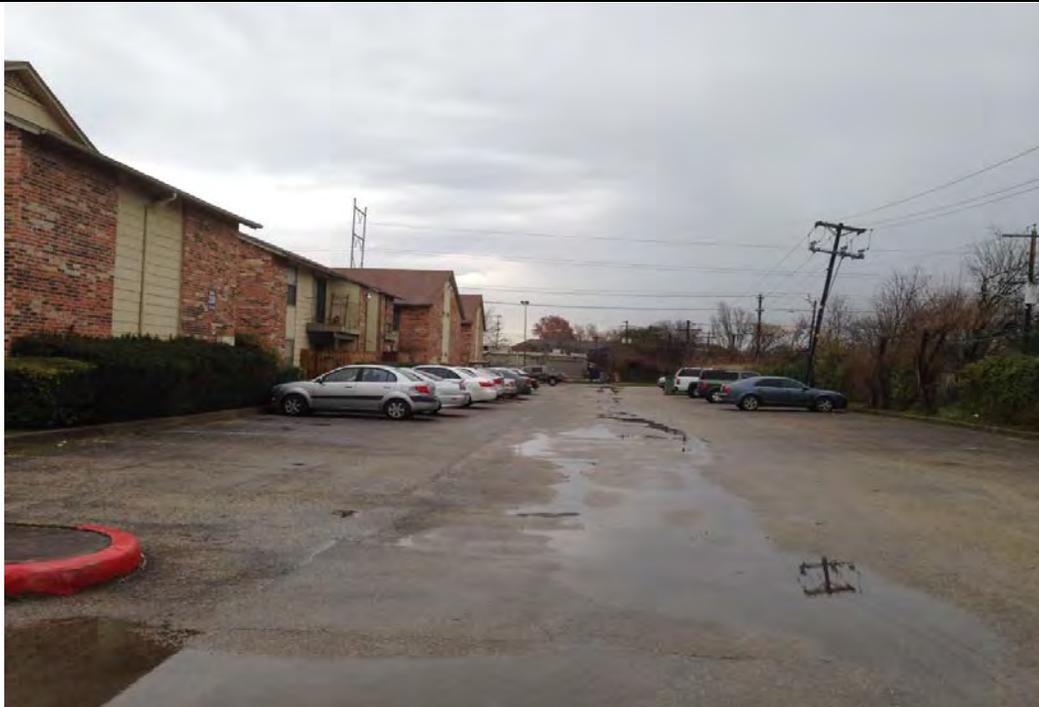
P2 *Looking NE from S corner of apartment complex towards E corner of apartment complex*

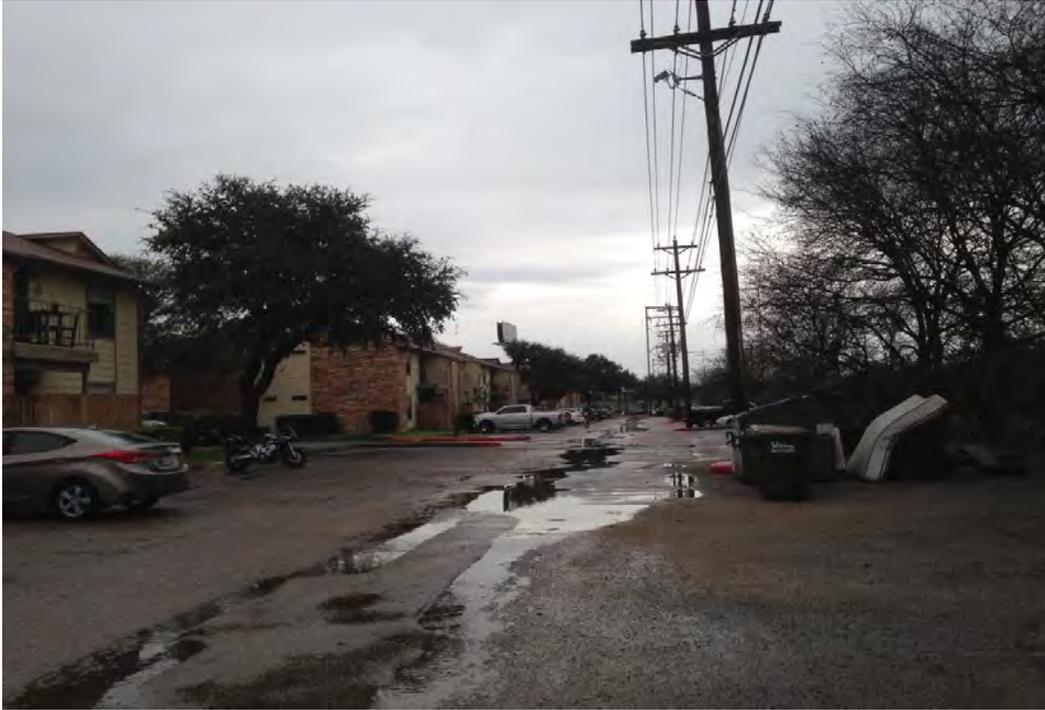
P3	Looking NW from E corner of apartment complex towards Linda Drive
----	---

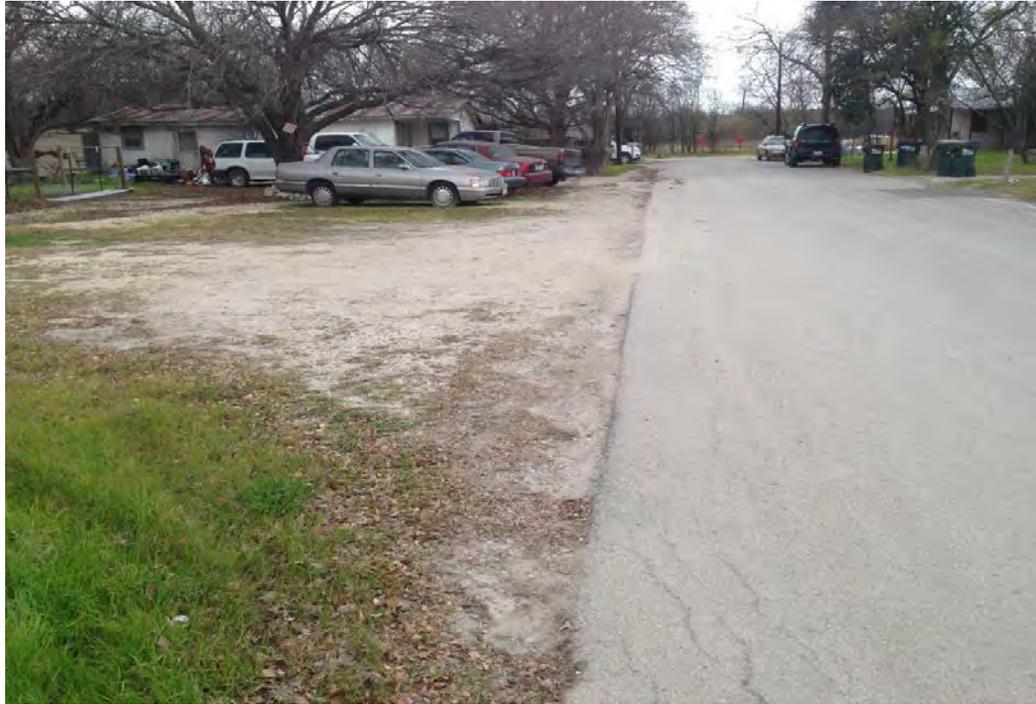
Cause of Flooding: Water frequently ponds at end of Kingswood Street; there is no outfall for runoff.

P1 *Looking NW on Kingswoods St at edge of pavement and grading of properties*

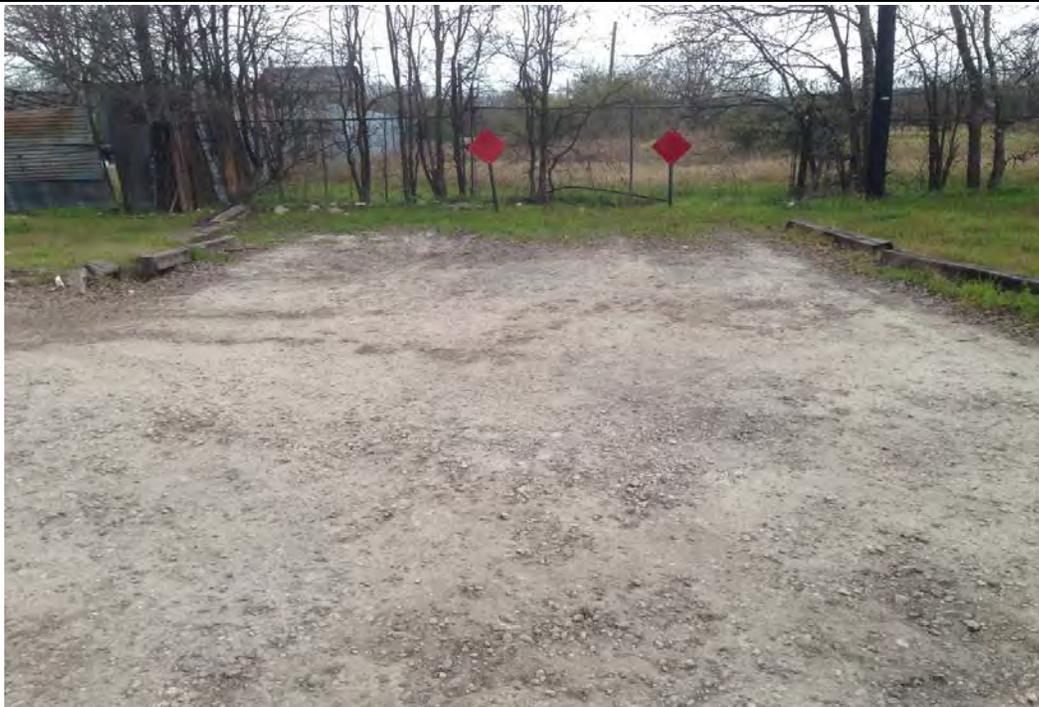
P2 *Looking NW at end of Kingswood St*

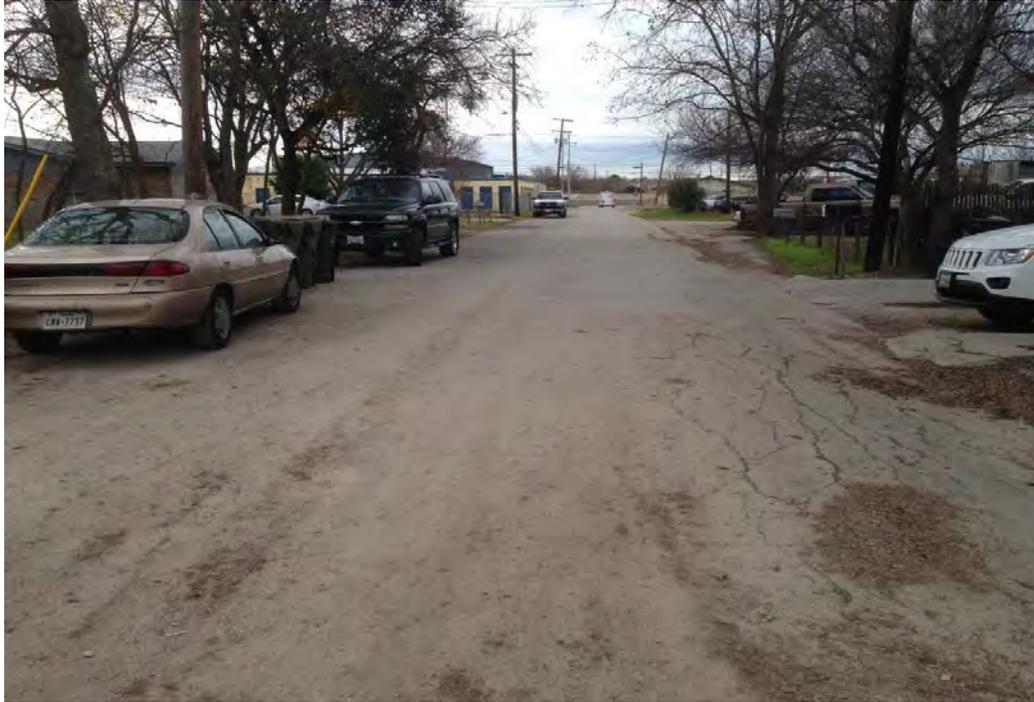
P3 *Looking SE from end of Kingswood St towards I-35*

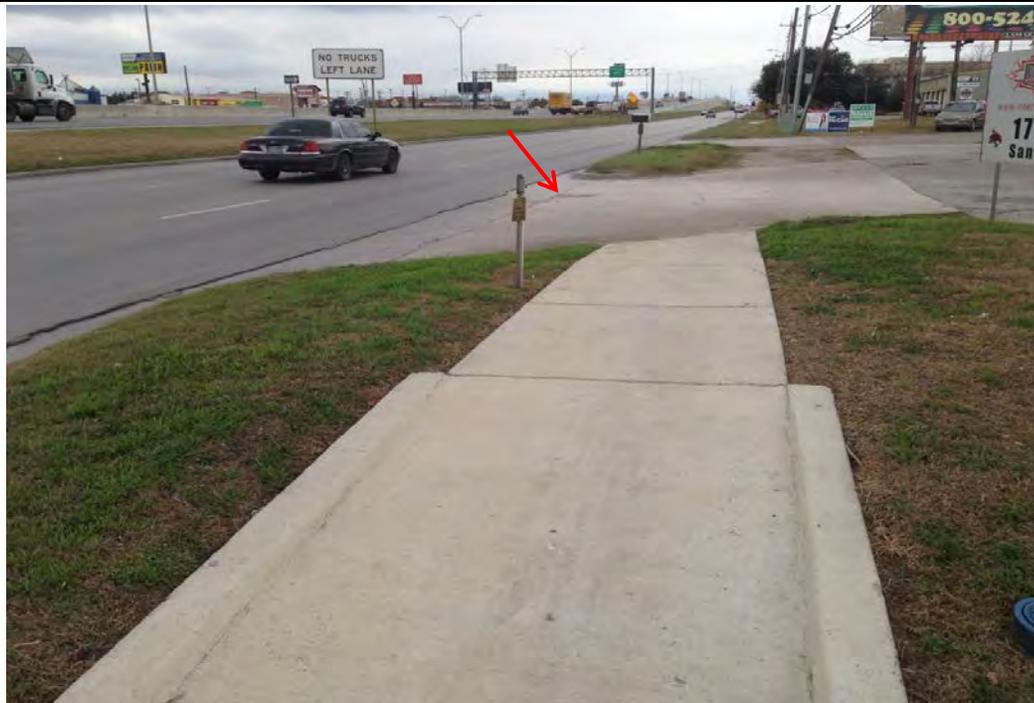
P4 *Looking SW at I-35 and Kingswood St towards shallow stormwater inlet*

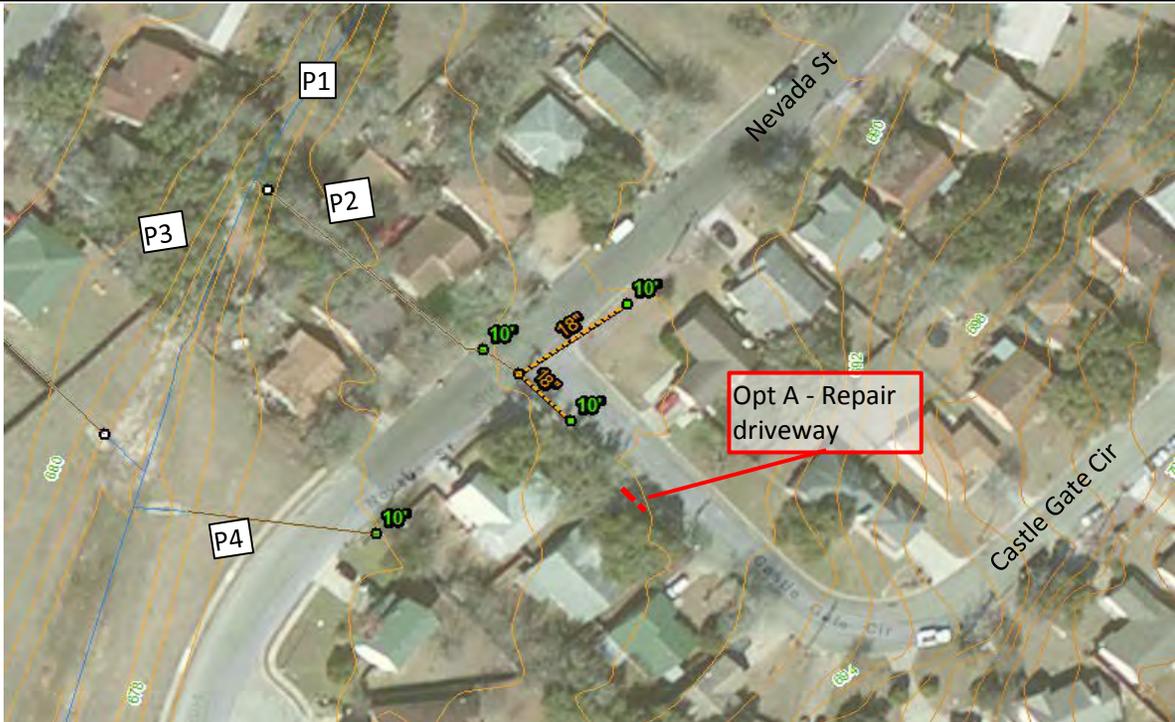
Cause of Flooding: Water flows onto lots from Castle Gate Circle.

Notes: Repair and adjust driveway at 2027 Castle Gate Circle to redirect flow to stormdrain inlet.

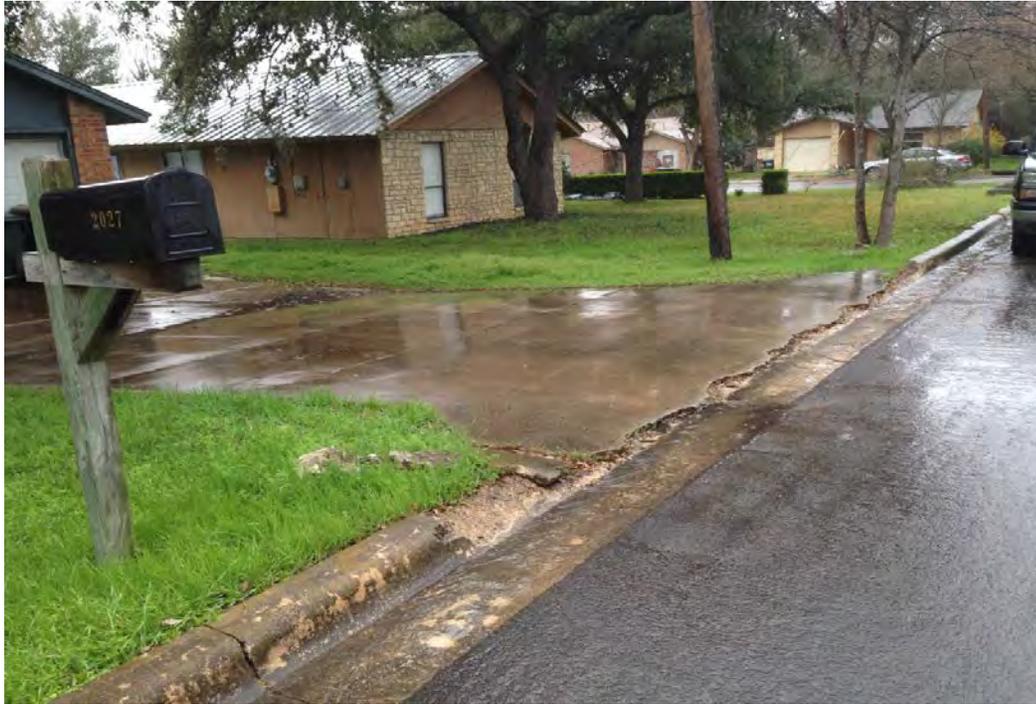
P1	Looking NW from 2027 Castle Gate Cir towards Nevada St and 2029 Castle Gate Cir
----	---

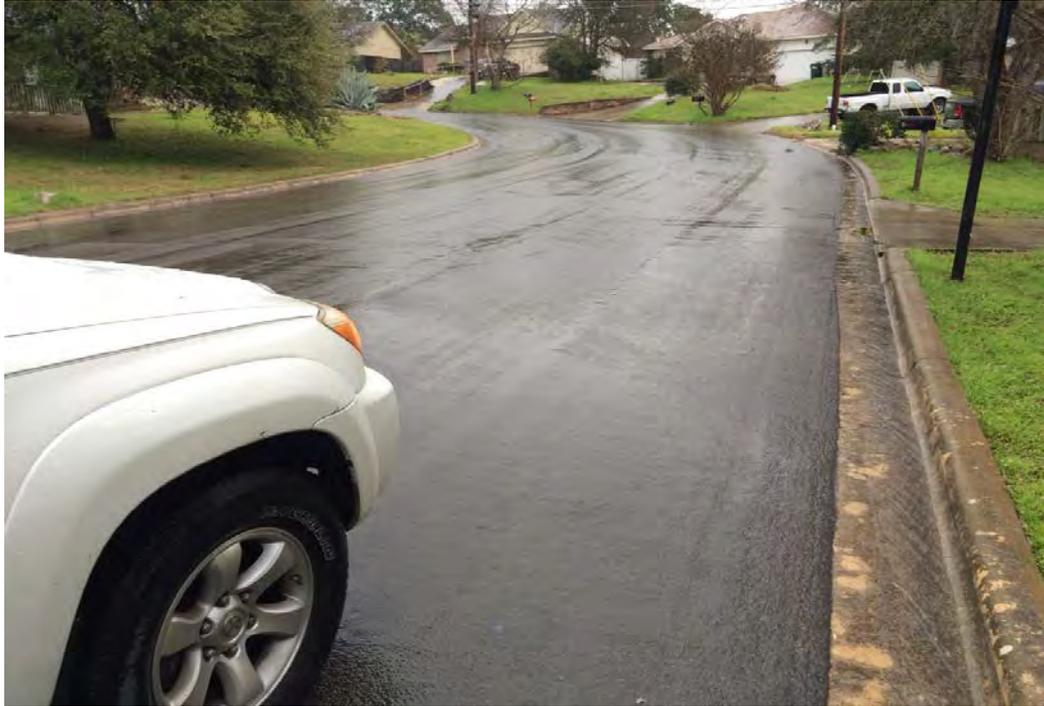
<i>P3</i>	<i>Looking SE from 2027 Castle Gate Cir at grading of street</i>
-----------	--

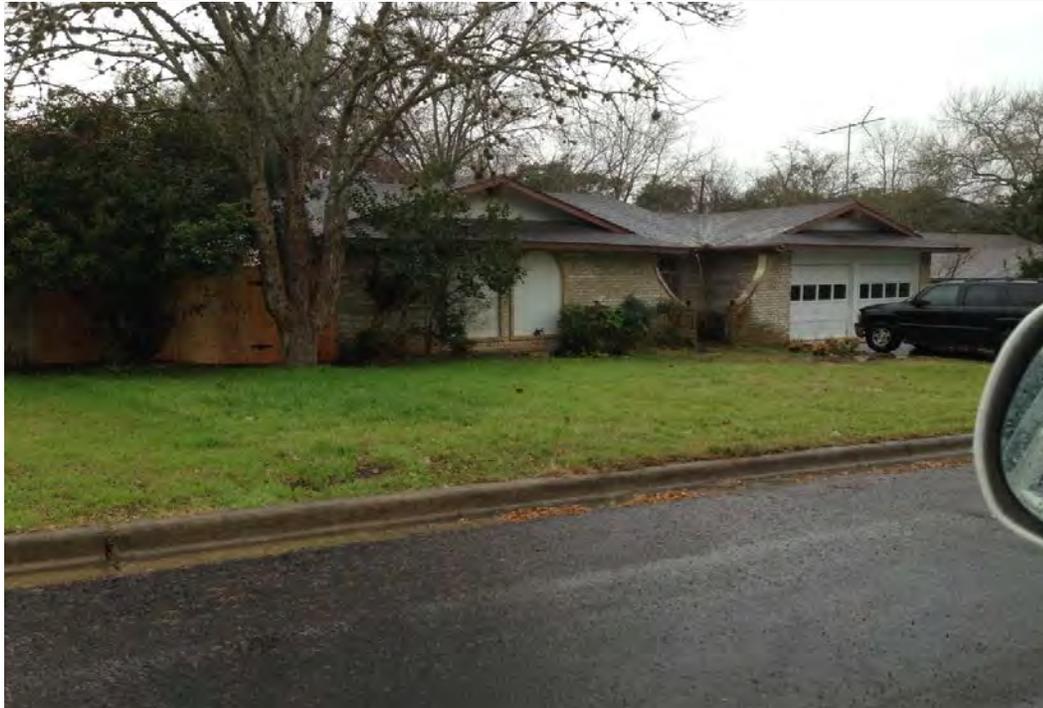
P1 Looking S ta 129 Chaparral Street

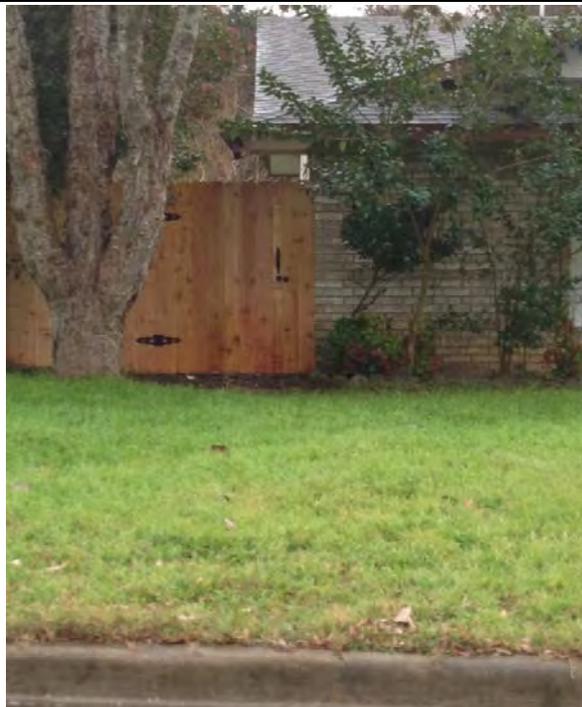
P2 Looking S at E side of property at 129 Chaparral Street

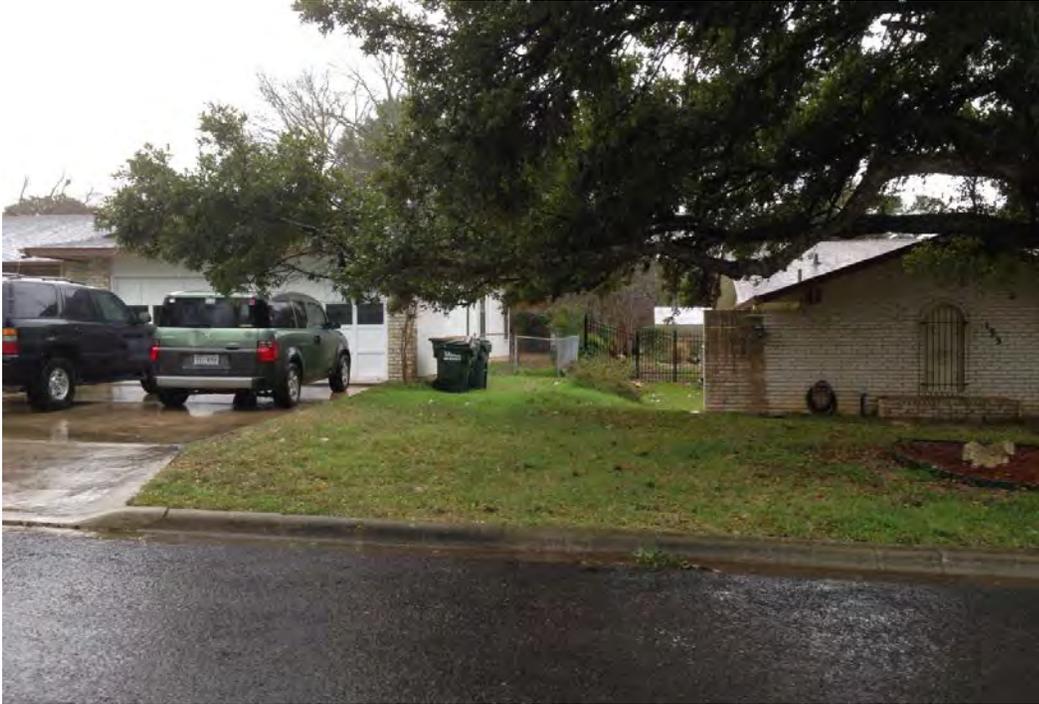
Photo #	Caption
<i>P3</i>	<i>Looking S at W side of property at 129 Chaparral Street</i>

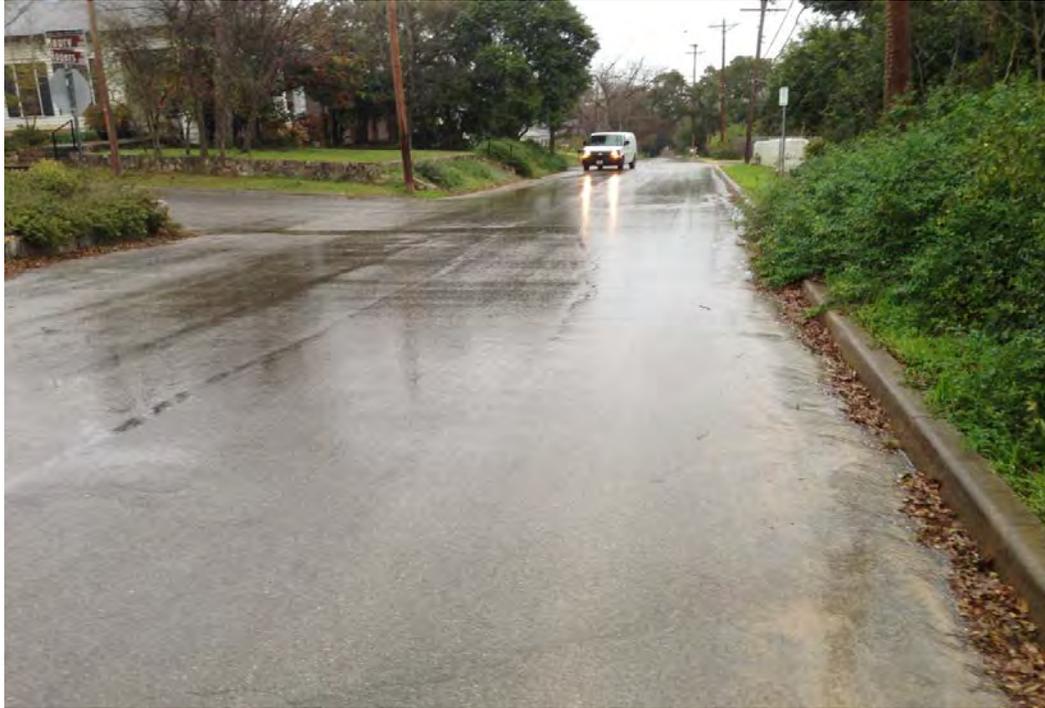
Cause of Flooding: Water overtopped curb on Rogers Street at Maury St and flowed onto property at 612 Lindsey Street.

P1	Looking NE on Rogers St towards intersection at Rogers St and Maury St
----	--

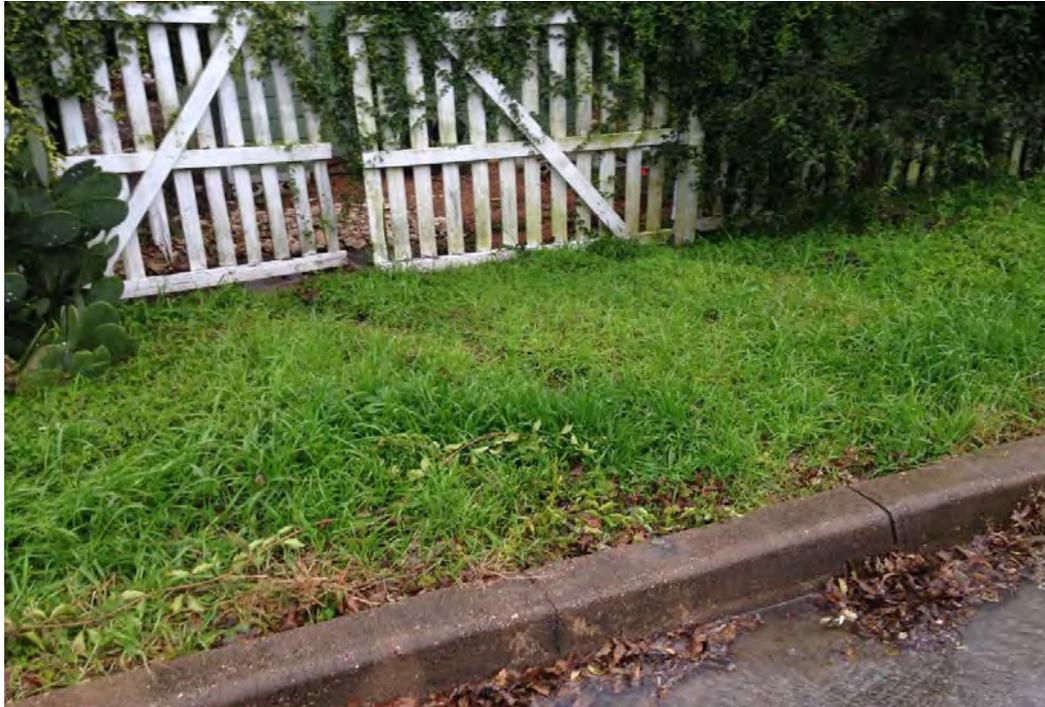
P2	Looking SE at back of lot at 612 Lindsey St
----	---

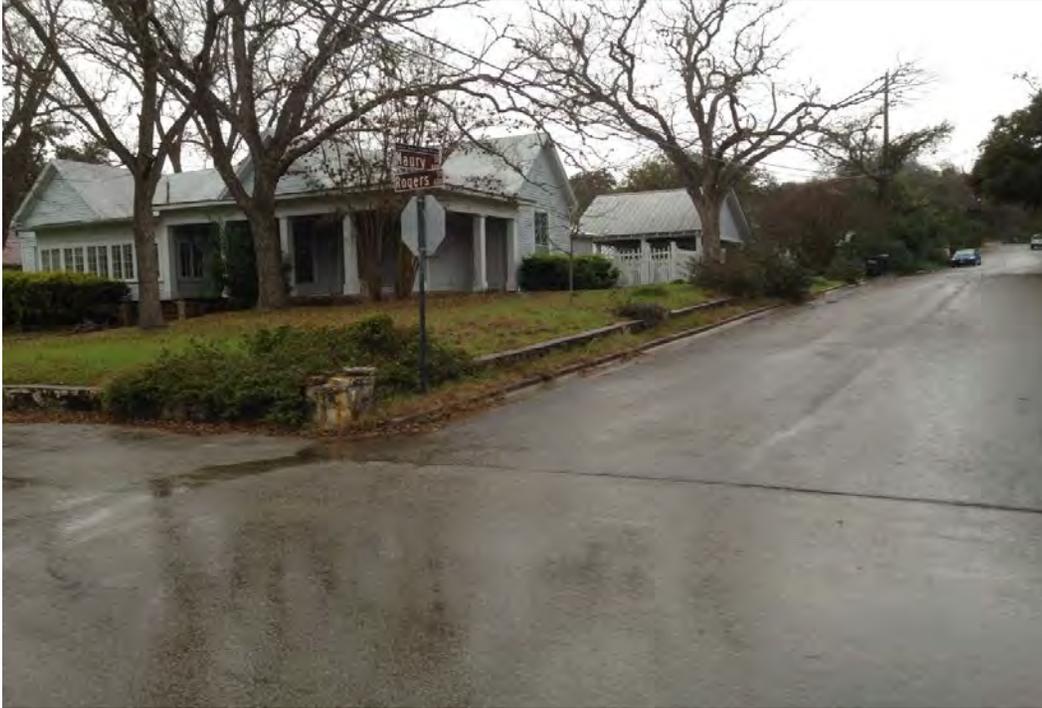
P3	Looking NW at Maury St from Rogers St at back of 612 Lindsey St
----	---

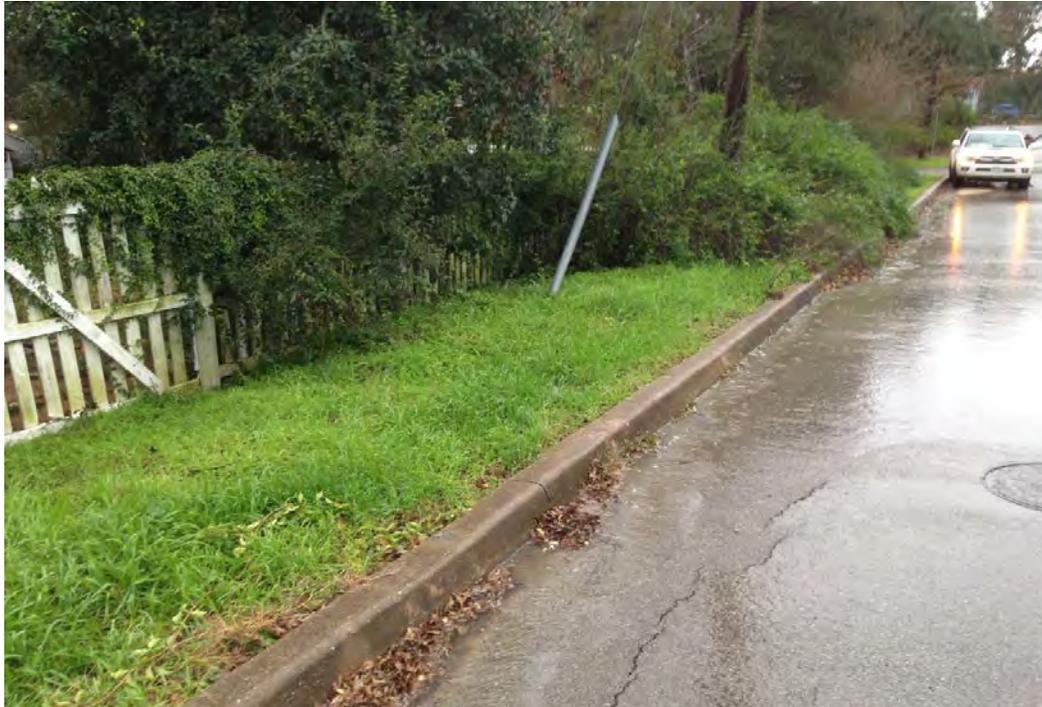
P4	Looking SW on Rogers St towards Serur St
----	--

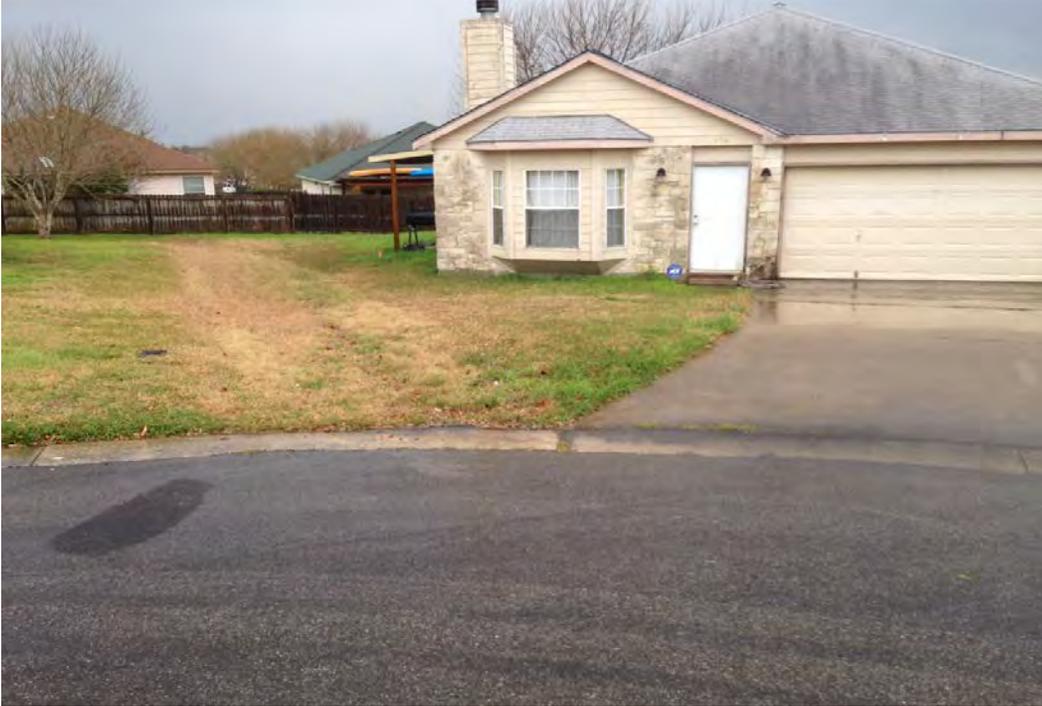
Cause of Flooding: Water overtops driveway and enters property; drainage channel adjacent to property.

P1	<i>Looking E at property at 720 Clearview Circle and adjacent stormwater flow path</i>
----	--

Replace driveway approach, grade gutter to drainage swale

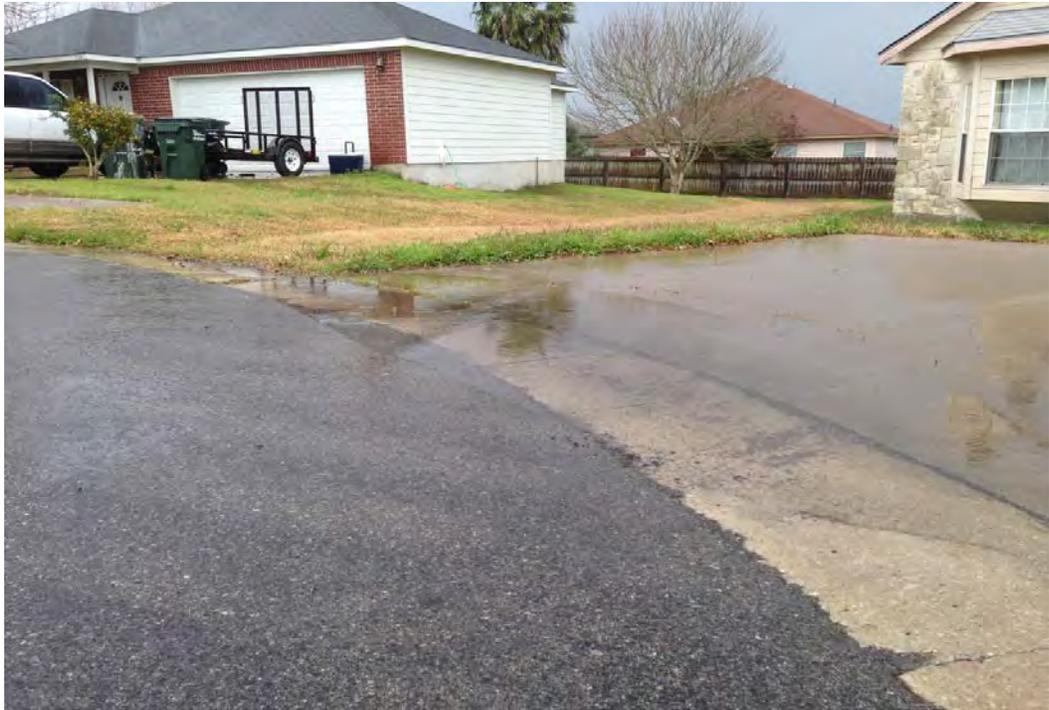
P2	<i>Looking NE at stormwater flow along driveway at 720 Clearview Circle</i>
----	---

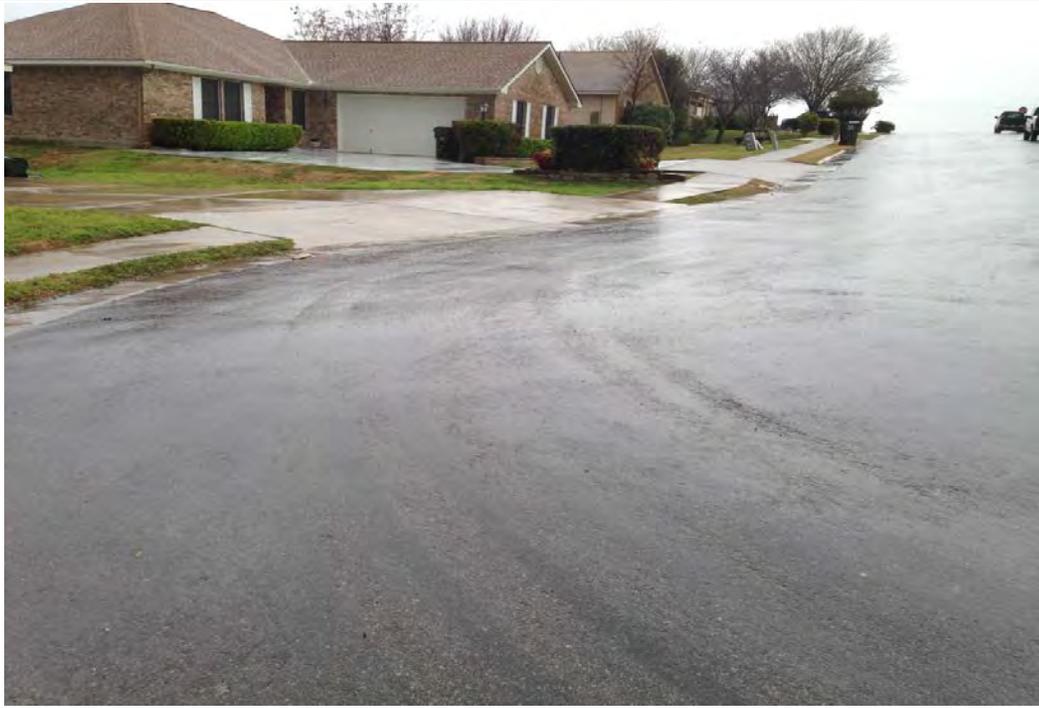
P3	<i>Looking W on Clearview Circle from 720 Clearview Circle</i>
----	--

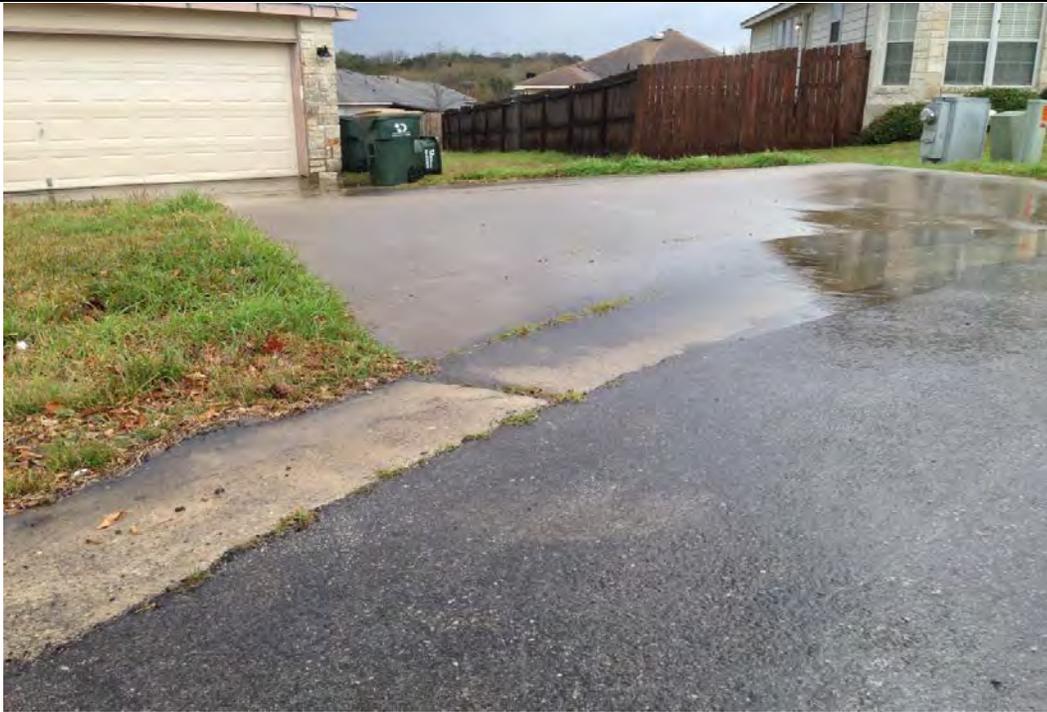
P4	<i>Looking SW at driveway at 720 Clearview Circle</i>
----	---
