Field Assessment Report (Hot Spots)

Site No.: 1 Location: 700 Blk McKie St (Willow Springs Creek)

San Marcos Comprehensive Watershed Master Plan
Field Assessment Form - Local Flood Complaints

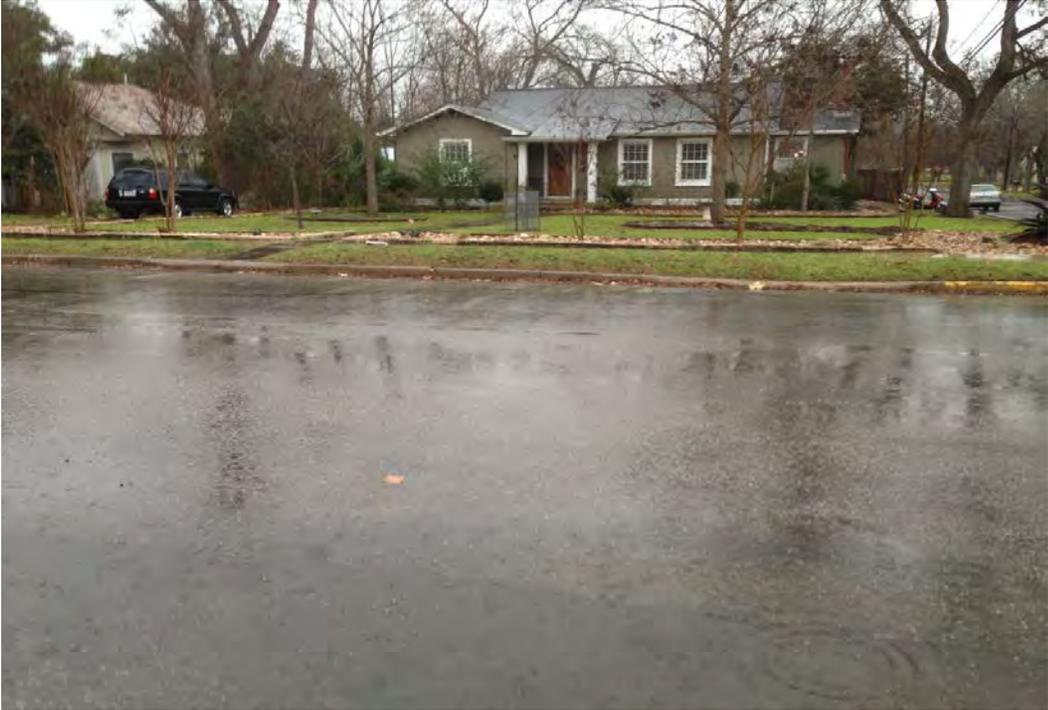
P1	<i>Looking S at 1029 San Antonio St from Johnson Ave</i>
----	--

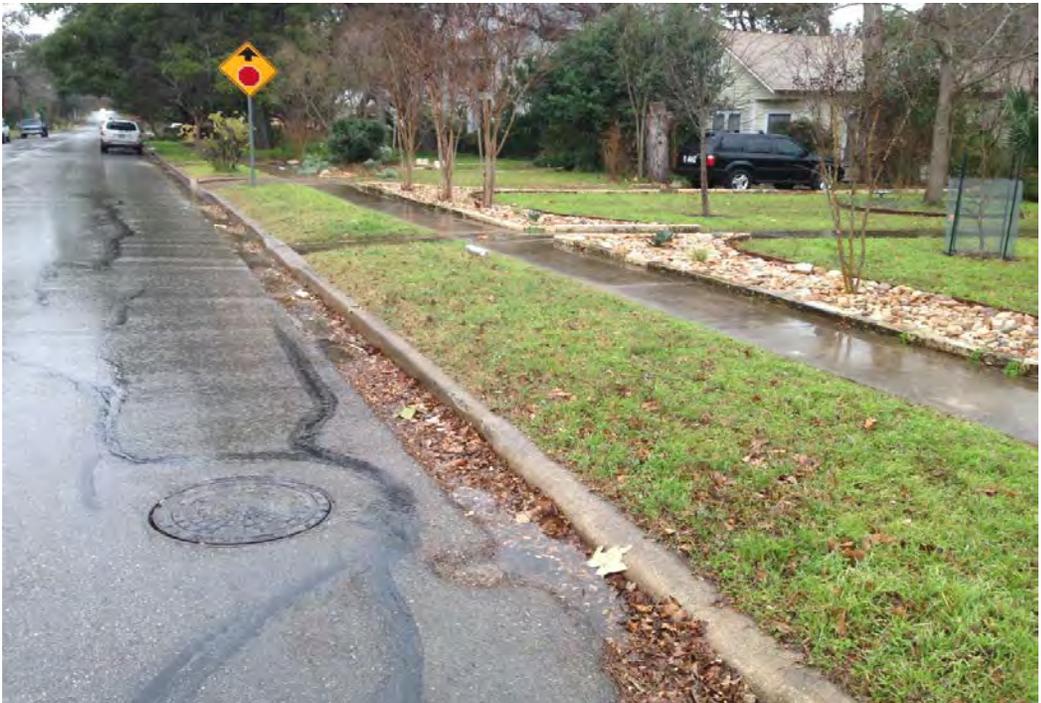
Cause of Flooding: *During heavy rain events, stormwater overtops curb and goes onto property. There is no storm drain system in this neighborhood. It also appears that the road was raised due to repaving.*

P2	<i>Looking NE at paving and curb adjacent to 1029 San Antonio St</i>
----	--

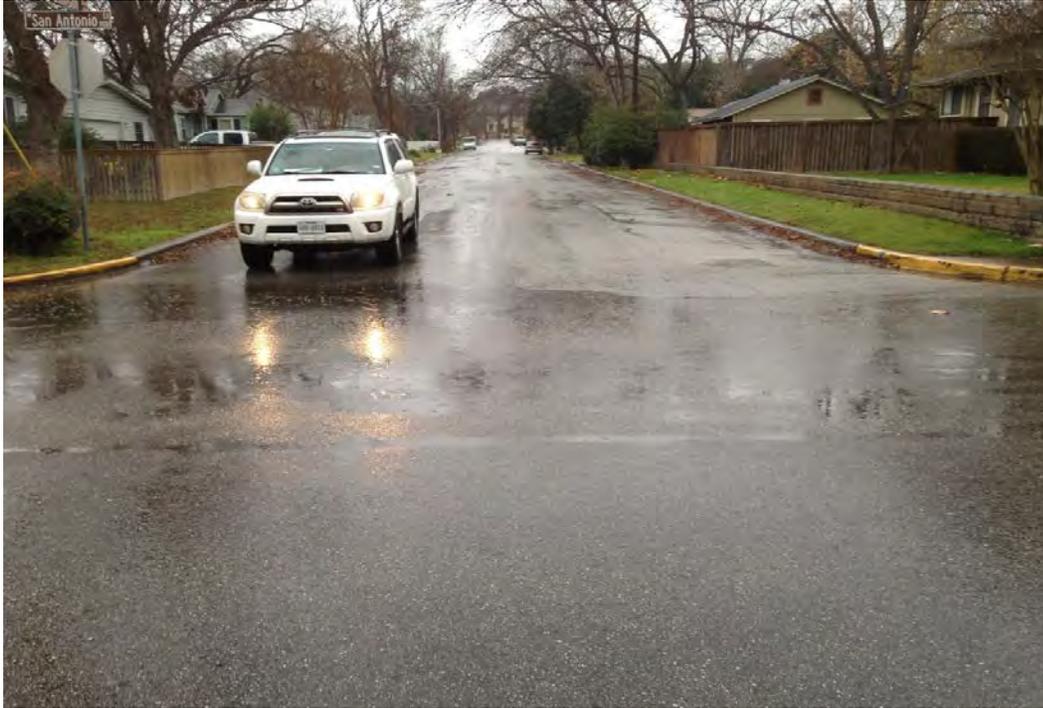
P3	Looking NW at Johnson Ave from 1029 San Antonio St
----	--

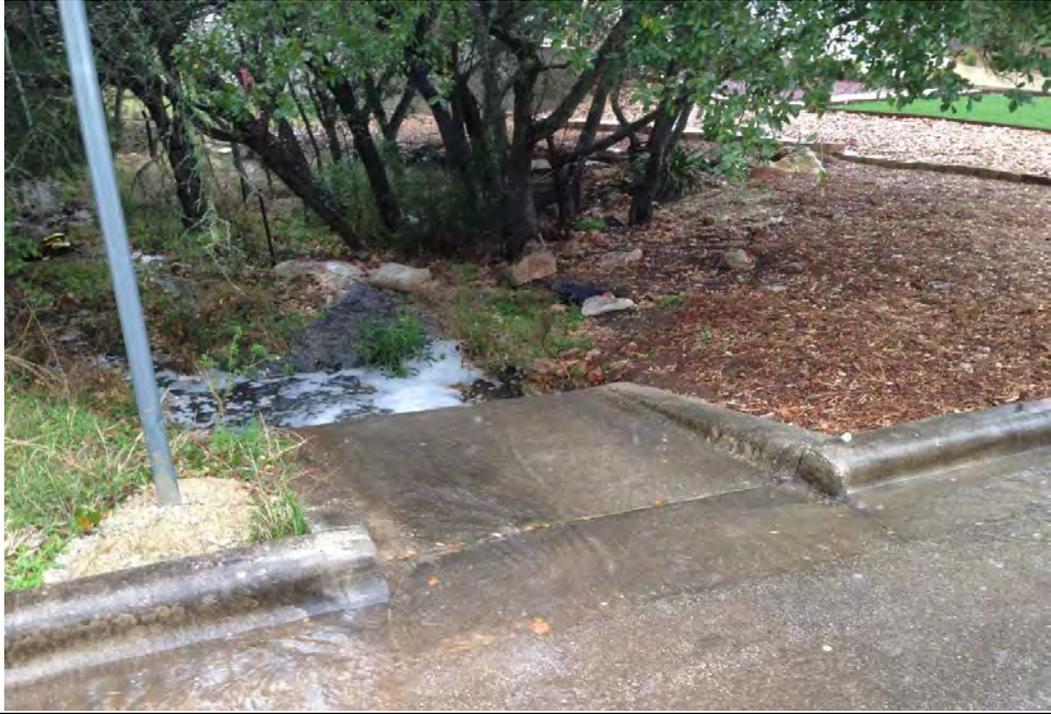
Cause of Flooding: Stormwater overtops curb @ flows into residential lot during heavy rain events.

P1	<i>Looking S at the existing curb cut on Summit Ridge Drive</i>
----	---

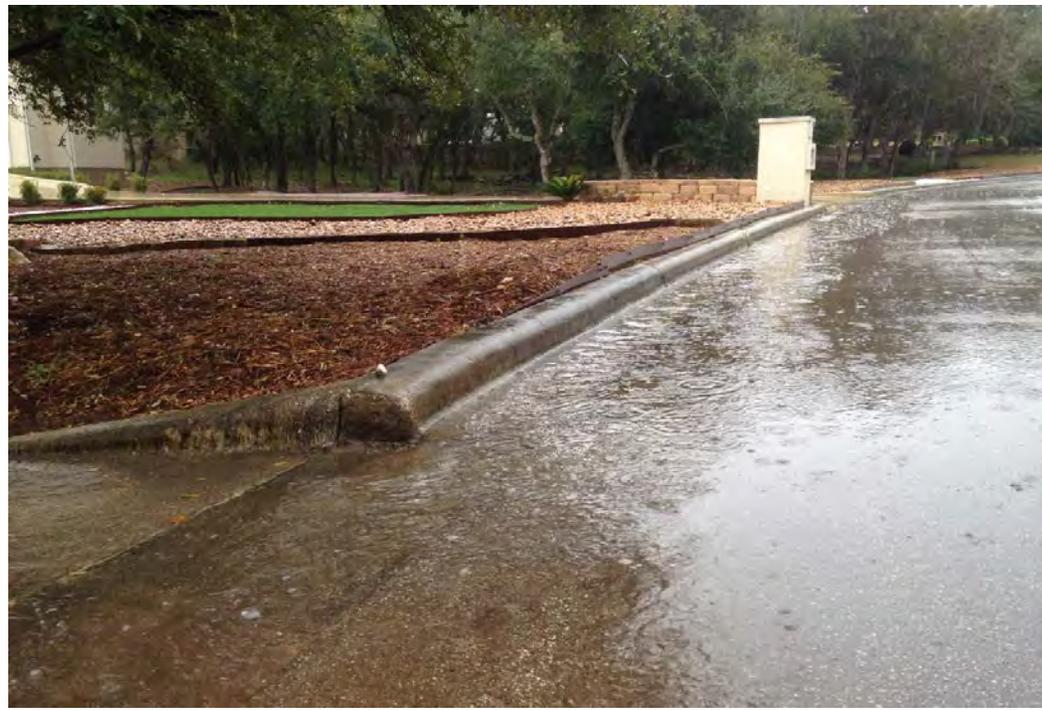
P2	<i>Looking SW from curb cut at water flowing on Summit Ridge Drive to curb cut</i>
----	--

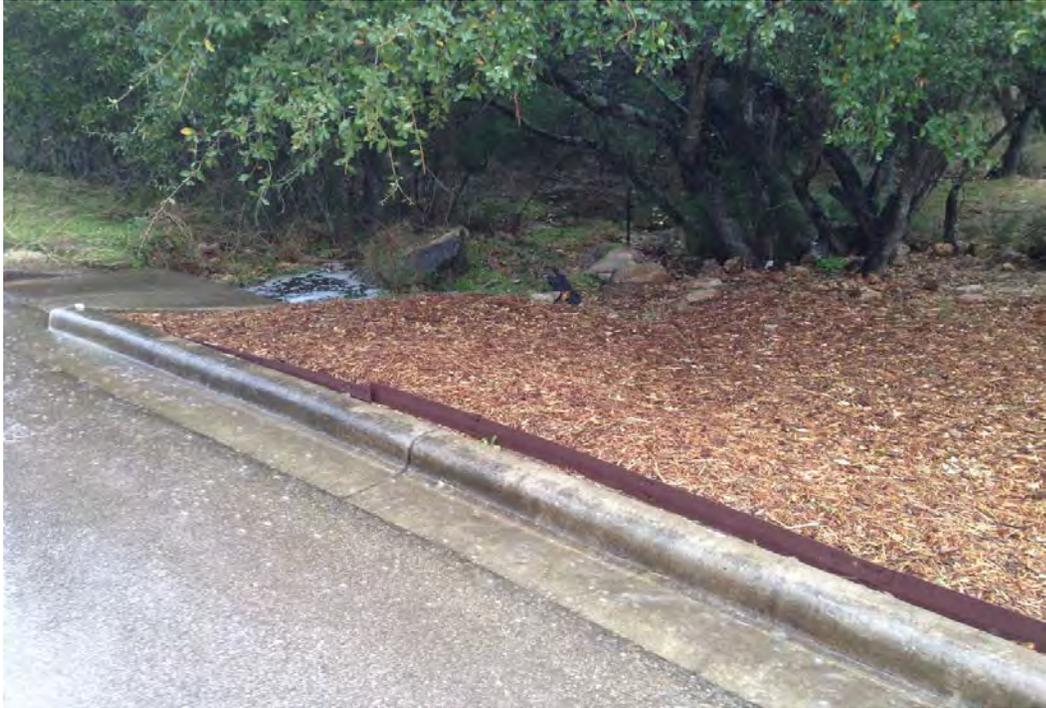
<i>P3</i>	<i>Looking S at 2319 Summit Ridge Drive towards the creek</i>
-----------	---

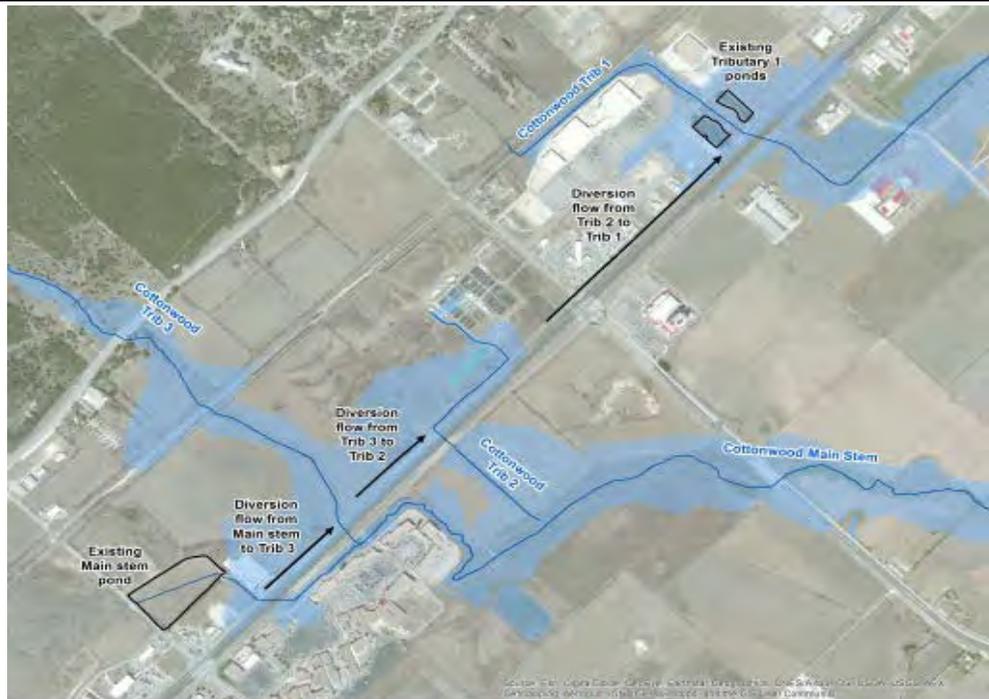
Figure 1. Overview of Cottonwood Creek and Tributaries at I-35

Cause of Flooding: Conveyance issues exist at the I-35 crossing, resulting in stormwater backing up on W side of I-35 and overflowing from Tributary 3 to Tributary 2 and Tributary 2 to Tributary 1.

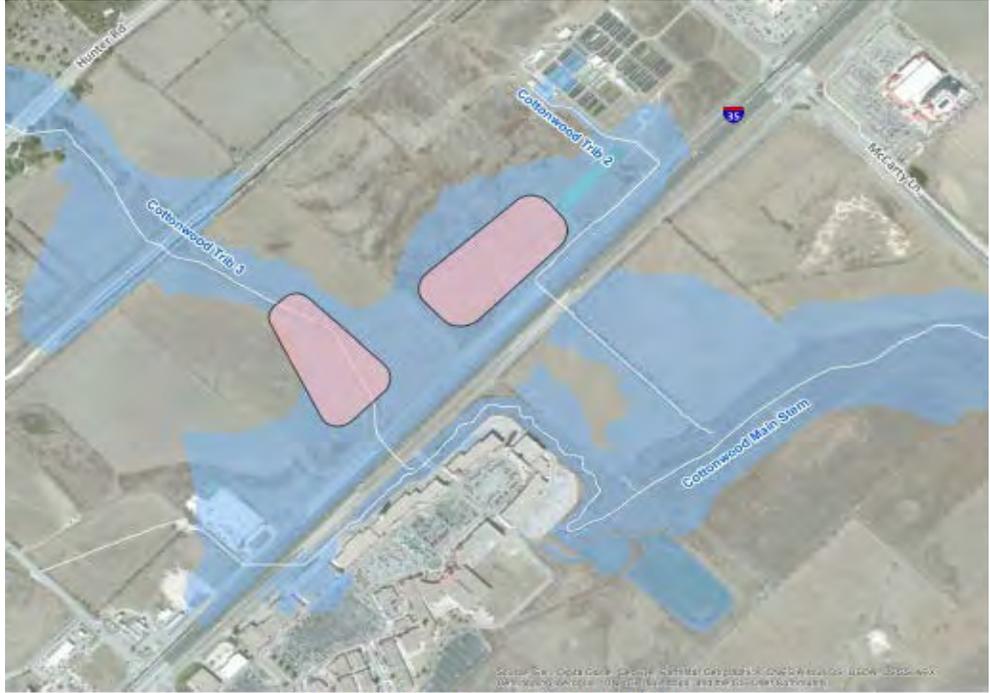
Figure 2. Option 1 Alternative Conceptual Layout

P1 *Option 1 Alternative Conceptual Layout*

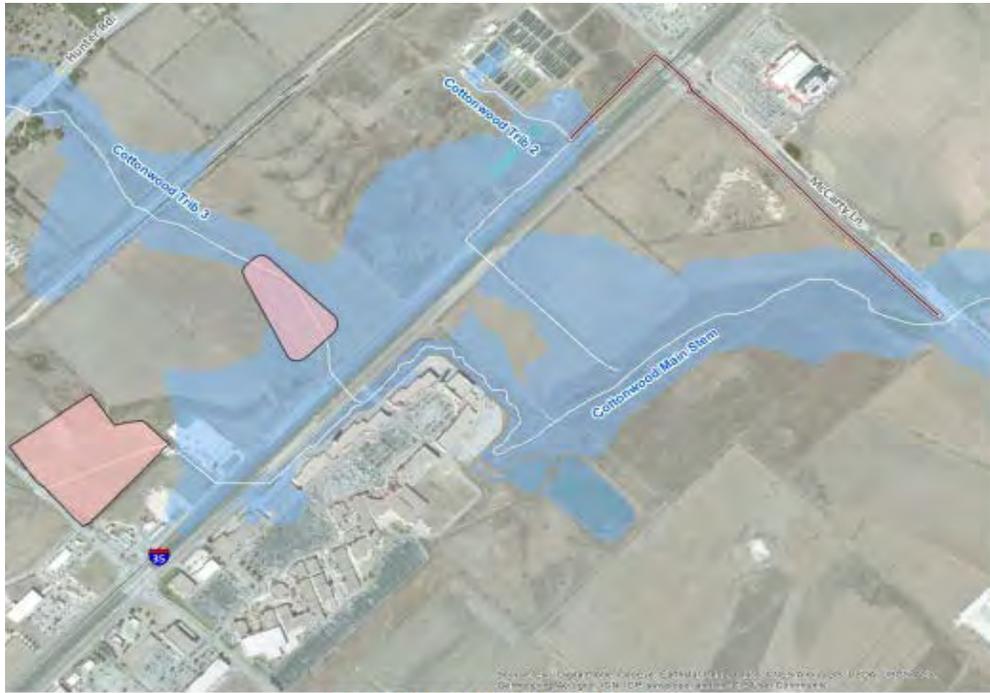
Figure 3. Option 2 Alternative Conceptual Layout

P2 *Option 2 Alternative Conceptual Layout*
